# ROAD SAFETY AUDIT

Orleans/Eastham Rotary  
Route 6/Van Dale Avenue Intersection  
Towns of Eastham and Orleans  
April 2019

**Michael Baker**

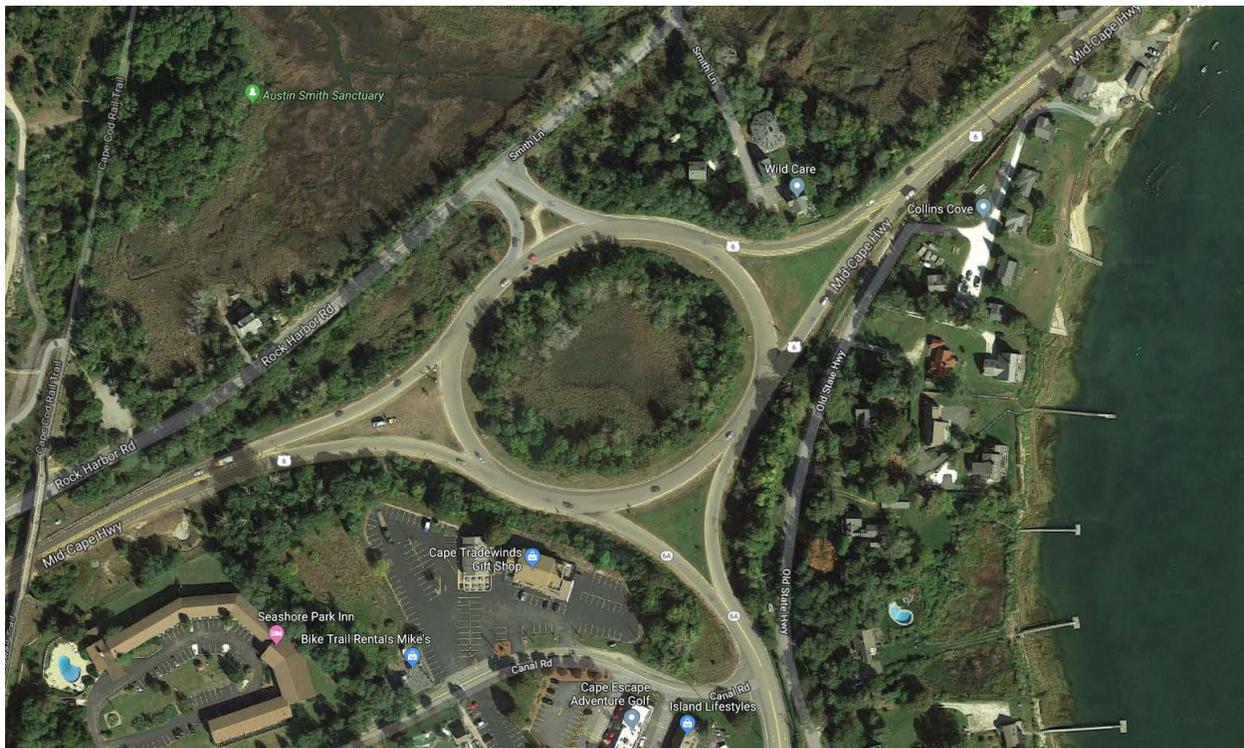
**Figure 3: Aerial image of Eastham/Orleans rotary depicting tangential entries and exits**

The approaches to the rotary align on a tangent, allowing entering and exiting motorists to maintain high speeds and drivers to disregard the need to slow down and yield to circulating/exiting vehicles. Audit team members noted that the current alignment and angle of the roadways create ‘slip lane’ geometry which allows drivers to enter and exit the circle without yielding, and that the excessively large entry radii produce a fast entry speed into the rotary. Audit team members also noted the long tangential approaches provide too much time for drivers approaching the circle to view the circulating traffic. This condition causes the driver to become distracted and pay less attention to the vehicle directly in front of them,

resulting in a rear-end crash. During the three-year period of crashes collected and reviewed, rear-end crashes accounted for 76% of all crashes (39 of 51 crashes between 2014-2016). Crashes occurring at the entrance approaches to the rotary from Route 6 or Route 6A accounted for 71% (36 of 51 crashes between 2014-2016)

On the Route 6 eastbound approach, participants noted skid marks on the pavement and median as evidence of deficient geometry encouraging high entry speeds instead of geometry that enforces yielding and slower entries.

- Participants discussed modifying the geometry of the splitter islands, so vehicles enter the circulating roadway at more of a ‘T’ than a ‘Y’ configuration, reducing the radius of the entry curve and tangent. The modifications would more closely resemble a modern roundabout with approach geometry designed to slow vehicles upon entry into the roundabout.
- Evaluate the feasibility of replacing the existing rotary with a modern roundabout. During the discussion it was noted that the center island is designated as wetland.
- Consider the feasibility of right turn bypass lane (6A Northbound) that is separated/channelized with the circle.

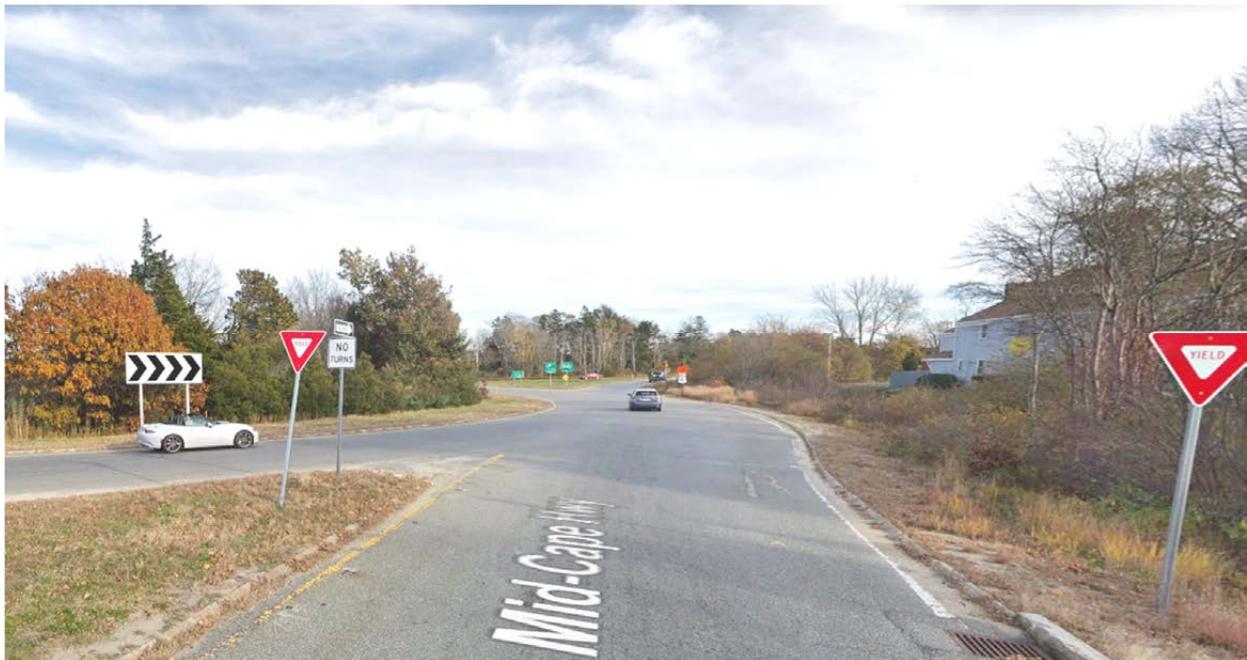
**Figure 4: Route 6 eastbound approach to Eastham/Orleans rotary**

During the RSA virtual field visit, participants noted that at the rotary approaches, departures and circulating roadways there is an extensive amount of pavement (20’-30’ wide) that is very wide and unmarked. It was remarked that the wide unmarked lanes cause confusion for positioning and frequent adjustments of position by drivers. The unmarked nature and inconsistent widths encourage erratic merging, weaving, and jockeying maneuvers. The inconsistent lane widths and limited pavement marking also contribute to drivers being in the ‘wrong’ lane when circulating verse exiting the rotary. Participants noted the yield signage is located too early and is not aligned with the location where drivers need to or should be yielding, and that there is no yield line pavement marking. Participants also noted that the signage at the guardrail at the Smith lane intersection was unclear. Vegetation obscuring the existing signage was also noted.

- Stripe the approaches, exits, and circulating roadway for one lane.
- Where Route 6A enters the roundabout consider a two-lane approach with a two-lane departure to Route 6 eastbound. This modification would provide a dedicated lane for drivers turning from Route 6A to Route 6 eastbound. Flexible delineators were discussed to channelize this dedicated movement. The impact of this treatment on vehicle speeds at the pedestrian crossing just north of the rotary would need to be evaluated.
- Reposition the yield signs closer to the merge point.
- Consider striping the approaches to include “yield markings”, YIELD (word) and YIELD AHEAD (symbol or word) markings
- Consider addition of a 25 MPH speed limit sign on Route 6 eastbound as drivers approach the circle. There is some speed signage currently but no sign for the actual speed limit.

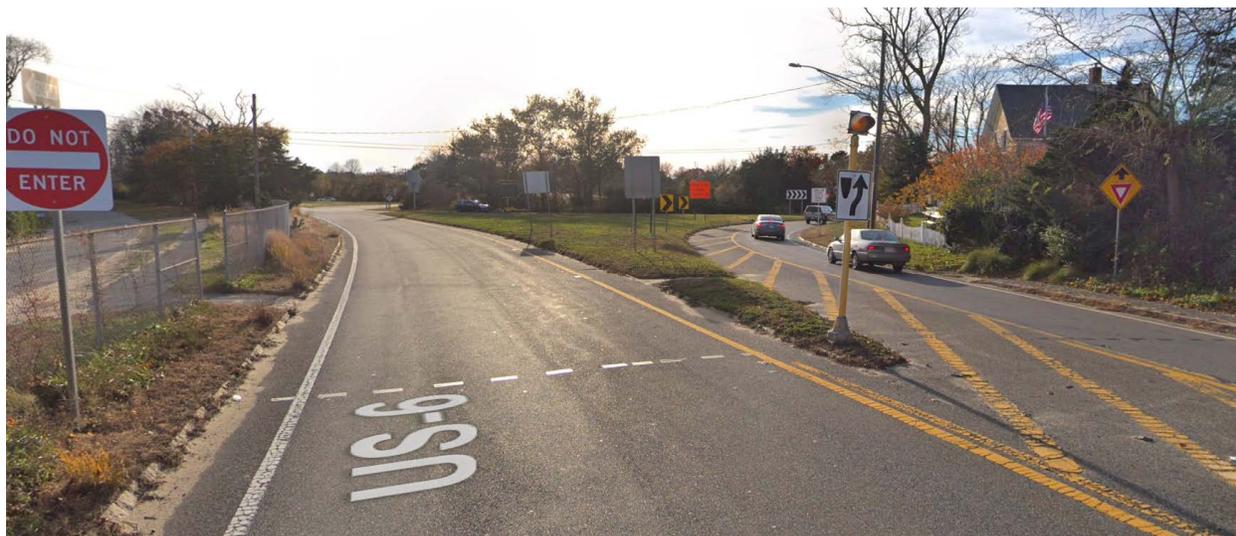
**Figure 6: Unmarked crossing at Route 6 eastbound exit lane, looking west**

Audit team members expressed concern that pedestrians are present within the vicinity of the rotary. Participants noted a break in the chain-link fence on the east side of the Route 6 eastbound exit lane that pedestrians frequently utilize. Most pedestrians cross at the unmarked crosswalk location. Neither a crosswalk nor truncated domes are present at this location.

- Provide high-visibility marked crosswalk at current unmarked location. Upgrade curb ramps to meet the minimum ADA requirements. Investigate whether enhanced crossing treatments such as a Rectangular Rapid Flashing Beacon (RRFB) or Pedestrian Hybrid Beacon (PHB) are necessary due to the speed and volume of the vehicular traffic.

- As a short-term measure, consider striping and/or signing the existing crossing.
- Evaluate pedestrian desire lines and the feasibility to provide a sidewalk between Route 6 westbound approach and Rock Harbor Road/Smith Lane. The Cape Cod Rail Trail (CCRT) and Orleans District Court can be accessed from Rock Harbor Road.

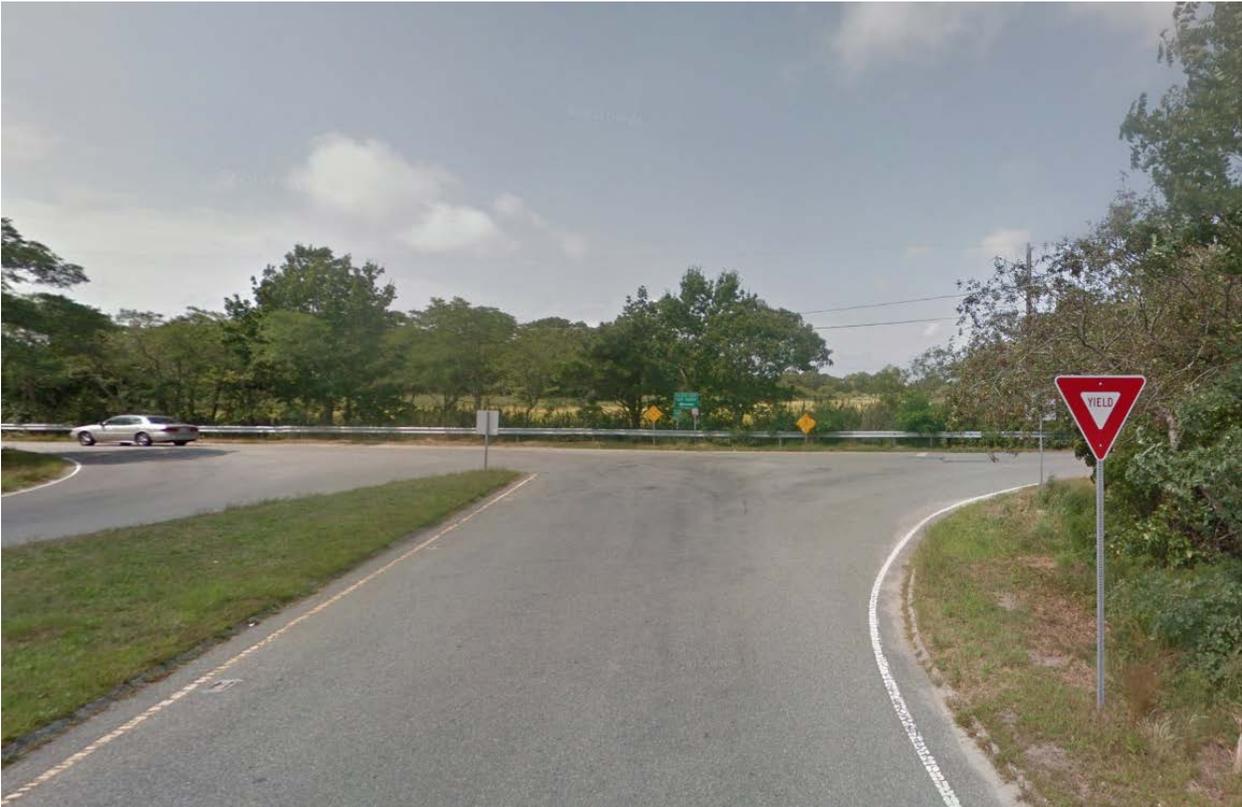
**Figure 7: View of Eastham/Orleans rotary exit at Rock Harbor Road/Smith Lane**

The Rock Harbor Road/Smith Lane intersection is located directly north of the rotary, approximately 150' from the circulating roadway, resulting in an abrupt, unexpected stop. In addition to its proximity to the rotary, the signage is unclear regarding who has the right-of-way causing driver confusion. There is a yield sign on the rotary exit located approximately 50-feet before the intersection. The Smith Lane stop sign is not visible to exiting traffic. Additionally, the Smith Lane stop bar and stop sign are not aligned. Participants understand the exiting traffic has the right-of-way and is not required to stop, but this may be not be clear to drivers unfamiliar with the area.

- Consider additional pavement markings to facilitate a direct connection from the rotary exit to Rock Harbor Road. Realign Smith Lane to intersect perpendicularly to the direct connection.
- Align the Smith Lane stop bar and stop sign. Consider relocating so oncoming traffic can see Smith Lane stop sign and markings. Consider signage alerting drivers that Smith Lane is controlled by a stop sign.

- Provide signage for Rock Harbor Road approach.

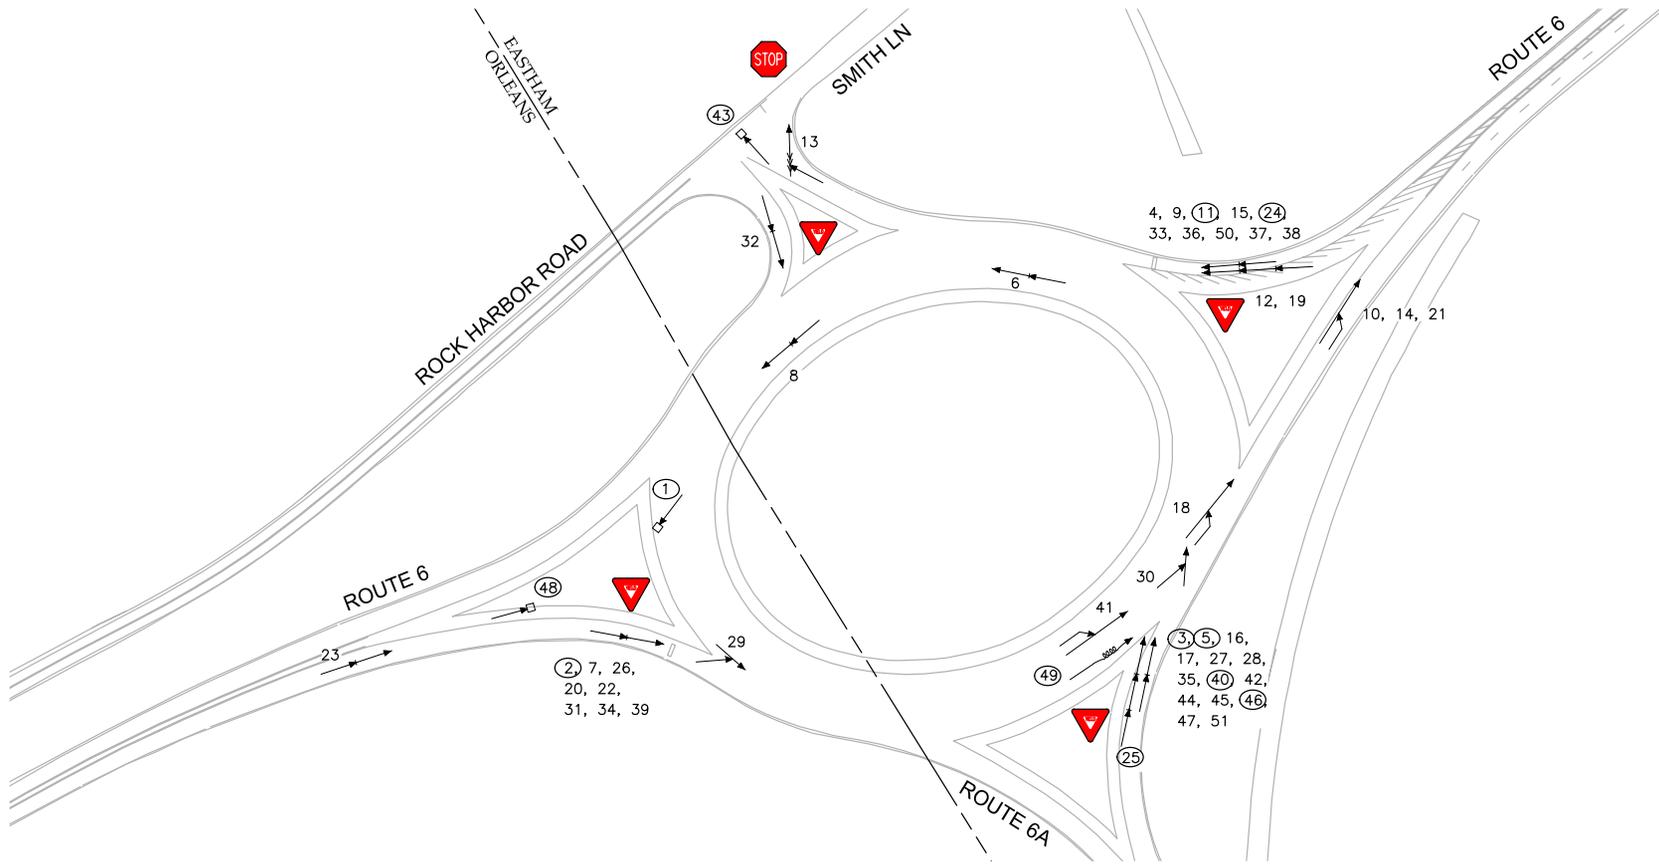
**Figure 1**  
 Collision Diagram  
 Rotary at Mid-Cape Highway (Rte. 6)  
 Eastham & Orleans, Massachusetts

For the Eastham/Orleans rotary, the most prevalent crash type was rear-end crashes, accounting for 76% of all crashes. Sideswipe crashes were the second most common manner of collisions, accounting for 12% of crashes. Single vehicle crashes and angle collisions account for 6% and 6% of the crashes, respectively. 78% of crashes occurred under daylight conditions, while 22% of crashes occurred under dark conditions.
