CAPE COD
COMMISSION

Side Path Crossings Inventory

FINAL | SEPTEMBER 2024

Prepared by Cape Cod Commission Staff.

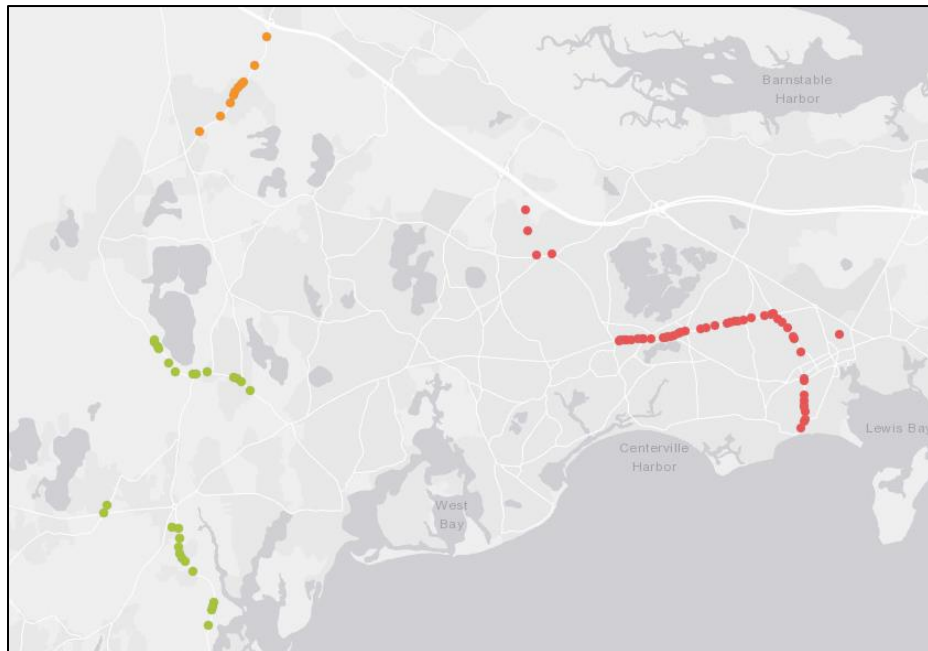
Figure 1: Sandwich, Mashpee, and Barnstable At-Grade Side Path Crossings (from left to right)

The following figures (Figure 1 and 2) are maps showing the location of the at-grade crossing. At-grade crossings are locations where the roadway and the side path cross at the same elevation. These at-grade crossings were chosen to be inventoried as they are the locations that non-motorists encounter motorists and as such the safety features at these locations are significant and should be kept track of. The points are color coded by town with Barnstable in red, Chatham in pink, Dennis in blue, Mashpee in green, Sandwich in orange, and Yarmouth in purple.

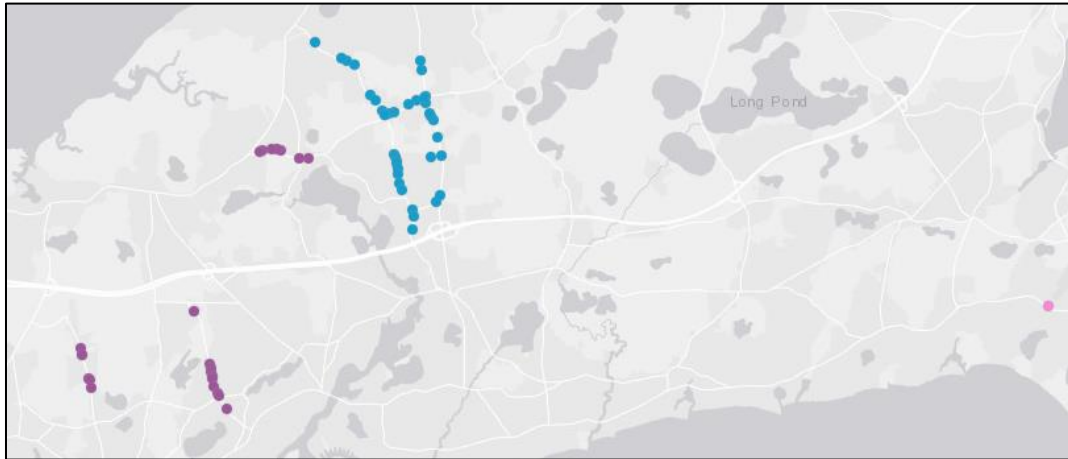
Figure 2: Yarmouth, Dennis, and Chatham At-Grade Side Path Crossings (from left to right)

Some points in Figures 1 and 2 may appear to be overlapping and/or not appear in their correct geographical location. This is due to the zoom level used to fit all points in a scaled down view for the purpose of display in this report.

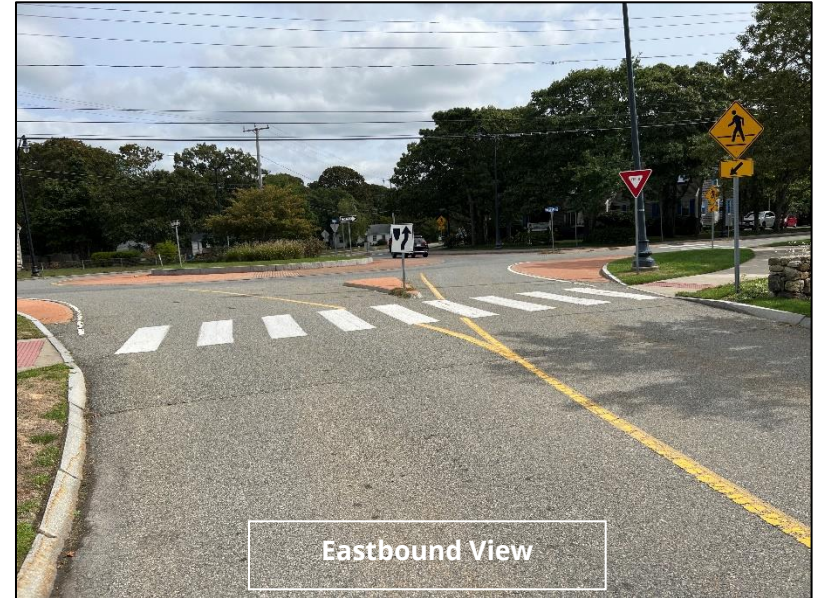
Eastbound View

The crossing is 40 feet across. There are no stop signs or MUTCD R5-3 “No Motor Vehicles” signs on either path approach. The crosswalk is a continental style crossing with cracked pavement markings. The northbound side path approach is 10 feet wide while the southbound approach is 12 feet wide. Both approaches are offset from the rotary and set back from the roadway. There are detectable warning panels and concrete curb ramps on both approaches. There are no additional pavement markings.

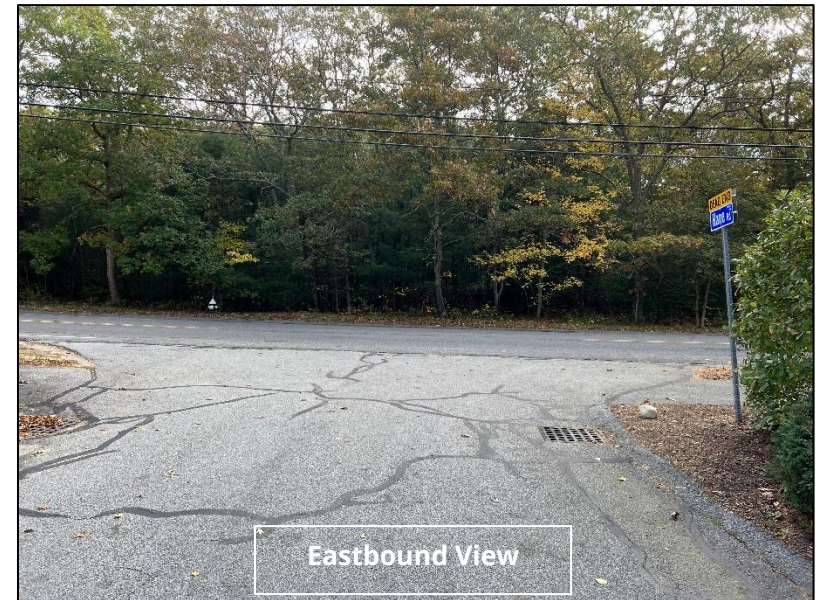
Eastbound View

The crossing is 30 feet across. There are no stop signs or MUTCD R5-3 “No Motor Vehicles” signs on the path approaches. The crosswalk is a standard style crosswalk with cracked and faded crosswalk markings. The side path approaches are both 8 feet wide. The northbound side path approach has a 4-foot offset from the roadway while the southbound approach is separated by a garden, trees, and grass. The crossing itself is set back a considerable distance from the intersection. There are no detectable warning panels or additional pavement markings.

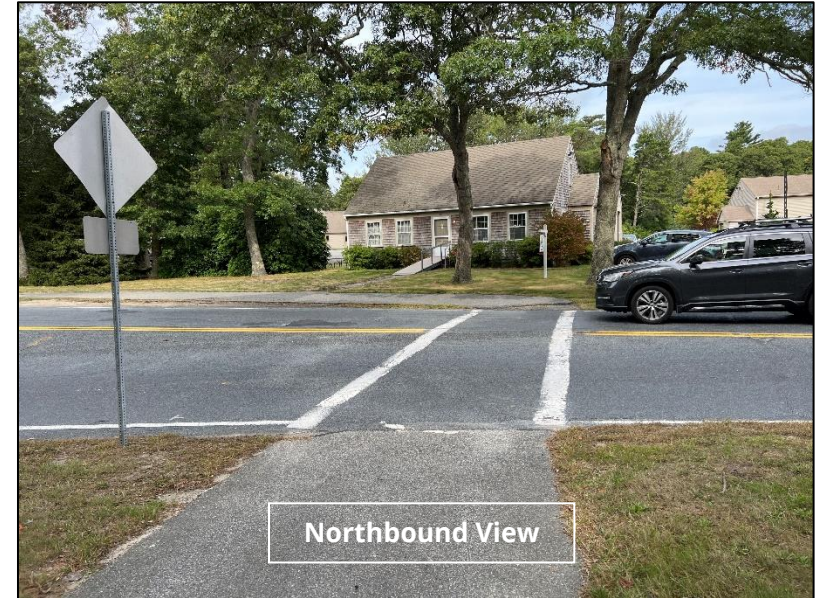
Northbound View

The crossing is a two-stage crossing that is 38 feet across. There are no stop signs or MUTCD R5-3 “No Motor Vehicles” signs on the path approaches. The crosswalk is a standard style crosswalk with cracked and faded crosswalk markings. Both side path approaches are 8 feet wide. The crossing itself is set back from the intersection. On the side path approaches, the northbound approach has a 4-foot offset from the roadway and a 4-foot offset on the southbound approach. There are no detectable warning panels or additional pavement markings on either side.

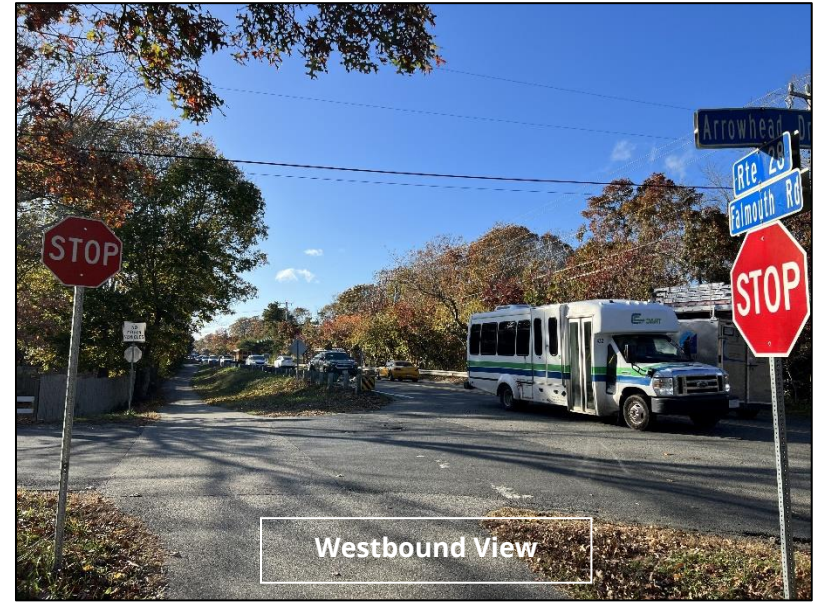
Westbound View

The crossing is 43 feet across. There is a stop sign on the westbound approach and a MUTCD R5-3 “No Motor Vehicles” sign on the eastbound approach. The crosswalk is unmarked. Both side path approaches are 8 feet wide. The eastbound approach is offset from the road by 18 feet while the westbound approach has an offset of 23 feet. There are no detectable warning panels or additional pavement markings on either approach. The side path approaches are in poor condition.

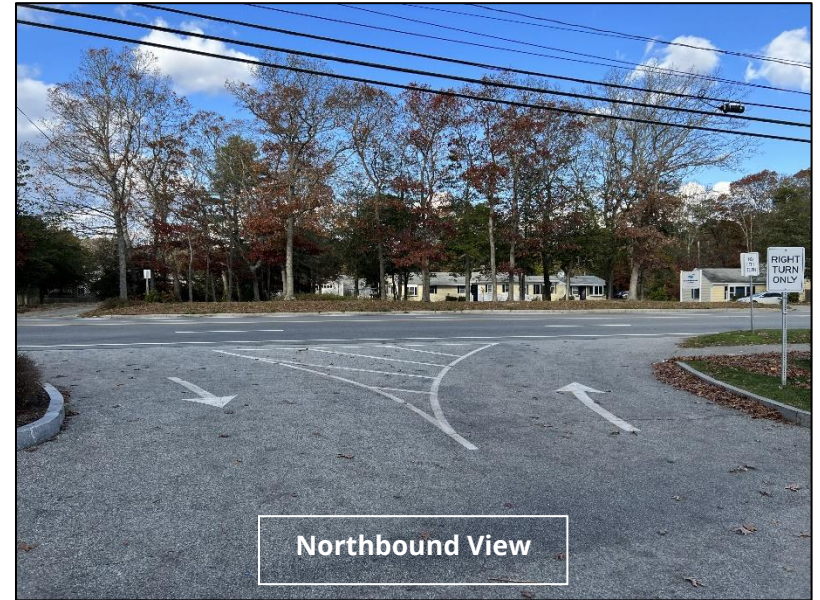
Northbound View

The crossing is 46 feet across. There are no stop signs or MUTCD R5-3 “No Motor Vehicles” signs on either side path approach. The crosswalk is unmarked and the pavement at the crossing is in poor condition. Both side path approaches are 8 feet wide. The eastbound side path approach has a 5-foot offset from the roadway while the westbound approach has a 7-foot offset. There are no detectable warning panels or additional pavement markings on either approach.

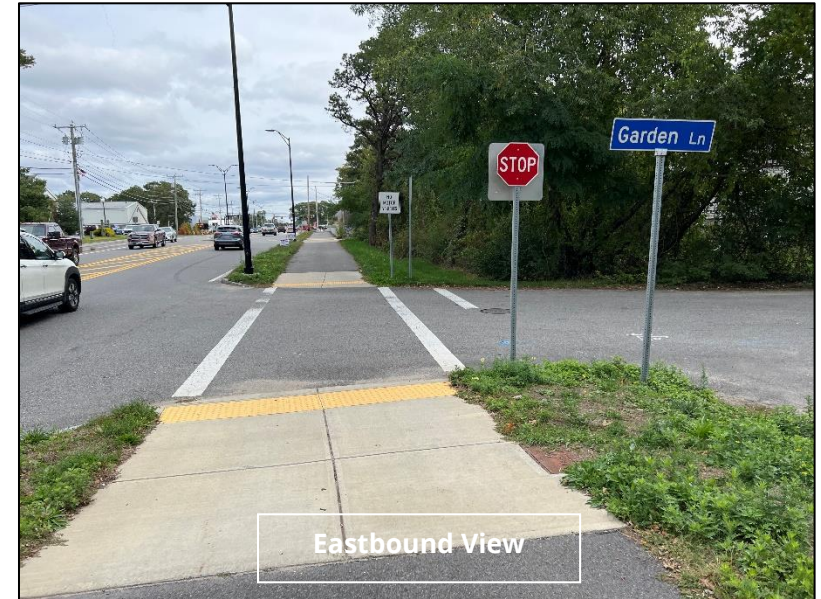
Eastbound View

The crossing is 27 feet across. There are no stop signs or MUTCD R5-3 "No Motor Vehicles" signs on the path approaches. The crosswalk is a ladder style crosswalk with cracked and has very faded crosswalk markings. The side path approaches are both 7 feet wide. Both the side path approaches have an 8-foot offset from the roadway. Both approaches have detectable warnings panels and concrete curb ramps. There are no additional pavement markings.

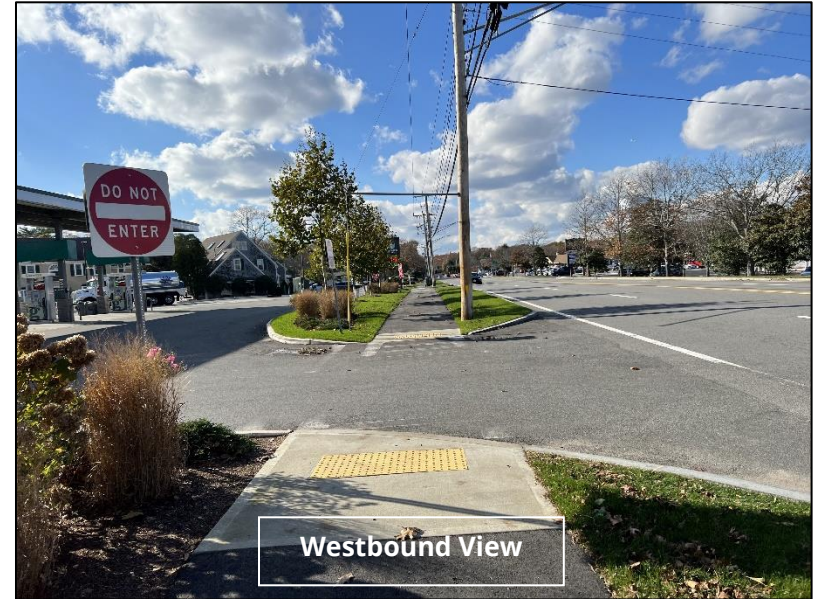
Westbound View

The crossing is 35 feet across. There are no stop signs or MUTCD R5-3 "No Motor Vehicles" signs on the path approaches. The crosswalk is a ladder style crosswalk that is cracked and faded. The side path approaches are both 7 feet wide. The side path approaches have an 8-foot offset from the roadway. Both approaches have detectable warnings panels and concrete curb ramps. There are no additional pavement markings.

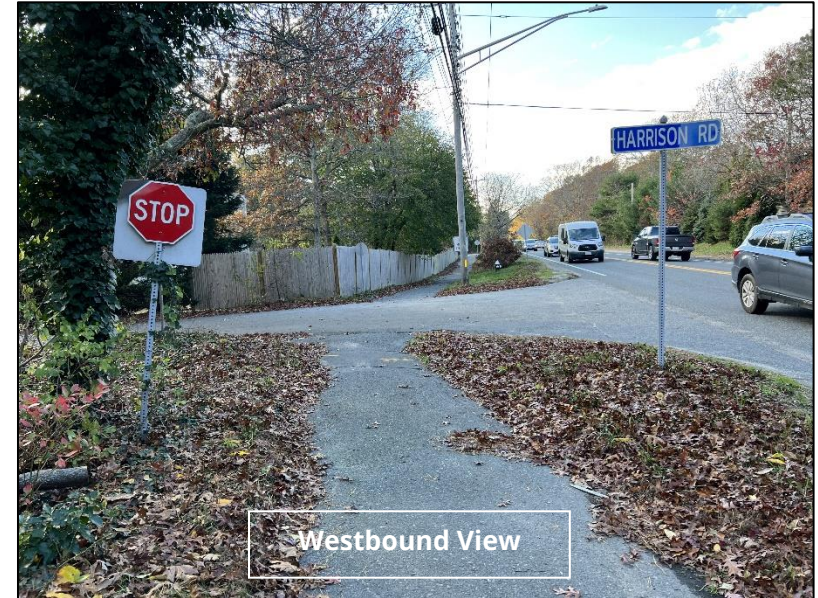
Westbound View

The crossing is 29 feet across. The crosswalk is a standard style with cracked and faded pavement crosswalk markings. There are stop signs on both path approaches with MUTCD R5-3 “No Motor Vehicles” signs. The path approaches are 8 feet wide on the eastbound approach and 7 feet wide on the westbound approach. There is a 14-foot offset from the path to the road on the westbound approach and an 8-foot offset on the eastbound approach. There are no detectable warning panels or additional pavement markings on either approach.

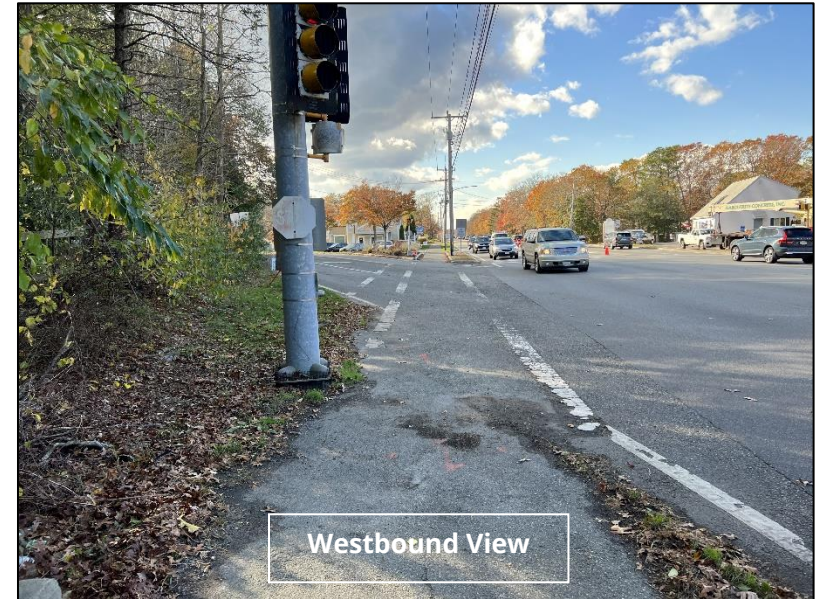
Westbound View

The crossing is 111 feet across. There are stop signs at the crossing in both directions, the westbound approach stop sign is extremely faded. There are MUTCD R5-3 "No Motor Vehicles" signs in both directions on the side path. The crosswalk is a standard style crosswalk with cracked and faded crosswalk markings. The eastbound side path approach is 8 feet wide, and the westbound approach is 7 feet wide. The eastbound side path approach has a 6-foot offset from the roadway while the westbound approach has a 3-foot offset. There are no detectable warning panels or additional pavement markings on either approach.

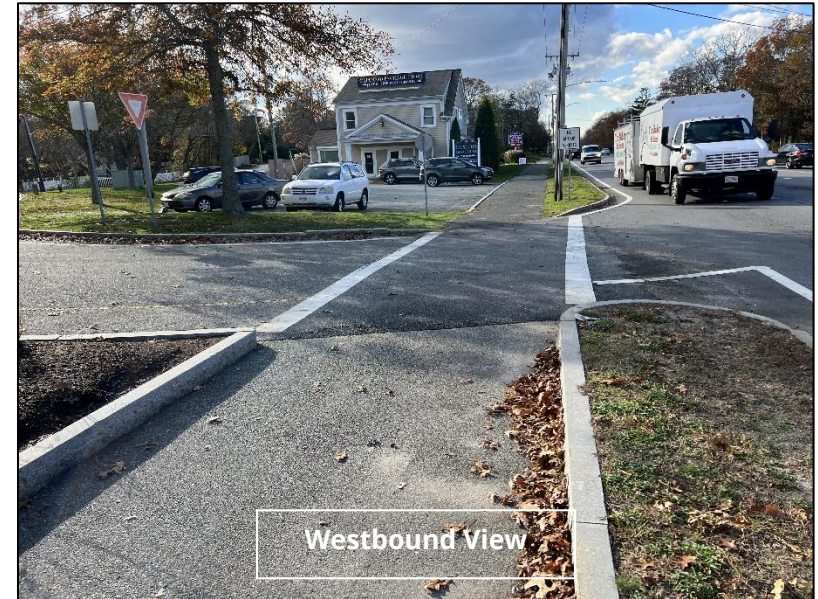
Westbound View

The crossing is 30 feet across. There is a stop sign at the crossing on the eastbound approach. There is a MUTCD R5-3 "No Motor Vehicles" sign when heading westbound on the side path crossing. The crosswalk is a standard style crosswalk with cracked crosswalk markings. The eastbound side path approach is 7 feet wide and while the westbound approach is 8 feet wide. Both side path approaches have a 6-foot offset from the roadway. There are no detectable warning panels or additional pavement markings on either approach.

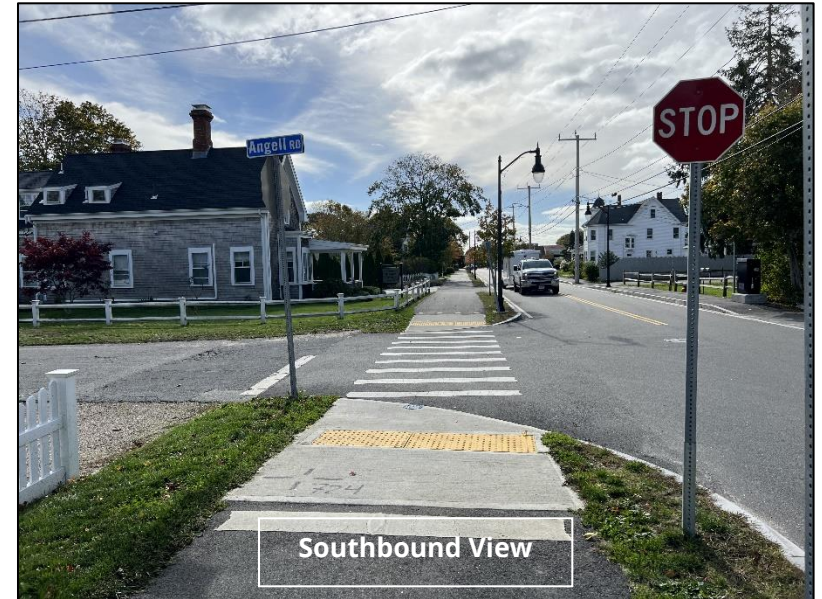
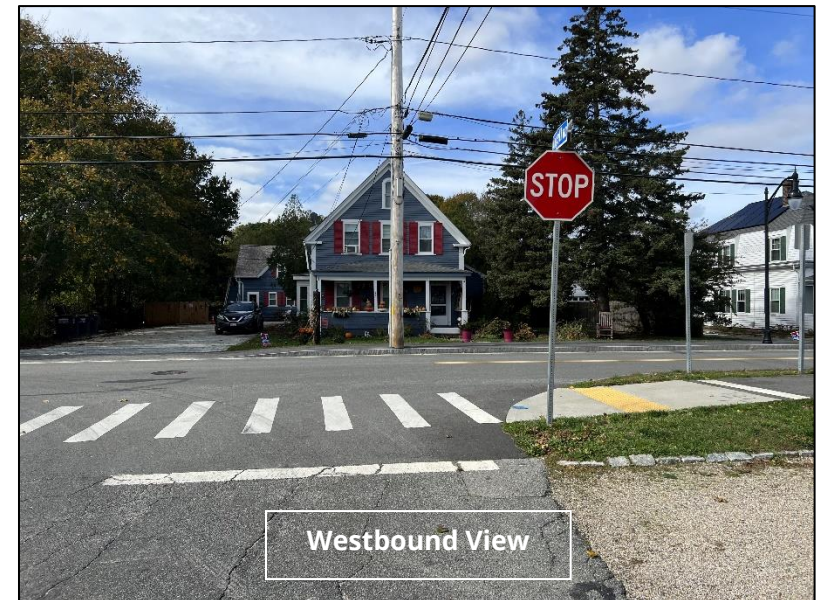
The crossing is 29 feet across. There is a yield sign on the northbound side path approach and a stop sign on the southbound approach. There are no MUTCD R5-3 "No Motor Vehicles" signs on either side. The crosswalk is a continental style crossing with cracked pavement markings. The side path approaches are 8 feet wide and offset from the roadway by 4 feet leading up to the crossing. There are detectable warning panels and concrete curb ramps on both approaches. There is a yield line on the northbound approach and a stop bar on the southbound approach before the concrete curb ramps.

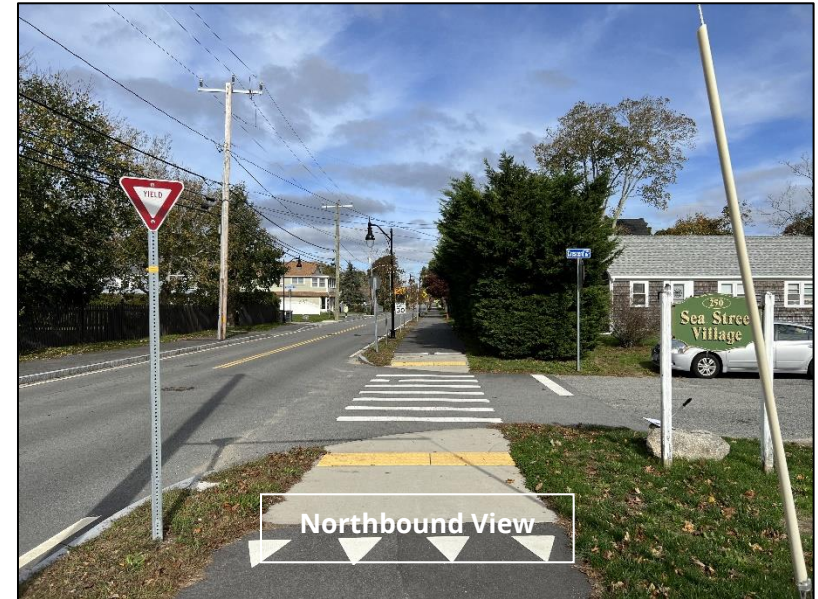
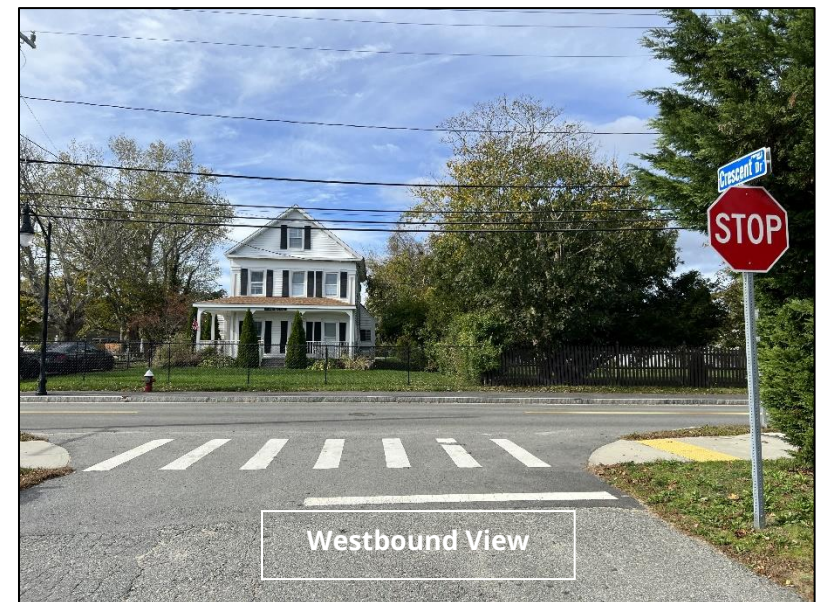
The crossing is 25 feet across. There is a yield sign on the northbound side path approach and a stop sign on the southbound approach. There are no MUTCD R5-3 "No Motor Vehicles" signs on either side. The crosswalk is a continental style crossing with cracked pavement markings. The path approaches are both 8 feet wide and offset from the roadway by 3 feet leading up to the crossing. There are detectable warning panels and concrete curb ramps on both approaches. There is a yield line on the northbound approach and a stop bar on the southbound approach before the concrete curb ramps.

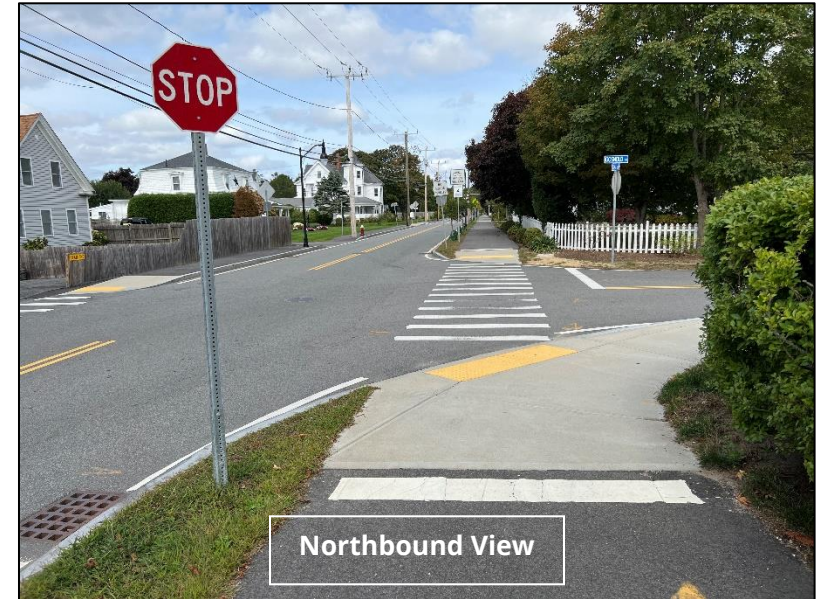
Northbound View

The crossing is 46 feet across. There are stop signs on both side path approaches and a MUTCD R5-3 “No Motor Vehicles” sign on the back of the stop sign heading northbound. The crosswalk is a continental style crossing with faded and cracked pavement markings. The side path approaches are both 12 feet wide and offset from the roadway by 4 feet leading up to the crossing. There are detectable warning panels and concrete curb ramps on both approaches. There are stop bars on both path approaches before the concrete curb ramps.

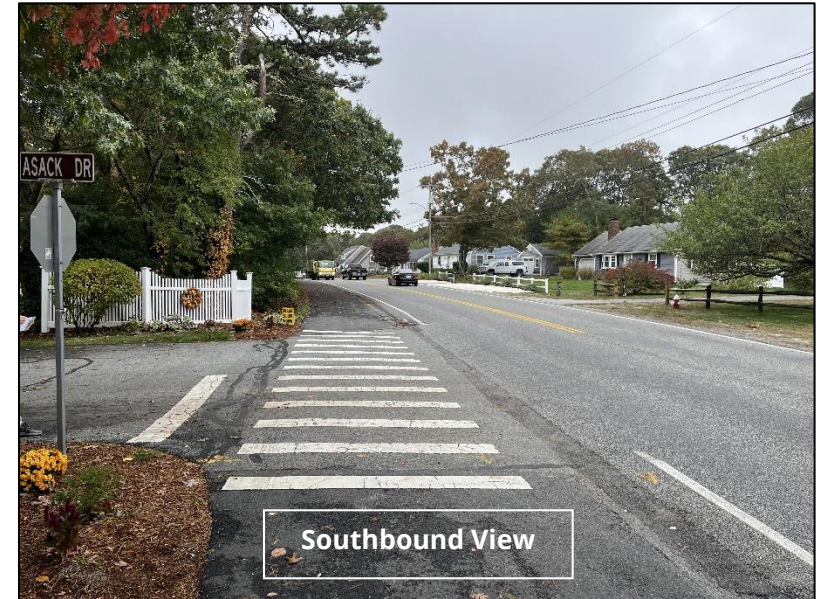
Southbound View

The crossing is 44 feet across. There are no stop signs or MUTCD R5-3 “No Motor Vehicles” signs on either side of the path approaches. The crosswalk is continental style and has cracked pavement markings. Leading up to the crossing, both side path approaches are 9 feet wide and have no offset from the adjacent roadway. There are no detectable warning panels or concrete curb ramps on either side. There are no additional pavement markings on the side path approaches.

The side path crosses Asack Drive which is a local road and has no posted speed limit. There is a stop sign and a stop bar before the crossing. The stop bar pavement markings are cracked and faded. The side path is adjacent to Old Bass River Road, which in this area is classified as an urban minor arterial with a speed limit of 40 mph.

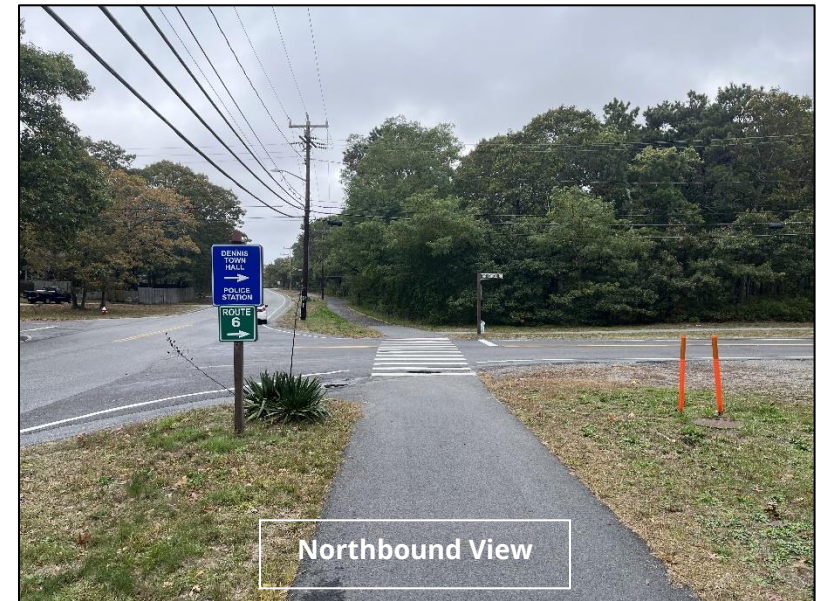
Northbound View

The crossing is 44 feet across. There are no stop signs or MUTCD R5-3 “No Motor Vehicles” signs on either side of the path approaches. The crosswalk is continental style and has cracked pavement markings. Leading up to the crossing, both side path approaches are 8 feet wide. The northbound side path approach is offset from the adjacent roadway by 14 feet and the southbound approach is offset by 15 feet. There are no detectable warning panels or concrete curb ramps on either side. There are no additional pavement markings on the side path approaches.

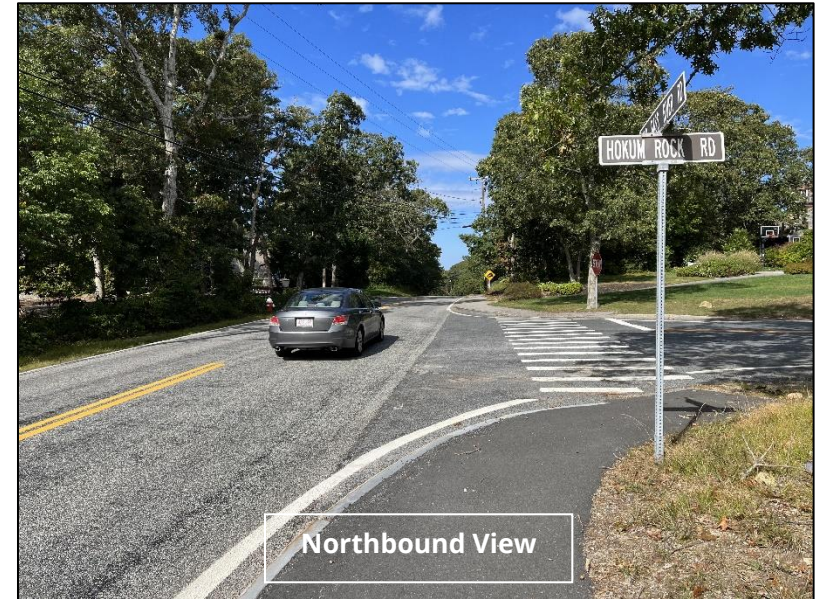
Northbound View

The crossing is 44 feet across. There are no stop signs or MUTCD R5-3 "No Motor Vehicles" signs on either side of the path approaches. The crosswalk is continental style and has cracked pavement markings. The northbound side path approach is 10 feet wide and has no offset from the adjacent roadway. The southbound side path approach is 8 feet wide and is offset from the adjacent roadway by 5 feet. There are no detectable warning panels or concrete curb ramps on either side. There are no additional pavement markings on the side path approaches.

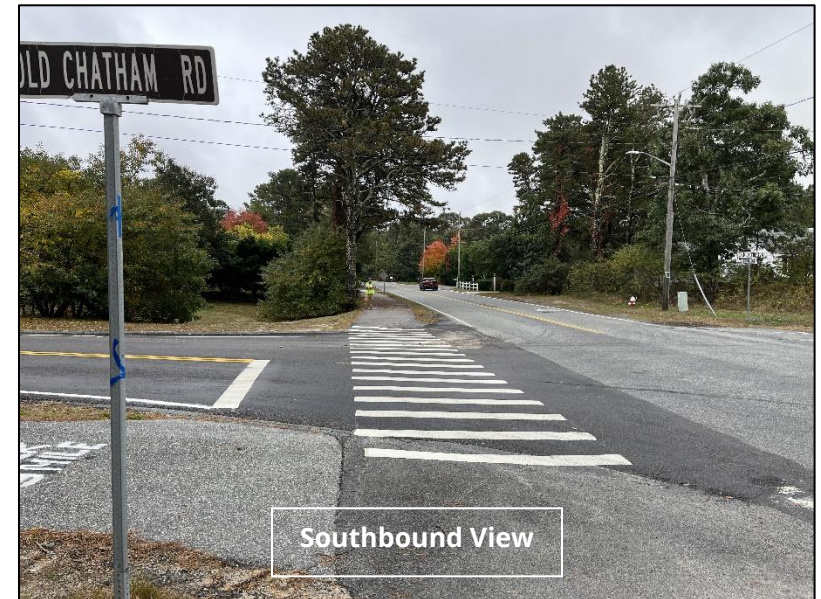
Southbound View

The crossing is 25 feet across. There are no stop signs or MUTCD R5-3 “No Motor Vehicles” signs on either side of the path approaches. The crosswalk is continental style and has cracked pavement markings. Leading up to the crossing, both side path approaches are 8 feet wide. The northbound side path approach is offset from the adjacent roadway by 3 feet while the southbound approach is offset by 10 feet. There are no detectable warning panels or concrete curb ramps on either side. There are no additional pavement markings on the side path approaches. During the site visit, there was a significant amount of water that had pooled on the southbound side of the crossing.

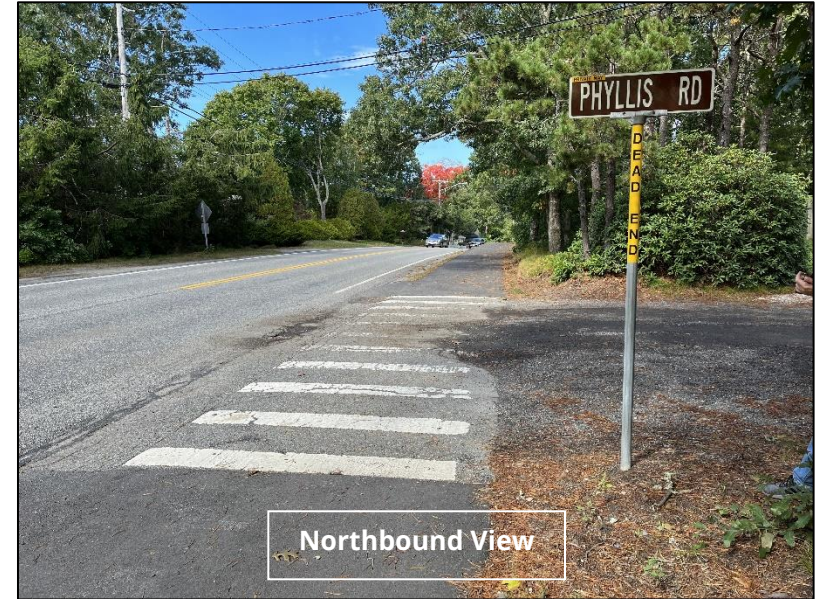
Northbound View

The crossing is 25 feet across. There are no stop signs or MUTCD R5-3 "No Motor Vehicles" signs on either side of the path approaches. The crosswalk is continental style and has cracked pavement markings. Leading up to the crossing, both side path approaches are 8 feet wide. The northbound side path approach is offset from the adjacent roadway by 4 feet while the southbound approach is offset by 5 feet. There are no detectable warning panels or concrete curb ramps on either side. There are no additional pavement markings on the side path approaches.

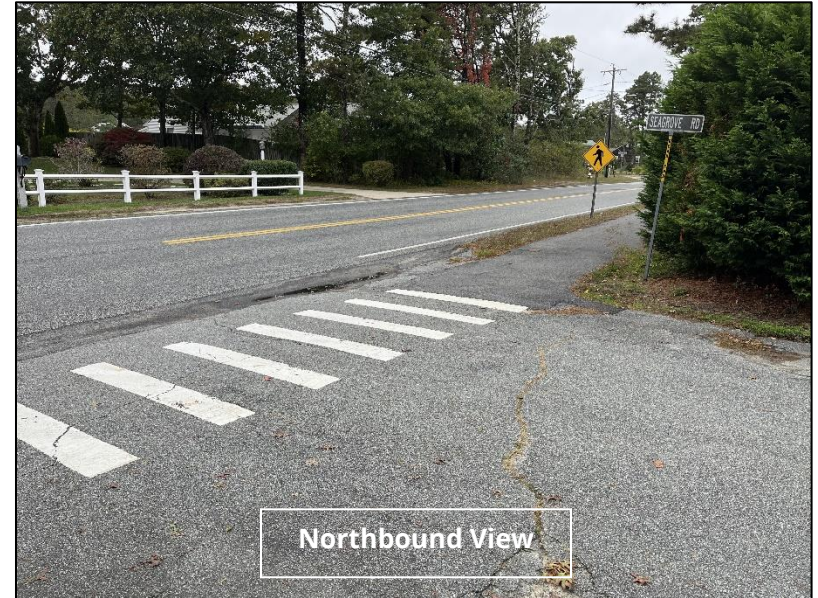
Northbound View

The crossing is 26 feet across. There are no stop signs or MUTCD R5-3 “No Motor Vehicles” signs on either side of the path approaches. The crosswalk is continental style and has cracked pavement markings. Leading up to the crossing, both side path approaches are 8 feet wide. The northbound side path approach is offset from the adjacent roadway by 4 feet while the southbound approach is offset by 5 feet. There are no detectable warning panels or concrete curb ramps on either side. There are no additional pavement markings on the side path approaches.

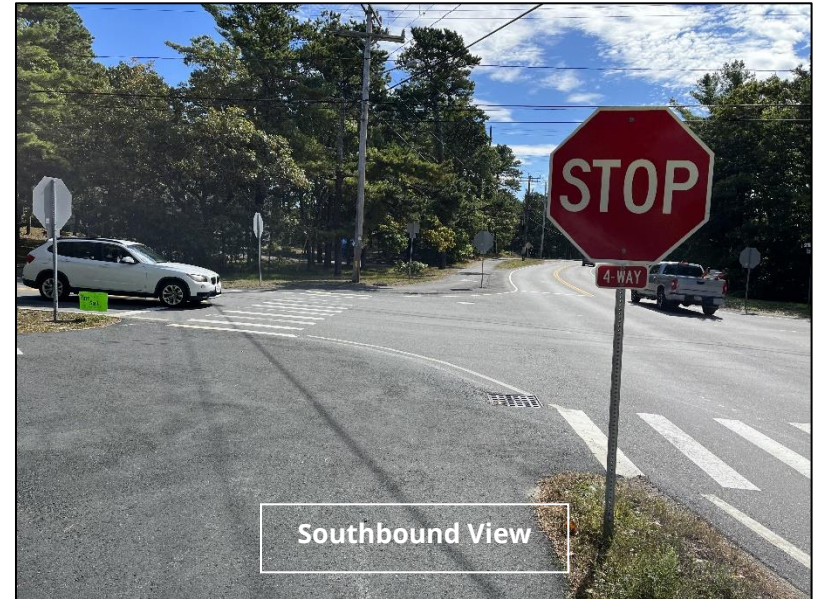
The crossing is 39 feet across. There are no stop signs or MUTCD R5-3 "No Motor Vehicles" signs on either side of the path approaches. The crosswalk is continental style and is in good condition. Leading up to the crossing, both side path approaches are 8 feet wide. The northbound side path approach is offset from the adjacent roadway by 9 feet while the southbound approach is offset by 6 feet. There are no detectable warning panels or concrete curb ramps on either side. There are no additional pavement markings on the side path approaches.

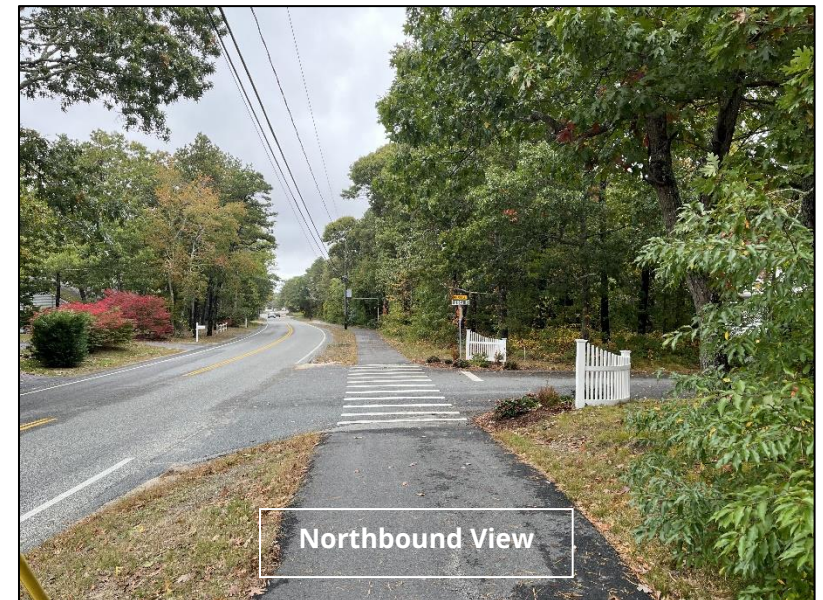
The crossing is 46 feet across. There are no stop signs and MUTCD R5-3 “No Motor Vehicles” signs on either side of the path approaches. The crosswalk is a continental style crosswalk which is in good condition. The side path approaches are both 8 feet wide leading up to the crossing. The westbound path approach is offset from the adjacent roadway by 5 feet while the eastbound path approach is offset by 6 feet. There are no detectable warning panels or concrete curb ramps on either side. There are no additional pavement markings on the side path approaches.

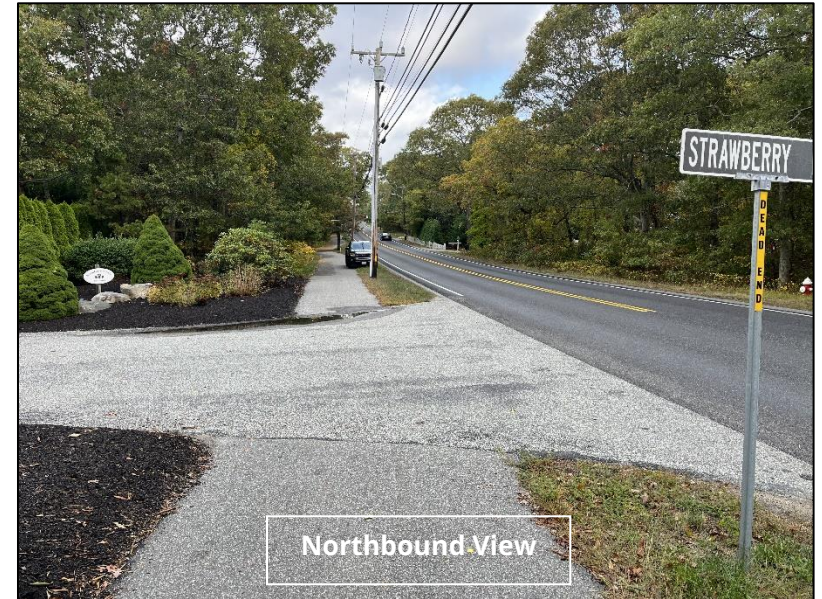
Northbound View

The crossing is 37 feet across. There are no stop signs or MUTCD R5-3 “No Motor Vehicles” signs on either side of the path approaches. The crosswalk is unmarked. The side path approaches are both 9 feet wide leading up to the crossing and both path approaches are offset from the adjacent roadway by 8 feet. There are no detectable warnings or concrete curb ramps on either side. There are no additional pavement markings on the side path approaches. There were drainage issues observed at the crossing, there was significant puddling on Strawberry Lane in the crosswalk.

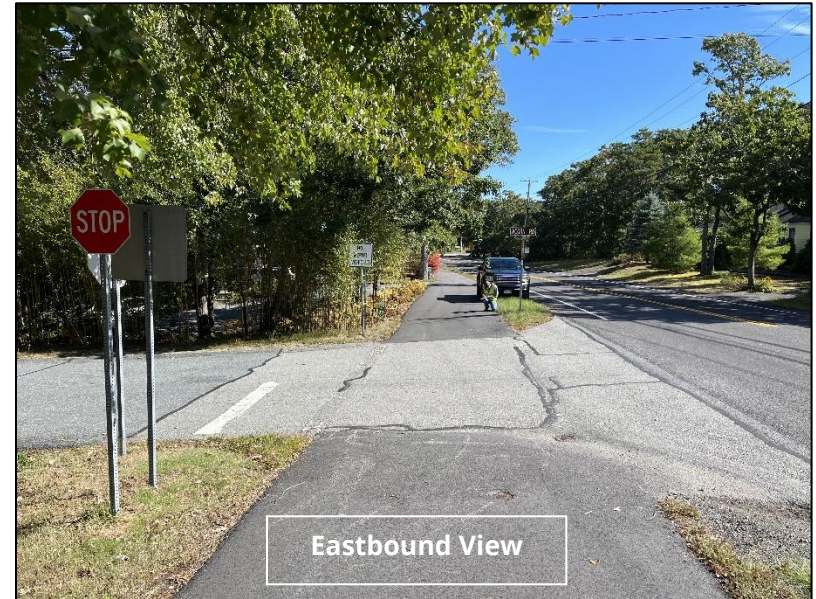
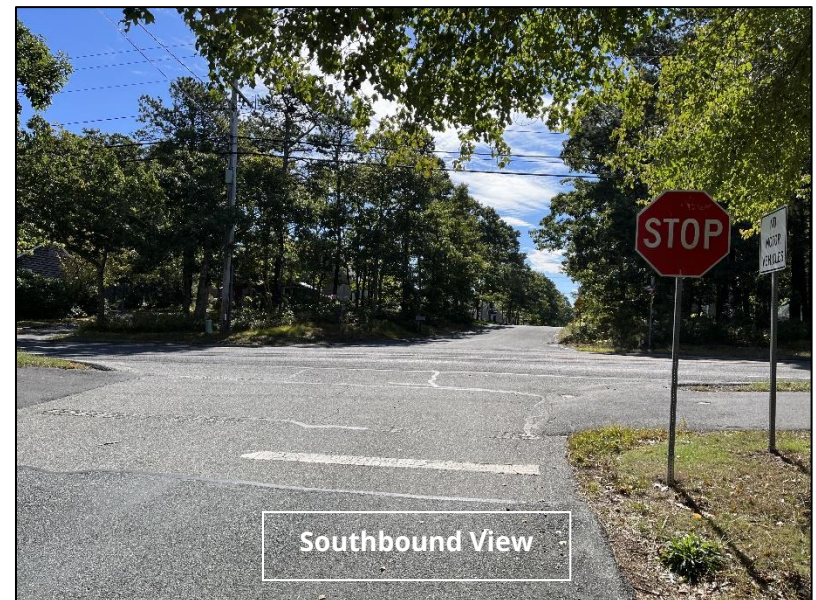
The crossing is 57 feet across. There are stop signs with MUTCD R5-3 “No Motor Vehicles” signs on both sides of the path approaches. The crosswalk is a standard style crosswalk with extremely faded and cracked markings. The side path approaches are both 10 feet wide leading up to the crossing. The westbound path approach is offset from the adjacent roadway by 6 feet while the eastbound path approach is offset by 4 feet. There are no detectable warning panels, concrete curb ramps or additional pavement markings on the side path approach.

The side path crosses Lady Slipper Drive, which in this area is classified as a local road with no posted speed limit. There is a stop sign and a cracked stop bar before the crossing. The side path is adjacent to Setucket Road, which in this area is classified as an urban minor collector with a posted speed limit of 35 mph.

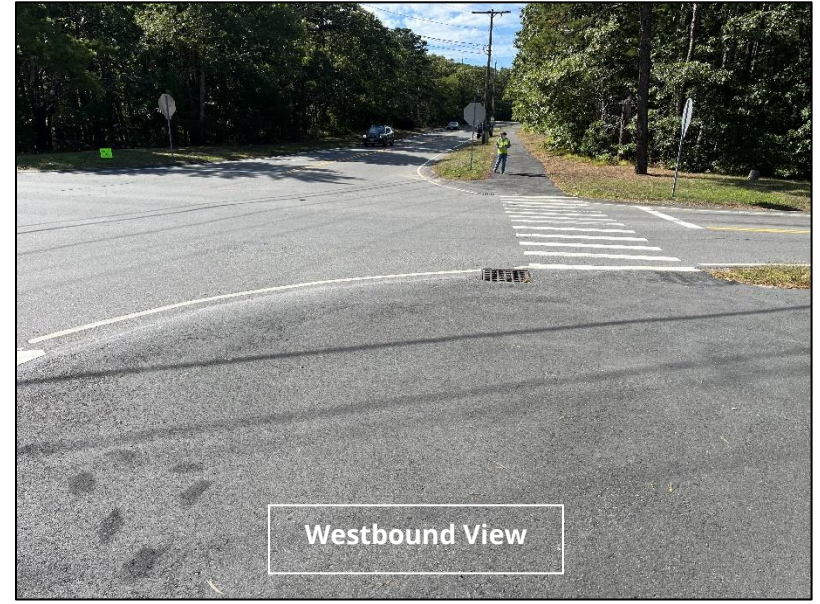
The crossing is 29 feet across. There are no stop signs on either path approach. There are MUTCD R5-3 "No Motor Vehicles" signs on both sides of the path approaches. The crosswalk is a standard style crosswalk with extremely faded and cracked markings. The side path approaches are both 11 feet wide and offset from the roadway by 5 feet leading up to the crossing. There are no detectable warning panels, concrete curb ramps or additional pavement markings on the side path approach.

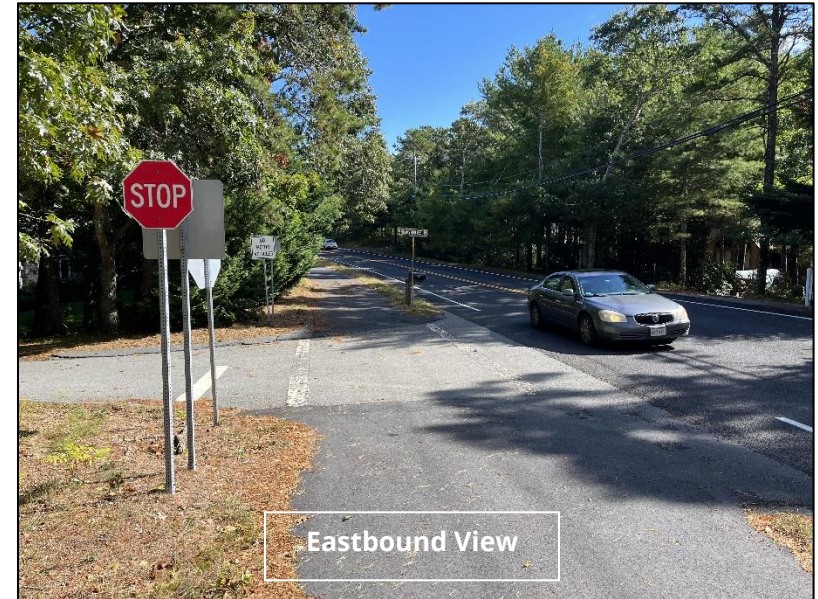
The crossing is 26 feet across. There are stop signs with MUTCD R5-3 “No Motor Vehicles” signs on both sides of the path approaches. The crosswalk is a standard style crosswalk with extremely faded and cracked markings. The side path approaches are both 10 feet wide and offset from the roadway by 4 feet leading up to the crossing. There are no detectable warning panels, concrete curb ramps or additional pavement markings on the side path approaches.

The side path crosses Simmons Pond Road West, which in this area is classified as a local road with no posted speed limit. There is a stop sign and a cracked stop bar before the crossing. The side path is adjacent to Setucket Road, which in this area is classified as an urban minor arterial with a posted speed limit of 35 mph.

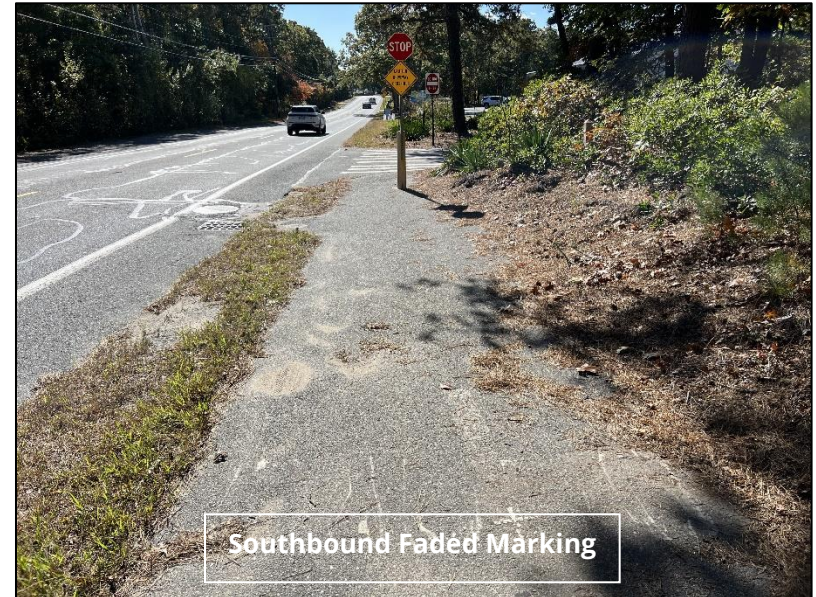
Southbound Faded Marking

The crossing is 30 feet across. There is a bollard with a stop sign and a caution driveway crossing sign on the southbound approach just before the crossing. There are no MUTCD R5-3 "No Motor Vehicles" signs on either side of the path approaches. The crosswalk is continental style and has cracked and faded pavement markings. Leading up to the crossing, the side path approaches are 8 feet wide. The side path starts at this crossing and then continues to the north. The southbound path approach is offset from the roadway by 3 feet. There are no detectable warning panels or concrete curb ramps on either side. There is an additional pavement marking on the southbound approach that says "Caution", and it is very faded.

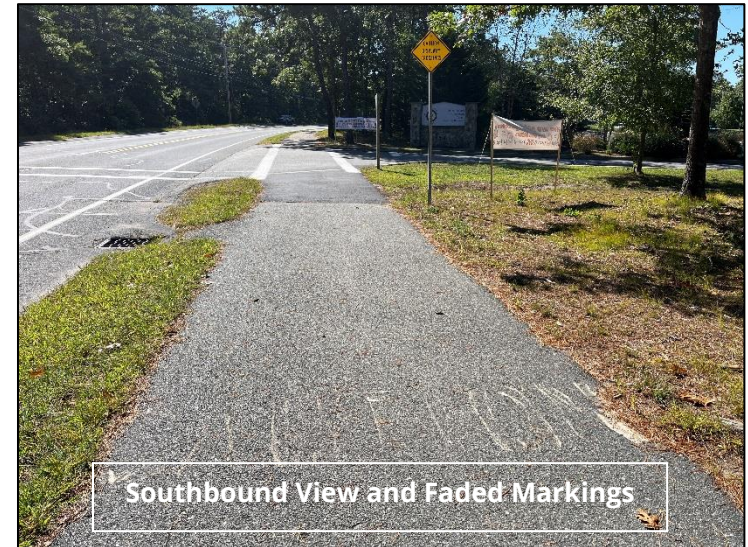
Southbound View and Faded Markings

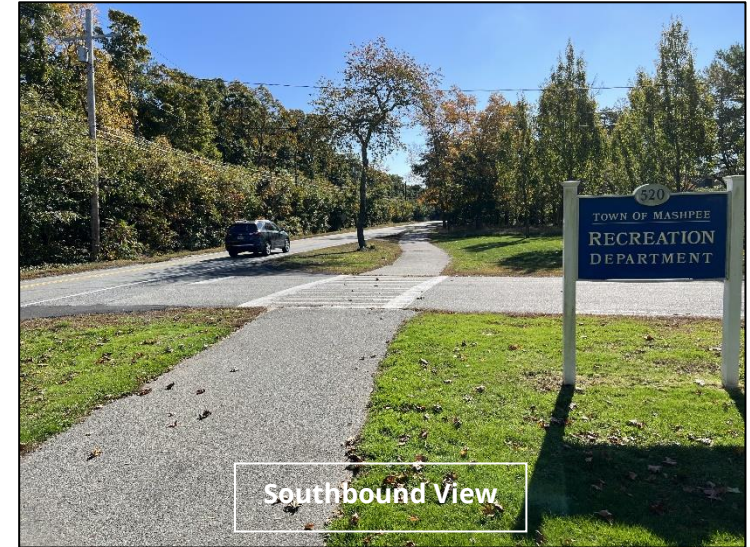
The crossing is 20 feet across. There are no stop signs or MUTCD R5-3 “No Motor Vehicles” signs on either path approach. The crosswalk is a ladder style with very cracked pavement markings. Approaching the crosswalk, both side path approaches are 8 feet wide and are offset from the adjacent roadway by 17 feet. There are no detectable warning panels or concrete curb ramps on either approach. There are no additional pavement markings on either of the side path approaches.

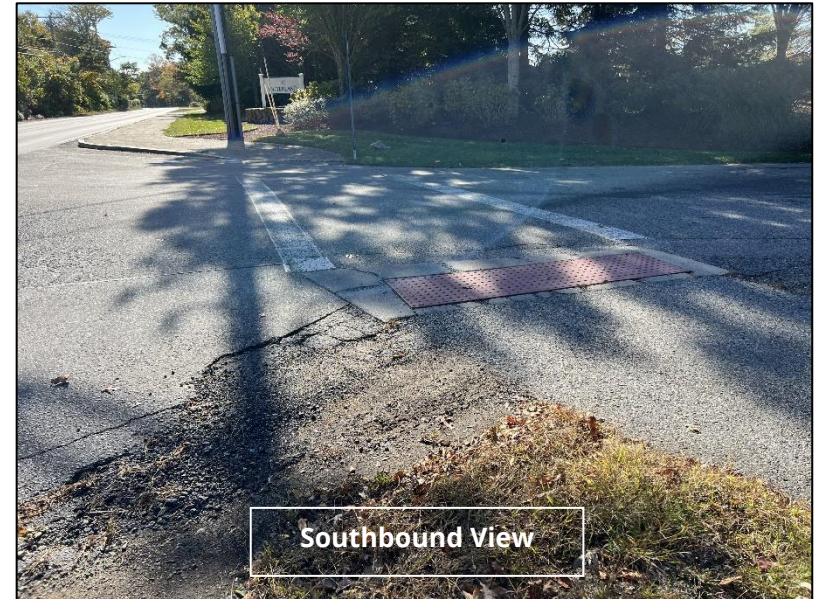
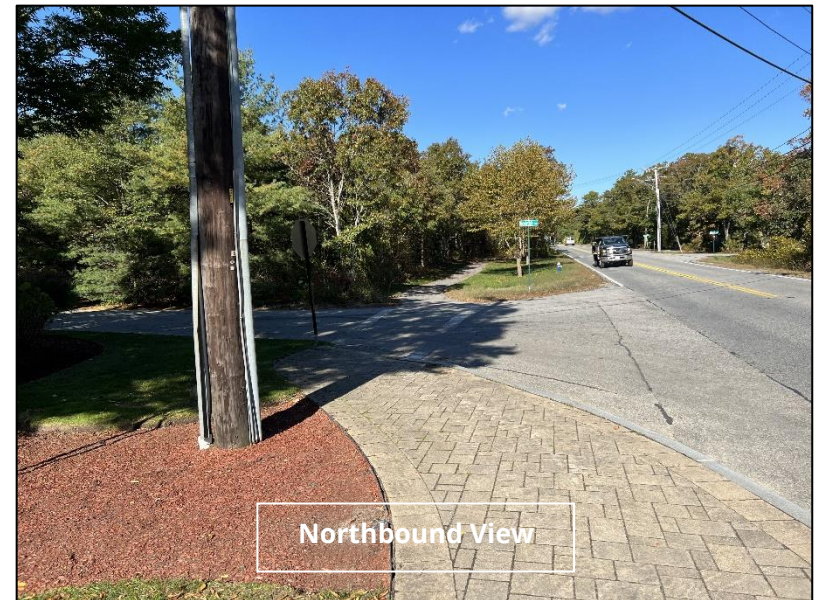
The crossing is 31 feet across. There are no stop signs or MUTCD R5-3 "No Motor Vehicles" signs on either side of the path approaches. The crosswalk is standard style and has cracked and faded pavement markings. Leading up to the crossing, both side path approaches are 8 feet wide. The northbound path approach is not offset from the roadway but is separated by a granite curb. The southbound path approach is offset by 26 feet from the adjacent roadway. There is a detectable warning pad on the southbound approach, however there are no concrete curb ramps on either side. The northbound approach is made up of concrete bricks which slope toward the crossing; the bricks create a textured surface on that side of the crossing. There are no additional pavement markings on either of the side path approaches.

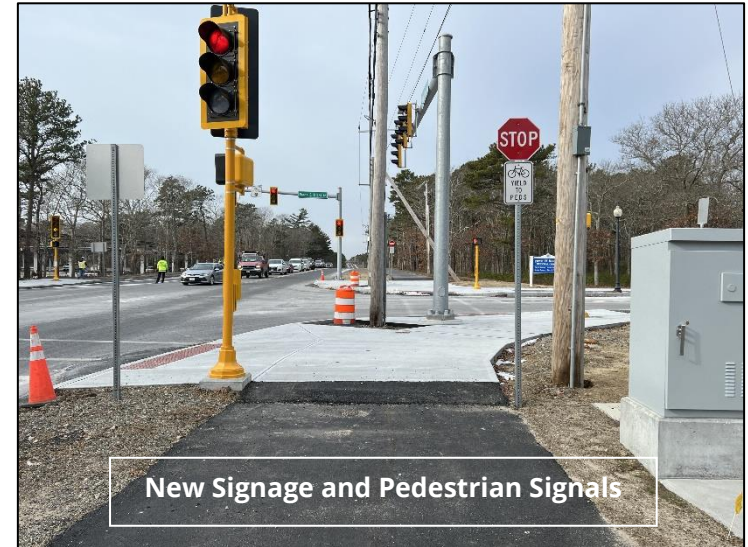
New Signage and Pedestrian Signals

The area of Route 151 @ Old Barnstable Road is categorized as a primary risk site for both pedestrians and bicyclists. The area of Route 151 @ Frank E. Hicks Drive/Job’s Fishing Road is categorized as a secondary risk site for both pedestrians and bicyclists. The area of Route 151 @ Market Street (Mashpee Commons) is not categorized as a risk site for either pedestrians or bicyclists, however it is close to the area of Route 151 @ Frank E. Hicks Drive/Job’s Fishing Road which is categorized as such.
