CAPE COD
COMMISSION

Side Path Crossings Inventory

FINAL | SEPTEMBER 2024

Prepared by Cape Cod Commission Staff.

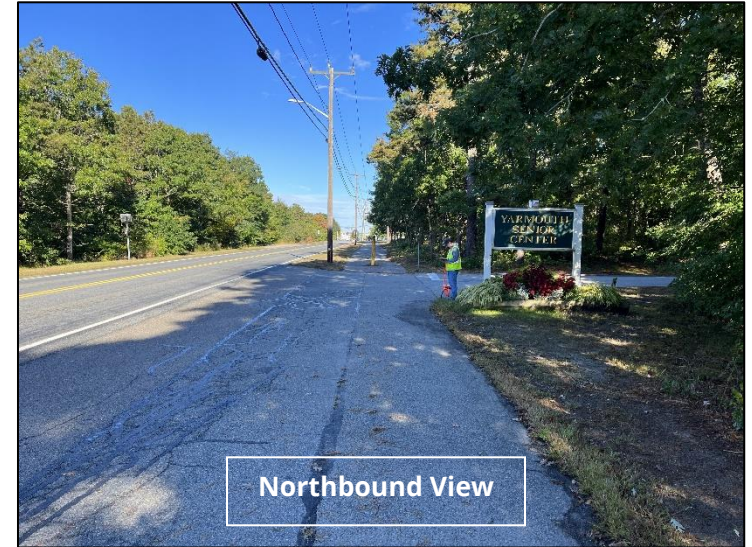
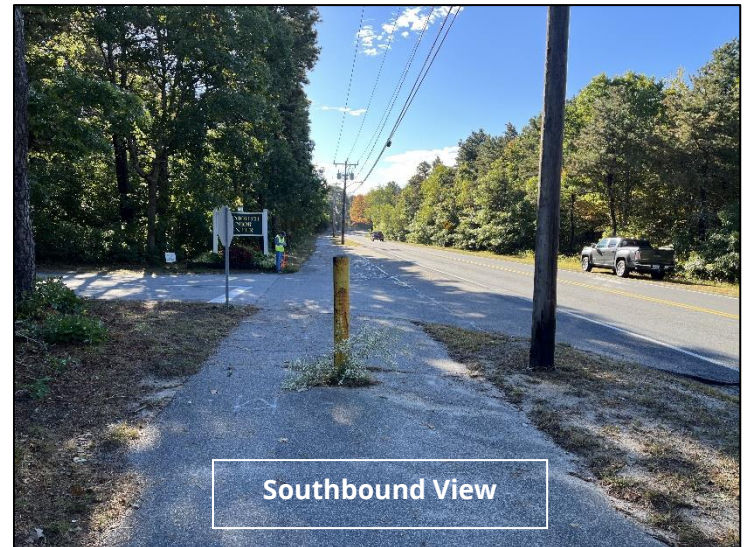
Forest Road @ Yarmouth Senior Center area is not categorized as a top risk site for either pedestrians or bicyclists.

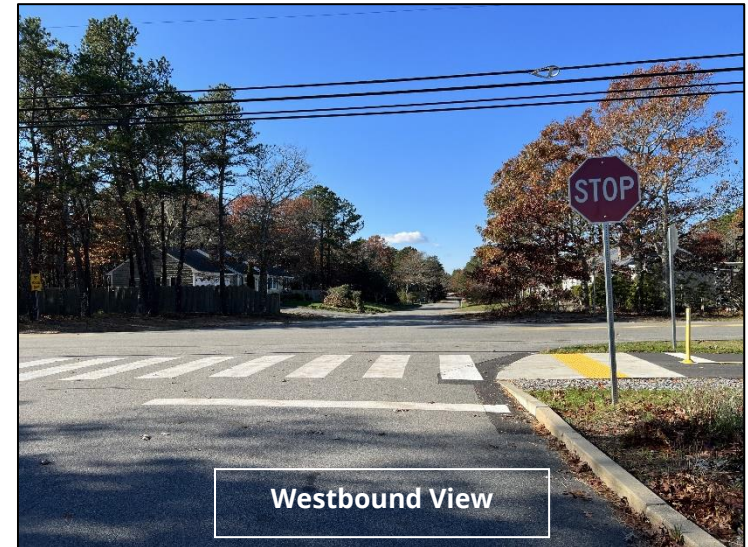
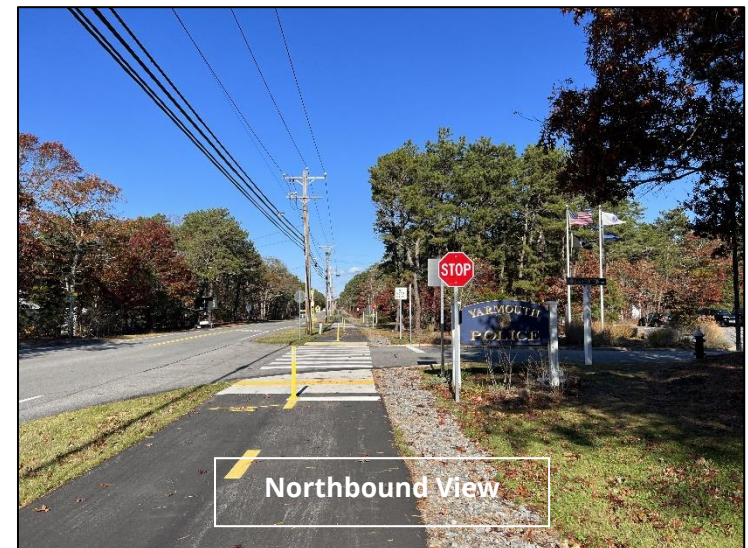
Higgins Crowell Road @ Brad Erickson Way (Yarmouth Police)

The crossing is 39 feet across. There are stop signs with MUTCD R5-3 “No Motor Vehicles” signs on both side path approaches. The crosswalk is marked as a continental style and is new in condition. Approaching the crosswalk, both side path approaches are 10 feet wide. The northbound approach is offset from the adjacent roadway by 9 feet while the southbound approach is offset by 12 feet. There are detectable warning panels and concrete curb ramps on the approaching sides. On both approaches, there are stop bars before the crosswalk. The side path in this area is marked with a centerline and there are bollards on each approach before the crossing. The crossing has recently had stop signs with flashing LEDs on the edges installed on the side path at both approaches before the crosswalk.

Higgins Crowell Road @ Brad Erickson Way area is not categorized as a top risk site for either pedestrians or bicyclists.

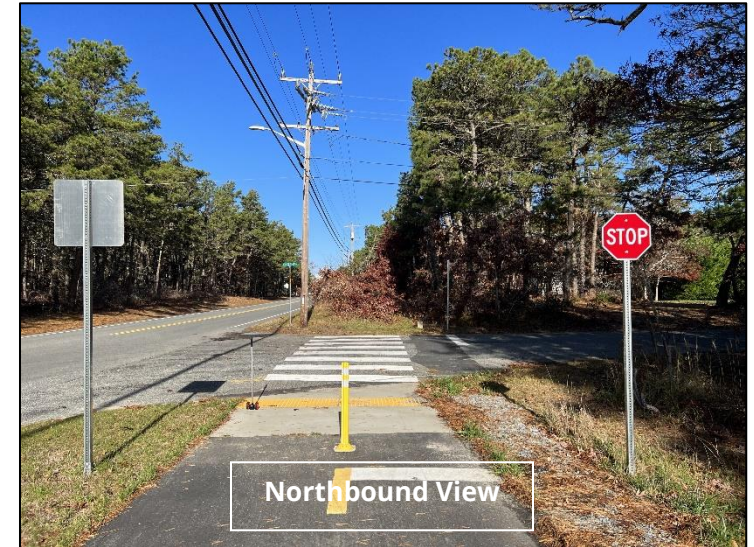
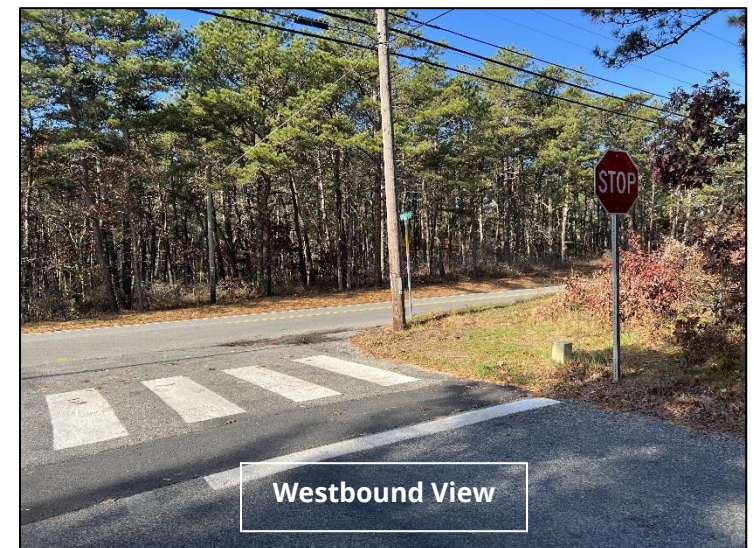
The crossing is 34 feet across. There is only one side path approach at this location, the northbound approach, as the side path terminated at this northerly location at the time of the data collection. There is a stop sign and MUTCD R5-3 "No Motor Vehicles" sign on this approach. The crosswalk is marked as a continental style and is new in condition. Approaching the crosswalk, the northbound approach is 10 feet wide and is offset from the adjacent roadway by 11 feet. There are detectable warning panels and concrete curb ramps on the northbound approach. On the northbound approach, there is a stop bar before the crosswalk. The side path in this area is marked with a centerline. There is also a bollard on this approach before the crossing.

Higgins Crowell Road @ Chickadee Lane area is not categorized as a top risk site for either pedestrians or bicyclists.

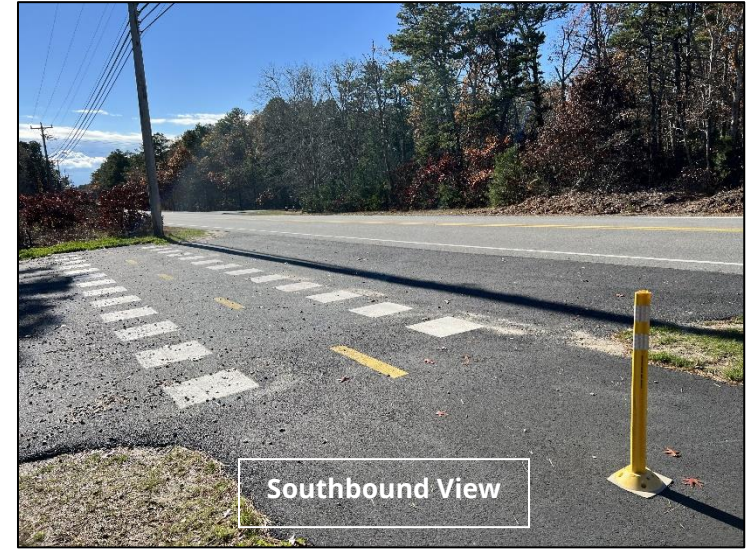
Southbound View

The crossing is 53 feet across. The side path along Higgins Crowell Road currently ends after this crosswalk in the southerly direction. There are no stop signs or MUTCD R5-3 “No Motor Vehicles” signs on either of the side path approaches. The crosswalk is marked as a dashed style crossing with a dashed yellow centerline and is in new condition. Approaching the crosswalk, the southbound side path approach is 10 feet wide and offset from the adjacent roadway by 9 feet. There are no detectable warning panels or concrete curb ramps. The side path in this area is marked with a centerline. There is a bollard on the southbound approach before the crossing.

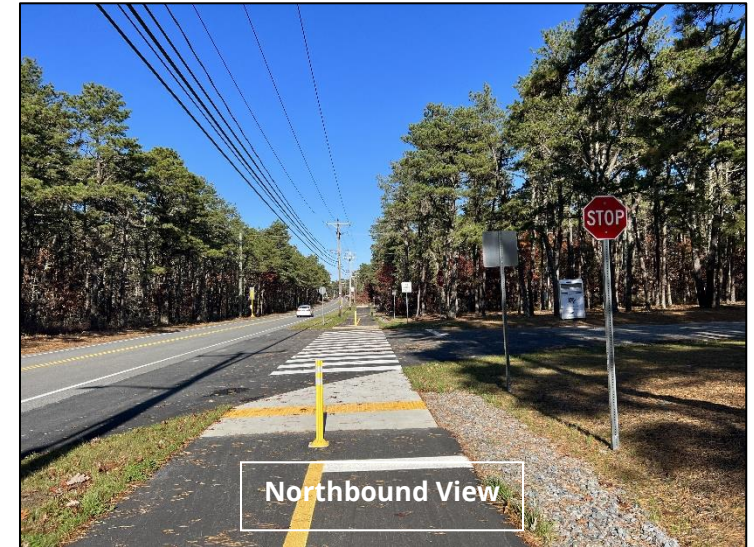
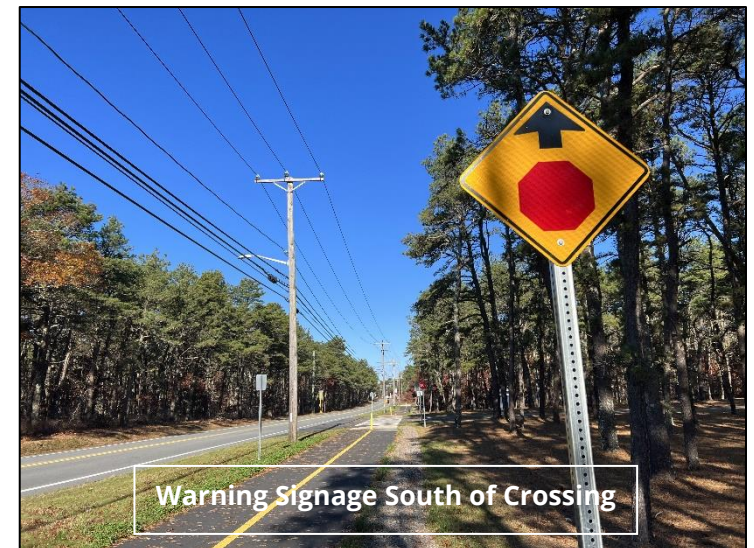
The crossing is 65 feet across. There are stop signs with MUTCD R5-3 “No Motor Vehicles” signs on both side path approaches. The crosswalk is marked as a continental style and is in new condition. Approaching the crosswalk, both side path approaches are 10 feet wide and offset from the adjacent roadway by 12 feet. There are detectable warning panels and concrete curb ramps on the approaching sides. On both approaches, there are stop bars before the crosswalk. The side path in this area is marked with a centerline. There are also bollards on each approach before the crossing. Additionally, there is a stop ahead sign on the side path on the northbound side before this crossing.

Higgins Crowell Road @ Marguerite E Small Elementary (North) area is not categorized as a top risk site for either pedestrians or bicyclists.

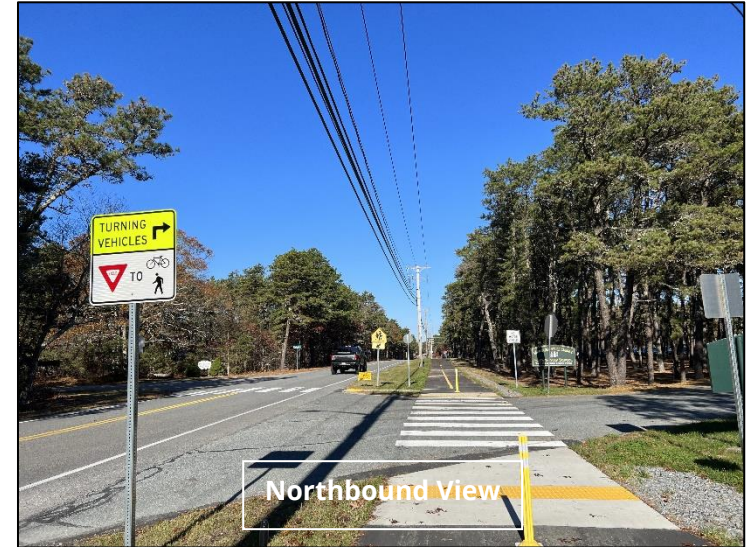
The crossing is 39 feet across. There are stop signs with MUTCD R5-3 “No Motor Vehicles” signs on both side path approaches. The crosswalk is marked as a continental style and is in new condition. Approaching the crosswalk, both side path approaches are 10 feet wide and offset from the adjacent roadway by 12 feet. There are detectable warning panels and concrete curb ramps on the approaching sides. On both approaches, there are stop bars before the crosswalk. The side path in this area is marked with a centerline. There are also bollards on each approach before the crossing.

Higgins Crowell Road @ Marguerite E Small Elementary (South) area is not categorized as a top risk site for either pedestrians or bicyclists.

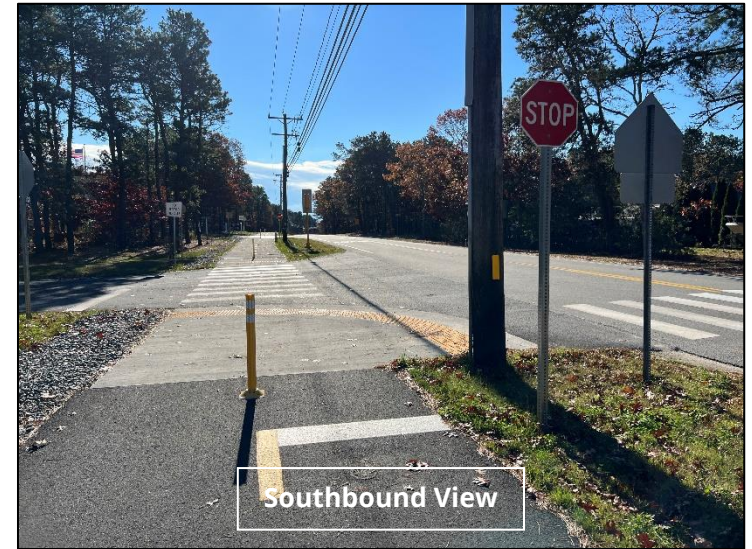
The crossing is 39 feet across. There are stop signs with MUTCD R5-3 “No Motor Vehicles” signs on both side path approaches. The crosswalk is marked as a continental style and is new in condition. Approaching the crosswalk, both side path approaches are 10 feet wide and offset from the adjacent roadway by 12 feet. There are detectable warning panels and concrete curb ramps on the approaching sides. On both approaches, there are stop bars before the crosswalk. The side path in this area is marked with a centerline. There are also bollards on each approach before the crossing. The southbound approach detectable warning pad and concrete curb ramp serve both the side path and a mid-block crossing at this approach.

Higgins Crowell Road @ Matacheese Middle School area is not categorized as a top risk site for either pedestrians or bicyclists.

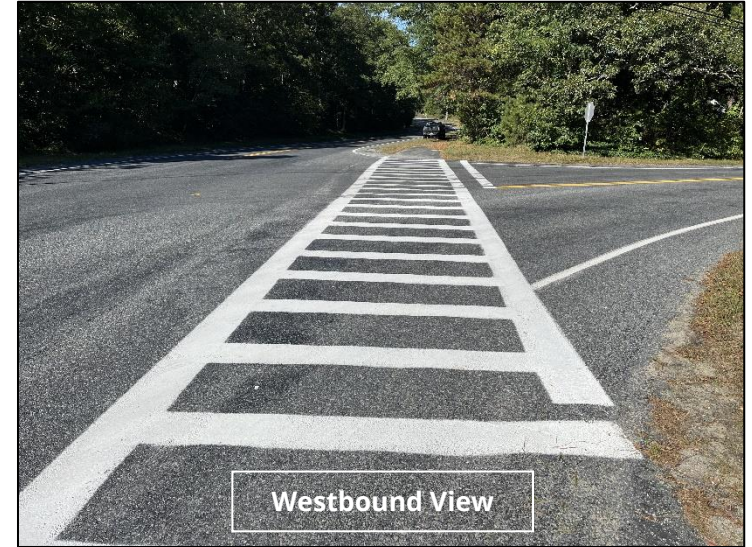
Westbound View

Setucket Road @ North Dennis Road area is not categorized as a top risk site for either pedestrians or bicyclists.
