ROAD SAFETY AUDIT

Great Neck Road North/Old Barnstable Road

Town of Mashpee

June 2009

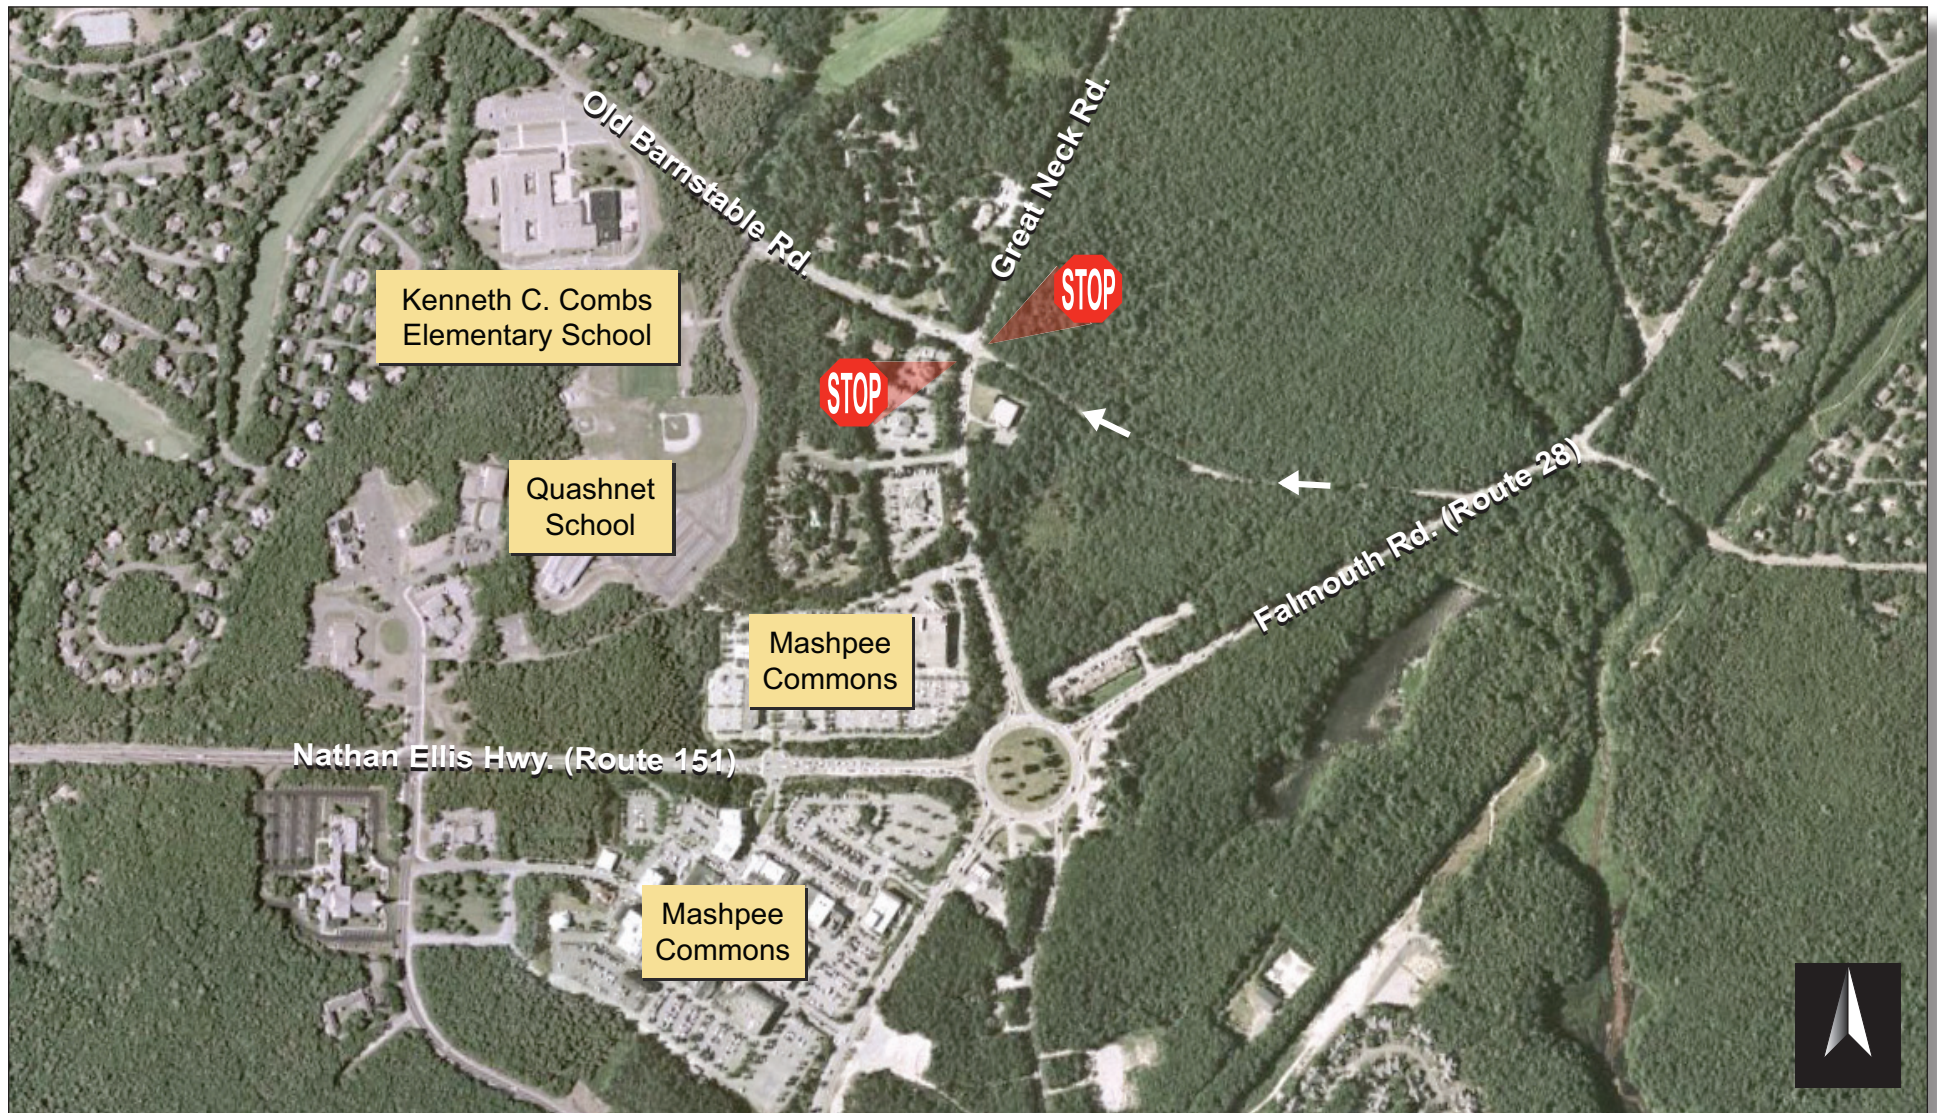
Figure 2. Project Location and Observations

Figure 2 shows field conditions at the intersection from an aerial perspective. The safety issues and possible enhancements determined in the RSA conducted on June 8, 2009, include:

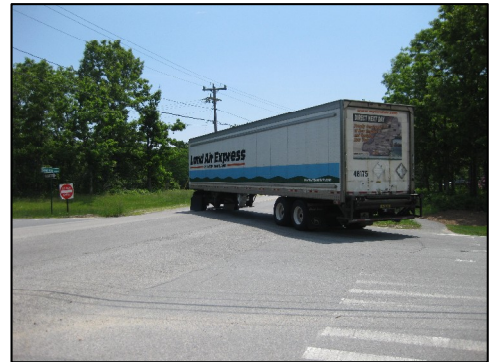
Several of the corner radii are too small for the types of vehicles using Great Neck Road North and Old Barnstable Road, as evidenced by the wheel tracks in the soft shoulders at the corners of the intersection. The RSA team observed several vehicles encroaching over the double yellow center line when turning onto either Great Neck Road North or Old Barnstable Road.

On the Old Barnstable Road westbound approach, which is configured for one-way operation, vehicles queue on the left side of the roadway across from opposing traffic on the Old Barnstable Road eastbound approach. This can be confusing for both eastbound and westbound drivers.

Tractor-trailer exiting Old Barnstable Road and heading south on Great Neck Road North.

1. Increase corner radii to accommodate larger vehicles.
2. Narrow the Old Barnstable Road westbound approach and align it with the departure lane on the other side of the intersection to the extent possible within the right-of-way.

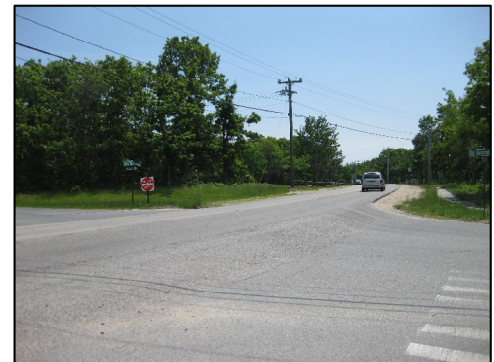
Approximately 42% of the crashes at the intersection of Great Neck Road North/Old Barnstable Road occurred when the roadway surface was wet. The RSA team noted that vehicles on both approaches of Old Barnstable Road must travel up a slight incline to cross or turn onto Great Neck Road North, which can be difficult when the roadway surface is wet or icy. It takes longer for a vehicle to complete a maneuver from a stopped condition on Old Barnstable Road. This may contribute to the high percentage of angle crashes under wet pavement conditions.

Additionally, RSA team members noted that ponding occurs on the Old Barnstable Road westbound approach. CCC photographs taken prior to the RSA under wet conditions show that there is a low spot on the Old Barnstable Road westbound approach in the vicinity of the stop line.

Grading changes between Great Neck Road North and Old Barnstable Road.

1. Change the crown line on Great Neck Road North to facilitate crossing and turning movements from Old Barnstable Road.

2. Re-grade the Old Barnstable Road westbound approach to eliminate the low spot.

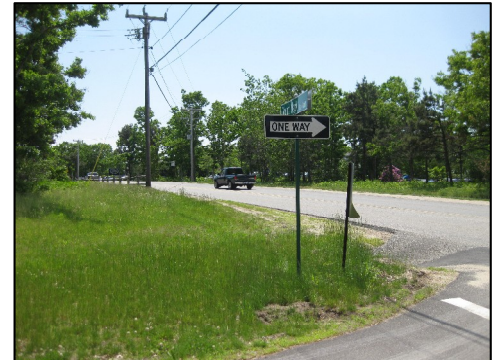
As previously stated, approximately 73% of the crashes at the intersection of Great Neck Road North/Old Barnstable Road were angle crashes. All of these angle crashes involved a vehicle from the Old Barnstable Road westbound approach. Field observations noted that vehicles stopped on the Old Barnstable Road westbound approach have difficulty seeing vehicles traveling northbound on Great Neck Road North due to existing signs, fence, and grass area.

Looking south from Old Barnstable Road at Great Neck Road.

1. Measure the sight distances from the Old Barnstable Road westbound approach and compare them to the required sight distances for the existing conditions. Based on these results, the following additional enhancements may be appropriate:

2. Relocate signs and fence on the southeast corner to increase visibility for vehicles exiting Old Barnstable Road westbound.
3. Re-align both the horizontal and vertical geometry of Great Neck Road North to provide adequate sight distance for all approaches.

4. Re-grade the slope on the eastern side of the Great Neck Road North northbound approach to provide adequate sight distance for the Old Barnstable Road westbound approach.

5. Study closing the Old Barnstable Road westbound approach to vehicle traffic. This would include traffic analysis of the Route 28/Great Neck Road/Route 151 rotary to ensure that the closure would not create undue traffic delay there.

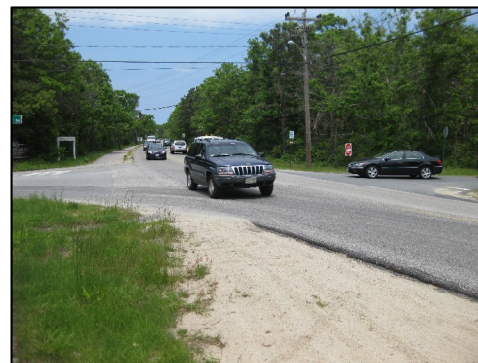
The intersection of Great Neck Road North/Old Barnstable Road has deficient pavement markings. The double yellow center lines and edge lines on all approaches, as well as the stop lines and crosswalks on Old Barnstable Road, are worn or missing.

Worn pavement markings at the Great Neck Road North/Old Barnstable Road intersection.

1. Re-stripe and maintain durable pavement markings at the intersection of Great Neck Road North/Old Barnstable Road.

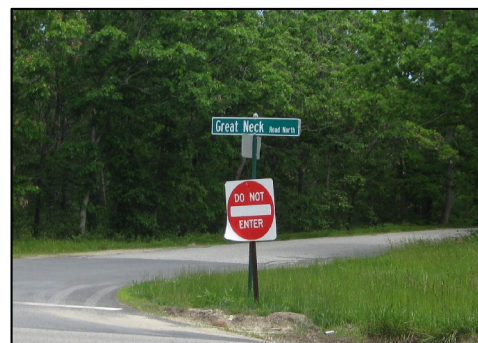
Some regulatory and warning signs are located so that they block the visibility of traffic. Additionally, some warning signs prior to the intersection are missing. Several sign locations, sizes, and heights do not conform to MUTCD requirements.

Signs located at the corner of Old Barnstable Road.

1. Install new double-sided one-way signs on both sides of the roadway on the Old Barnstable Road westbound approach to improve their visibility to vehicles traveling northbound and southbound on Great Neck Road North.
2. Replace the worn “Intersection Ahead” warning sign for the Great Neck Road North northbound approach.
3. Install an “Intersection Ahead” warning sign for the Great Neck Road North southbound approach.
4. Relocate the 45 mph speed limit sign for Great Neck Road North northbound traffic farther beyond the intersection with Old Barnstable Road. This may require modifications to the speed regulations.
5. Adjust sign locations, sizes, and heights to conform to MUTCD requirements and not to impair sight distance.
6. Remove the CCRTA bus stop sign located on the eastern side of Great Neck Road North just north of Old Barnstable Road.

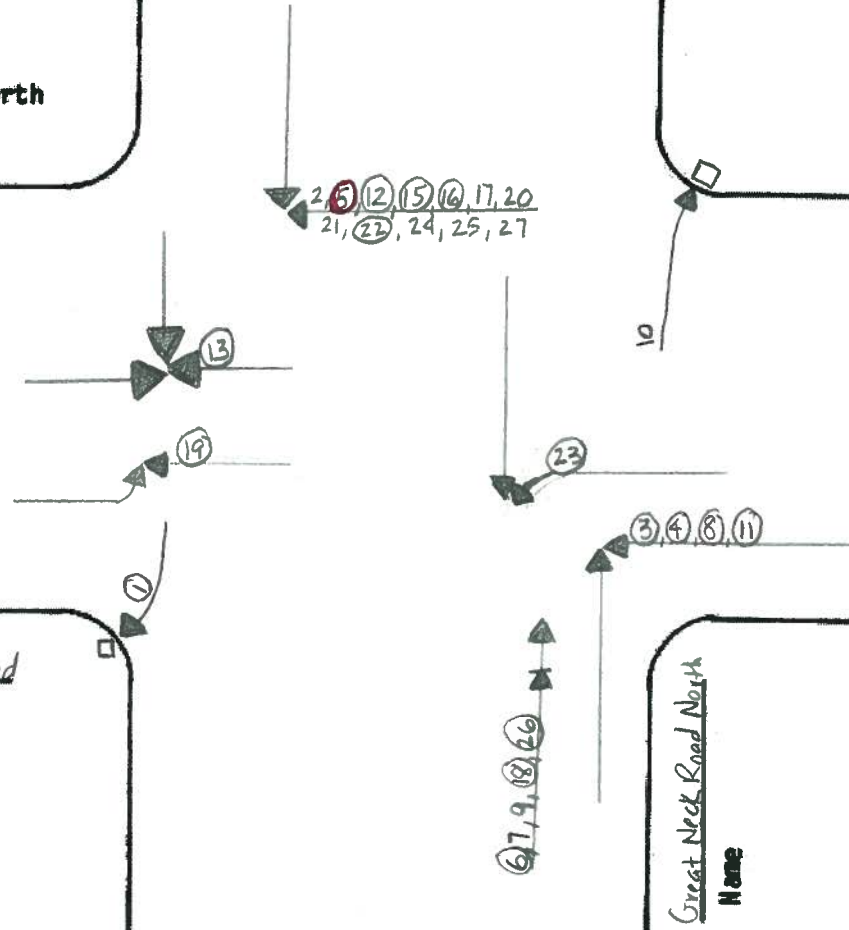
**COLLISION
DIAGRAM***

INTERSECTION Great Neck Road North and Old Barnstable Road

PERIOD FROM: 1/1/2004 to 1/31/2009

* Crash 5 is a fatal crash

* Diagram based on crash reports obtained from the Mashpee Police Department.
