Eliminating Transit Barriers

A review of bus stops and access to them on Cape Cod

October 2016

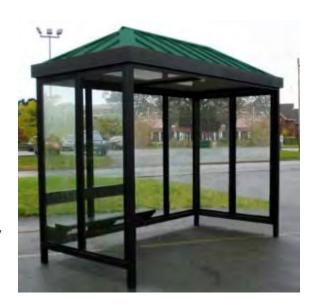
Figure 3: Bus Shelter Design

The current design of bus stops to be installed by the CCRTA is represented in Figure 3. Modifications to this design include brown metal trim. CCRTA previously built wood bus shelters, however due to the high costs of materials, construction, and maintenance, the CCRTA has discontinued this design.

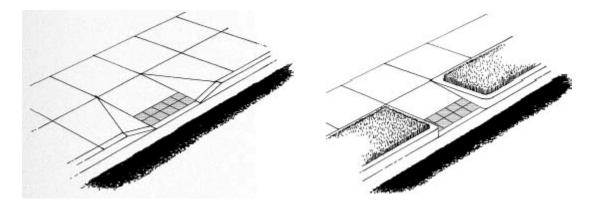
Figure 5: Curb Ramp Examples

Curb ramps are essential for handicap and stroller access. Modern design of all pedestrian facilities is guided by Americans with Disabilities Act (ADA) regulations. The design of curb ramps includes a four-foot-wide ramp, five-foot-wide turning areas, and textured pads at transitions from the ramp to a road crossing. Figure 5 shows drawings of typical curb ramps.

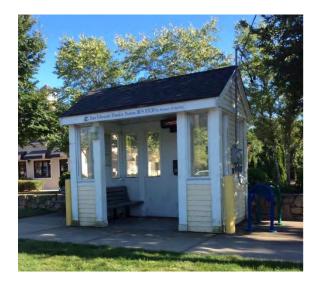
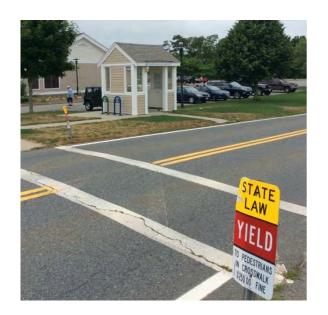
Dennis Crossing - H2O

<u>Pedestrian Accommodation:</u> crosswalk, curb ramps, sidewalks on both sides

<u>Transit Facilities:</u> Bus Shelter, Lighting, CCRTA sign, Benches, Bike Racks

East Falmouth Dunkin Donuts - Sealine

<u>Transit Facilities:</u> Bus Shelter, Lighting, CCRTA sign, Benches, Schedule, System Map, Bike Racks

Notes: Ongoing construction project at the Route 28 and Davisville Road intersection

<u>Proposed Improvements:</u> System Map, Schedules

Proposed Improvements: None

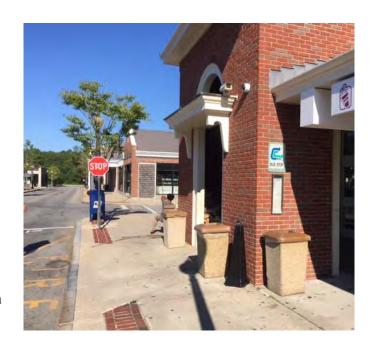
Mashpee Commons Stop and Shop- Sealine and Bourne Run

<u>Pedestrian Accommodation:</u> Curb ramps, Sidewalks, Crosswalk.

Development sidewalks connect to on street sidewalks.

<u>Transit Facilities:</u> CCRTA Logo sign, Stop and Shop bus shelter, benches, bike racks, and lighting are from development

Notes: Stop is curb side at grocery store

Proposed Improvements: Add system map and schedule. Extend sidewalks along Route 151 and Route 28, including the Mashpee Rotary. Consider adding a second stop at in other parts of Mashpee Commons.

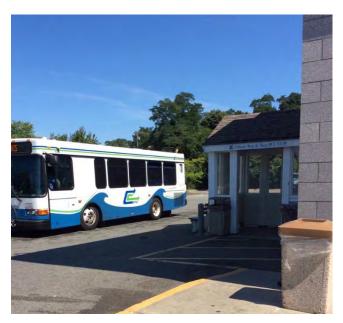
Stop and Shop Orleans – H2O and Flex

<u>Pedestrian Accommodation</u>: On street sidewalks are not connected to bus stop

<u>Transit Facilities:</u> Bus Shelter, benches, schedule

<u>Notes:</u> Bus stop is on the side of Stop and Shop. Visible to foot traffic only. In proximity to low-income EJ populations.

<u>Proposed Improvements:</u> Move the bus stop to be more visible or closer to the street and provide a sidewalk connection to the on street sidewalk. Include lighting, system maps, bike racks, and CCRTA signage in a redesign.

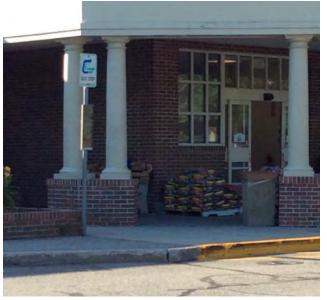
Stop and Shop South Yarmouth - H2O

<u>Pedestrian Accommodation:</u> Curb side stop with no connection to on street sidewalks.

<u>Transit Facilities:</u> Benches, lighting, sheltered area provided by development. CCRTA signage is at the stop.

<u>Notes:</u> Stop is curb side at grocery store and in proximity to low-income and minority EJ populations.

<u>Proposed Improvements:</u> Connect stop with on street sidewalk network. Consider location for bus shelter with all facilities.

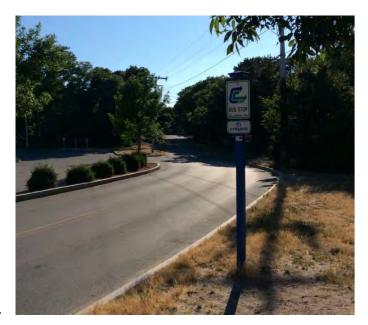
Shaw's South Yarmouth - H2O

Pedestrian Accommodation: None

Transit Facilities: CCRTA Signage

Notes: Stop is behind Shaw's near residential area and in proximity to low-income and minority EJ populations.

Proposed Improvements: Move stop to make it more visible from the roadway. Consider the location for a bus shelter with all facilities. Construct a sidewalk at the location of the stop that connects to on-street sidewalks.

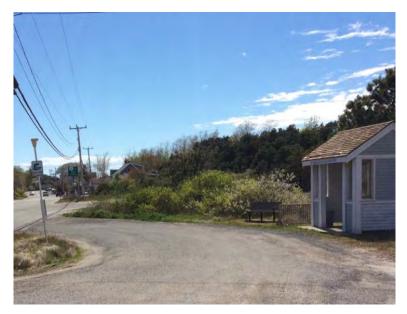
Highland Road – Flex and Provincetown/ North Truro Shuttle

<u>Pedestrian Accommodation:</u> None. Roadway is low volume.

<u>Transit Facilities:</u> Bus shelter, benches, lighting, CCRTA signage, schedule, system map, bike racks

Notes: Seasonal bus stop and bus pullout

<u>Proposed Improvements:</u> Consider sidewalks along the length of Highland Road

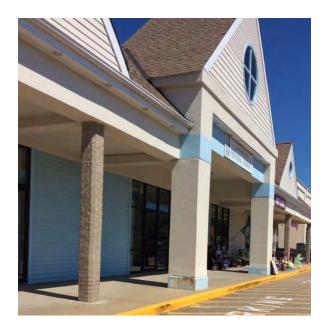
Stop and Shop at Quaker Meeting House Road – Sandwich Line

<u>Pedestrian Accommodation:</u> Development sidewalks do no connect to on street sidewalks

<u>Transit Facilities:</u> Lighting provided and benches provided by development.

<u>Notes:</u> Stop is curb side at grocery store and in proximity to minority EJ populations.

Proposed Improvements: Add signage, system maps and schedules. Consider moving stop closer to the street or connecting the development sidewalks with the on street sidewalks. Consider location for CCRTA bus shelter with all facilities. Extend sidewalks along Quaker Meeting House Road and Cotuit Road.

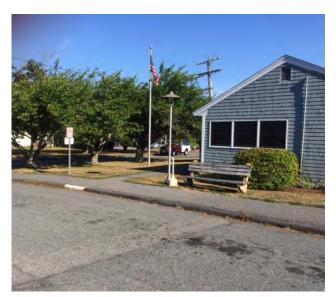
Anchorage at Crowell Road - H2O

<u>Pedestrian Accommodation</u>: Sidewalks on the opposite side of the development

<u>Transit Facilities</u>: Lighting and benches at development

Notes: Stop is curb side at Housing Authority

<u>Proposed Improvements:</u> Add a sidewalk on the other side of the road. Consider moving the bus stop to the street. Provide a cross walk at the bus stop location. Consider the location for a bus shelter with all transit facilities.

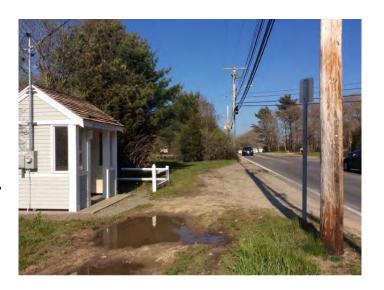
Seacoast Shores Boulevard - Sealine

<u>Pedestrian Accommodation:</u> Sidewalk on one side of the road (opposite of transit stop).

<u>Transit Facilities:</u> Bus Shelter, Lighting, CCRTA signage, Benches, Schedules, System Maps

<u>Notes:</u> Stop is near residential neighborhood and in proximity to minority EJ populations.

Proposed Improvements: Add sidewalk to north side of Route 28. Extend pavement or path from shelter to roadway. Consider location for Bus pullout. Add crosswalk on Route 28. Add bike racks to bus stop location.

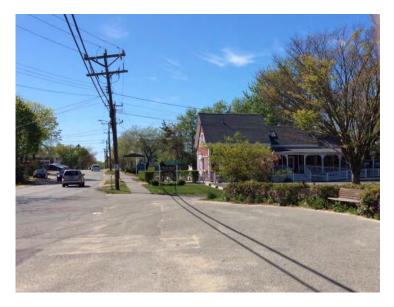
Chatham Rotary - H2O

<u>Pedestrian Accommodation:</u> Intermittent Sidewalks on one side of the road

<u>Transit Facilities:</u> CCRTA signs, Benches

Notes: Bus pullout is at the transit stop on the south side of Route 28.

Proposed Improvements: Consider adding sidewalks to both sides of Route 28 near the bus stop and upgrade existing sidewalks for accessibility with curb ramps. Consider the location for a bus shelter with all facilities. Add cross walk along Route 28.

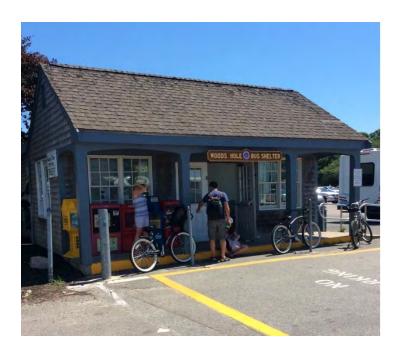
Woods Hole – Sealine and WHOOSH Trolley

<u>Pedestrian Accommodation:</u> Crosswalks, sidewalks on nearby street

<u>Transit Facilities:</u> Shelter and lighting provided by development

Notes: Stop is curbside stop at Steamship Authority terminal and site has been discussed for improvements.

Proposed Improvements: Add sidewalks to the development site with curb ramps for accessibility. Add CCRTA signage, schedule, system map, and bike racks to site.

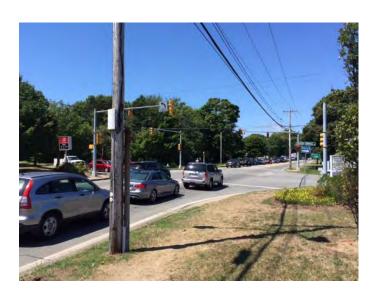
Cape Cod Mall Route 132 – Hyannis Loop and Barnstable Villager

<u>Pedestrian Accommodation:</u> Sidewalks on site, Crosswalk

<u>Transit Facilities:</u> Bus Shelter Lighting, CCRTA signage, benches, system map, schedule

Notes: Bus stop is located behind the mall closer to Route 28 and in proximity to low-income and minority EJ populations. Route 28 is scheduled for reconstruction in 2016 at this location.

<u>Proposed Improvements</u>: Add bike racks and curb ramps to increase accessibility. Construct Sidewalks along Route 28 and Route 132 with crosswalks and pedestrian signals at traffic lights. Consider moving stop or adding a stop at an on street location or curb side location.

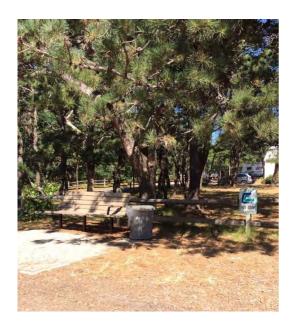
Higgins Crowell Road - H2O

<u>Pedestrian Accommodation:</u> Sidewalks on Route 28 and pedestrian crossing at traffic signal.

Transit Facilities: None

Notes: Stop is on street at intersection

<u>Proposed Improvements:</u> Consider location for bus shelter that includes all facilities. Upgrade curb ramps to include textured padding at street crossings.

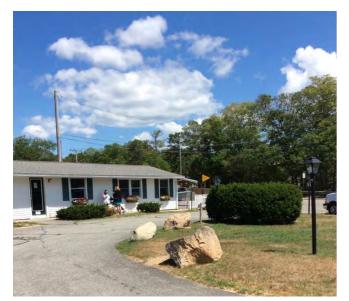
Catamount Motel – Bourne Run

Pedestrian Accommodation: None

Notes: Stop is in proximity to minority EJ populations. Motel name is not clearly marked and does not show up on Google Maps.

Proposed Improvements:
Consider sidewalks along Route
28A. Add CCRTA signage and
Benches. Consider location for
bus shelter that includes all
facilities. Consider moving the
bus location to on-street or to a
new location.
