# CAPE COD POND AND LAKE ATLAS

FINAL REPORT  
MAY 2003

prepared by  
Cape Cod Commission  
Water Resources Office

Project 2000-02

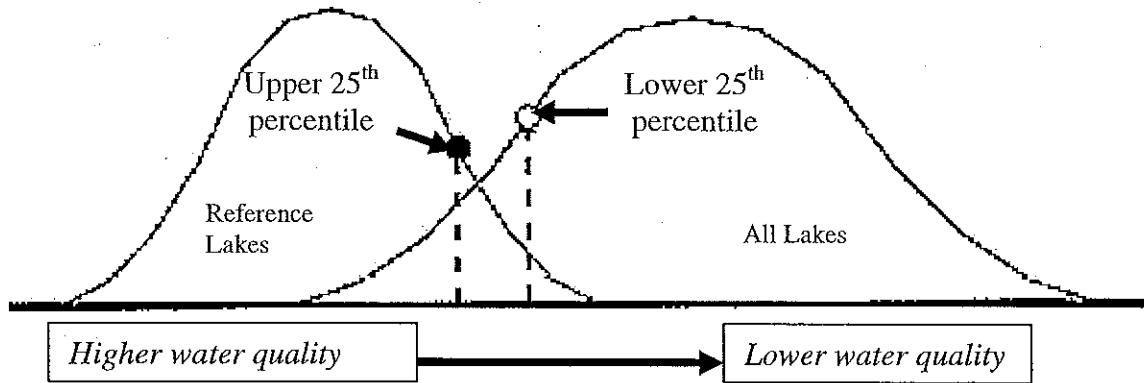
Figure 12. USEPA Methods for setting reference condition thresholds

The USEPA method for determining reference conditions utilizes one of two methods depending on the amount and quality of the data that is available (USEPA, 2001). One method is to determine the upper 25<sup>th</sup> percentile (75<sup>th</sup> percentile) of a
