CAPE COD
COMMISSION

Route 28 Centerville-Hyannis Corridor Study

Old Stage Road to Bearses Way

February 2016

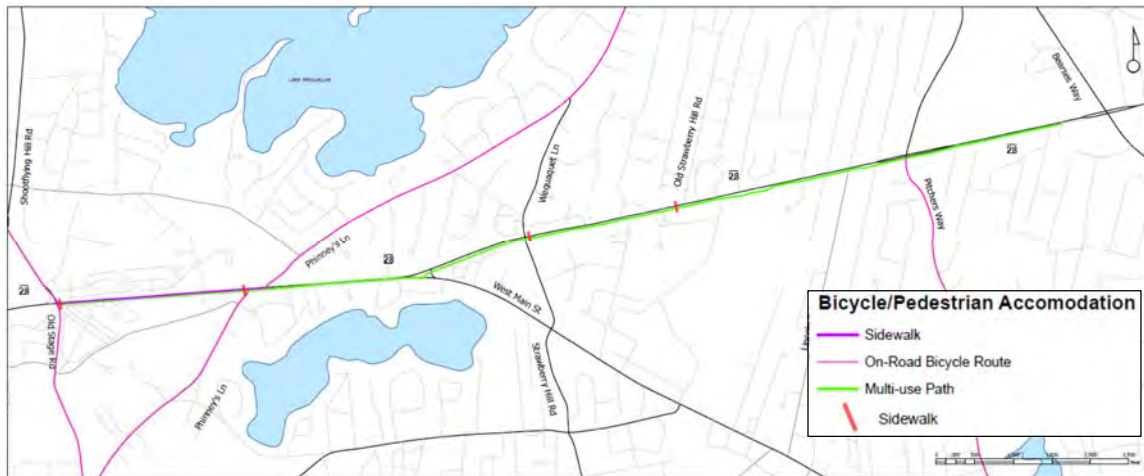
FIGURE 5 – EXISTING CONDITIONS: BICYCLE/PEDESTRIAN ACCOMMODATION

In addition to serving motorists, the Route 28 corridor provides an important link for bicyclists, pedestrians and transit users. The figures below show the bicycle, pedestrian, and transit accommodations within the corridor along with the transit routes in the vicinity of the corridor. While many multi-modal accommodations exist, there are still deficiencies along the corridor, such as a lack of safe north-south pedestrian connections, which will be discussed later in this report.

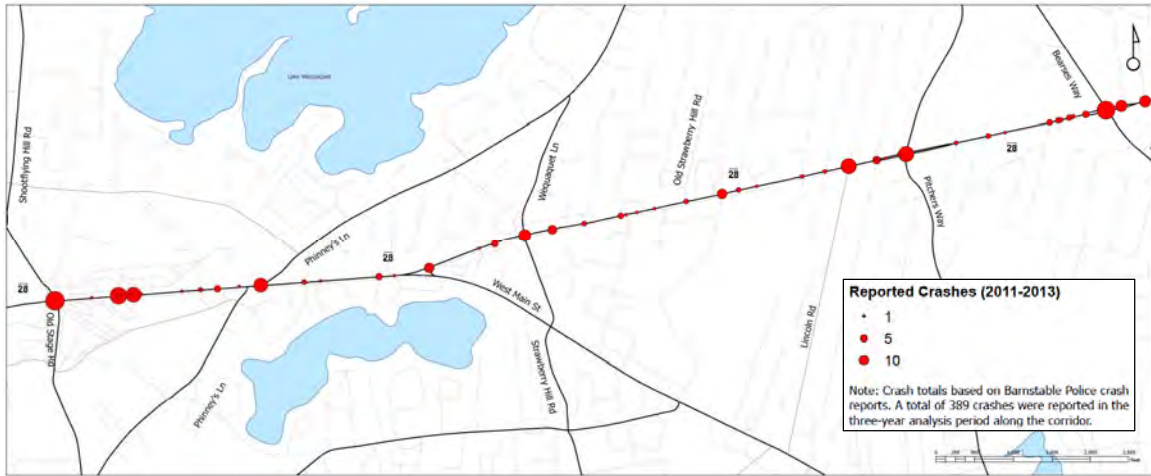
FIGURE 9 – EXISTING CONDITIONS: CRASH HISTORY

The highest crash locations along Route 28 were at the intersections: Old Stage Road (41), Bearses Way (37), the Centerville Shopping Area (33), Pitchers Way (28), Lincoln Road (27), the Bell Tower Mall Shopping Plaza (27), Phinneys Lane (23), and Strawberry Hill Road (17). With the exception of the Bearses Way intersection since it will soon be reconstructed by MassDOT, staff compiled detailed collision diagrams of these locations as included in the appendix.

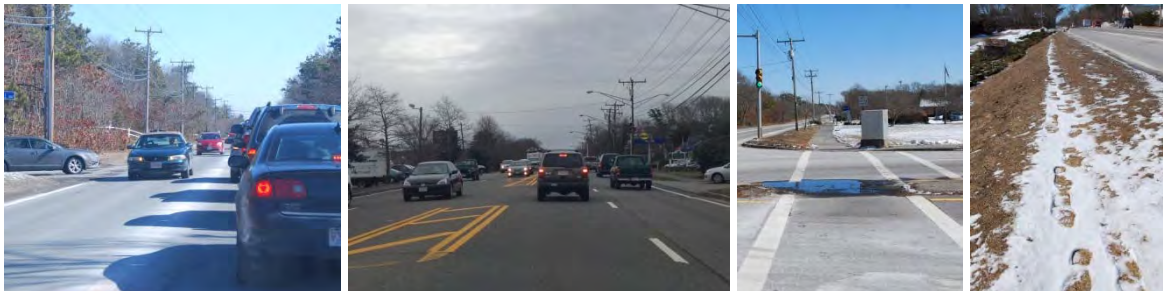
FIGURE 10 – SITE VISIT PHOTOGRAPHS

To take accurate measurements and gain a more complete awareness of conditions along the corridor, Commission staff made a number of site visits. As shown in the figure below, staff noted vehicle congestion and confusion, multi-use path design and maintenance issues, drainage issues, and evidence of pedestrian desire lines where no accommodations exist.

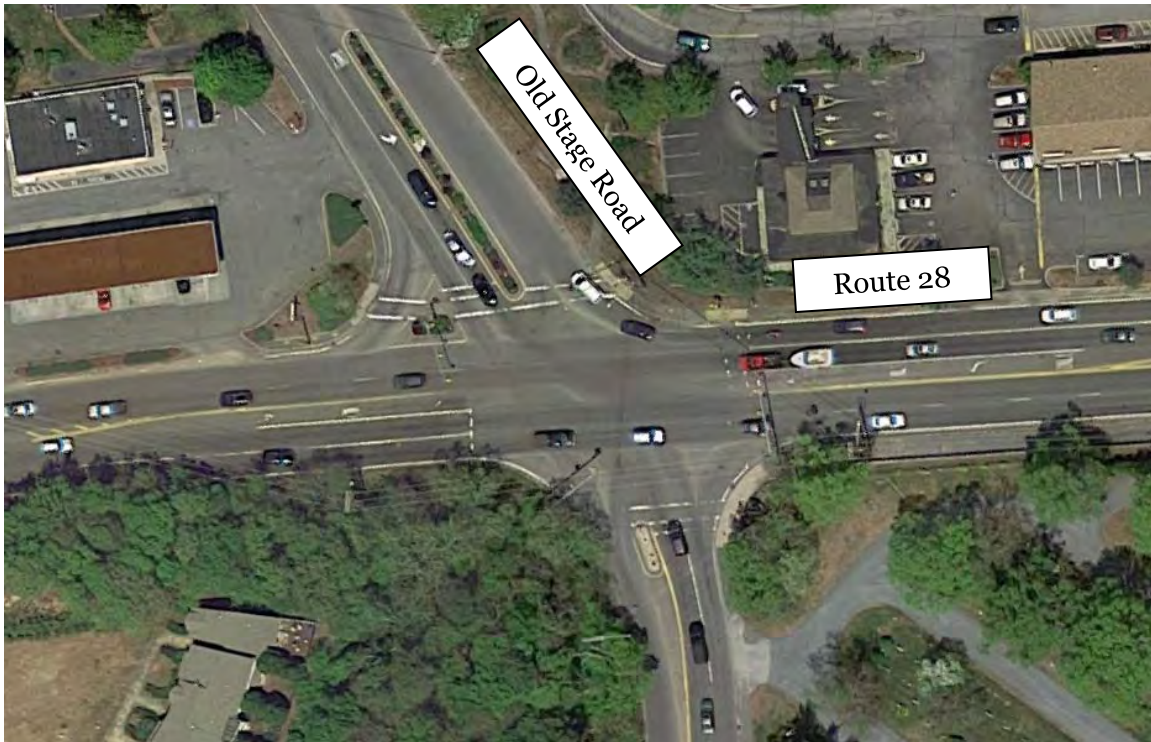
FIGURE 12 - ROUTE 28 AT OLD STAGE ROAD (AERIAL VIEW)

- Old Stage Road (south leg): through/left turn lane, right/through lane; median island; single receiving lane for outbound traffic. Includes a pedestrian push button/signal head and crosswalk with faded pavement markings. A sidewalk is available on the east side.

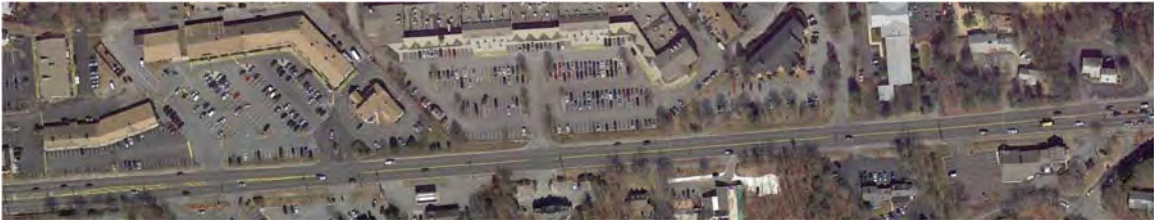
FIGURE 13 - AERIAL VIEW - ROUTE 28 CENTERVILLE FOUR-LANE SEGMENT - EXISTING CONDITIONS

From Old Stage Road to Phinneys Lane, Route 28 in Centerville consists of two travel lanes in each direction within an available right-of-way of 80 feet of width. A narrow sidewalk exists on the north side, often directly adjacent to the traveled way and protected by granite curbing. On the south side there is a substandard bike path approximately 8 feet wide that functions as a wide sidewalk. There are numerous curb-cuts and commercial sites on both sides of the road, including two major shopping centers on the north side of Route 28 and a variety of commercial businesses on the south side. Detailed concept plans for this segment of Route 28 are available in the appendix.

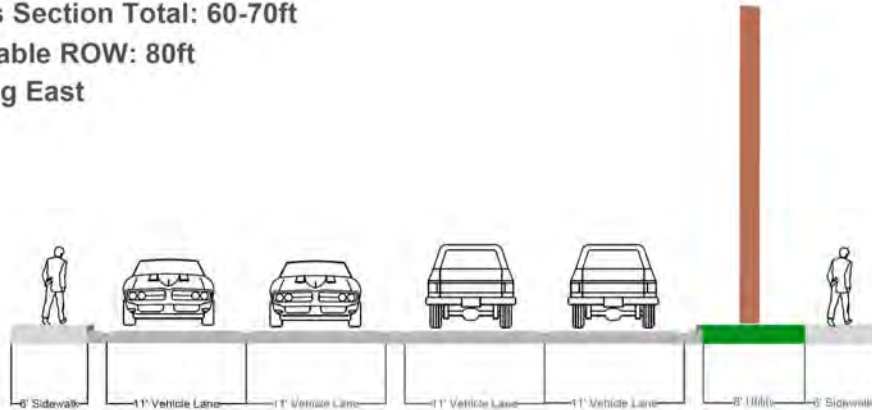
FIGURE 14 - ROUTE 28 CENTERVILLE FOUR-LANE SEGMENT CROSS-SECTION - EXISTING CONDITIONS

Cross Section Total: 60-70ft
Available ROW: 80ft
Facing East

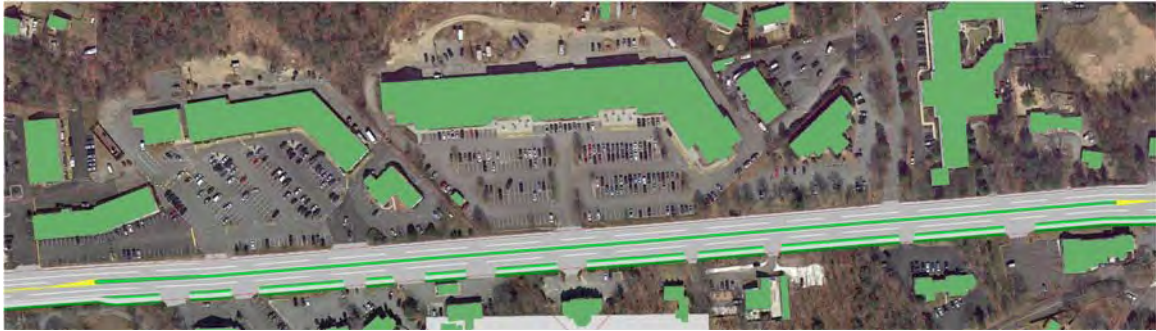
FIGURE 15 - AERIAL VIEW – ROUTE 28 CENTERVILLE CROSS-SECTION – OPTION 2A

Option 2A (long-term): Four-Lane, Median, Within Existing Right-Of-Way

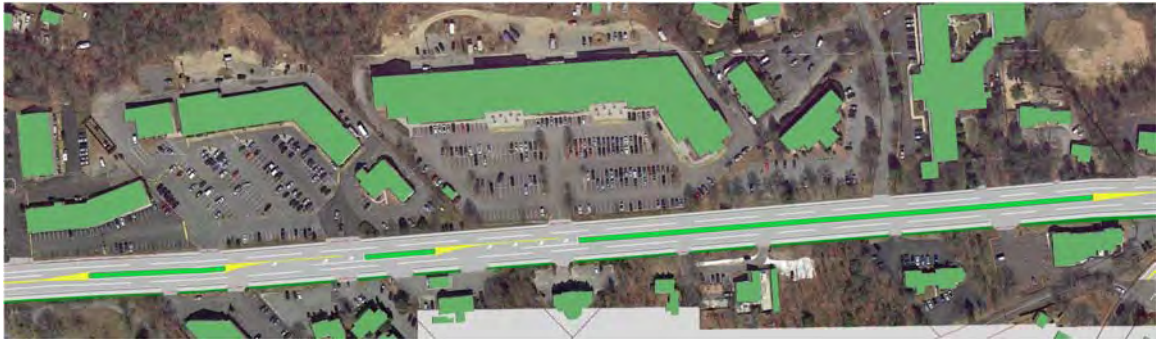
FIGURE 17 - AERIAL VIEW – ROUTE 28 CENTERVILLE CROSS-SECTION – OPTION 2B

Option 2B (long-term): Four –Lane, Median w/Turn Pockets, Within Existing Right-Of-Way

Cross Section Total: 80ft
Available ROW: 80ft
Facing East

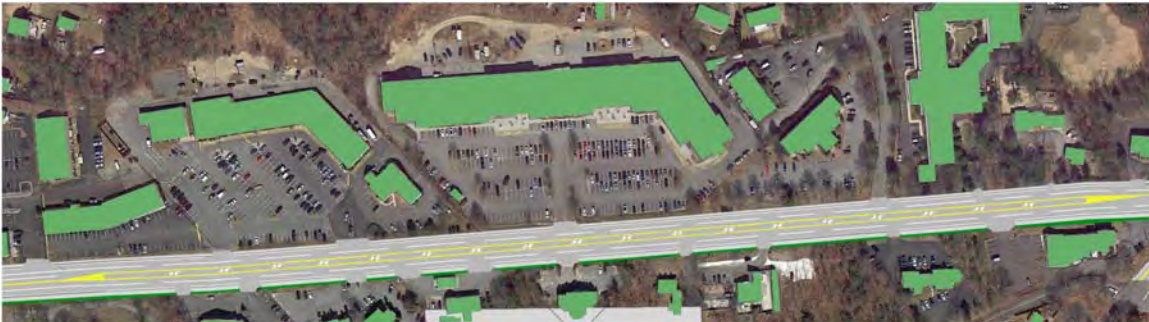
FIGURE 19 - AERIAL VIEW – ROUTE 28 CENTERVILLE CROSS-SECTION – OPTION 2C

Option 2C: Five-Lane, Undivided (Two Eastbound Lanes, Two Westbound Lanes, a Two-Way Left Turn Lane, Within Existing Right-Of-Way)

Cross Section Total: 80ft
Available ROW: 80ft
Facing East

Using nearly the entire right-of-way, this high-cost option includes an eleven-foot wide two-way left turn lane (TWLTL). The south side bike path would be adjacent to the traveled way and the utilities would be relocated to the southern edge of the right-of-way. Due to safety concerns associated with a five-lane TWLTL, this option is not recommended for further consideration. Expansion of this roadway is inconsistent with the Regional Transportation Policy: “For proposed roadways with cross-sections of four or more lanes, landscaped median dividers shall be included to provide a reasonable level of safety and access management.” A roadway expansion such as identified in this alternative would not be eligible for federal or state funding.

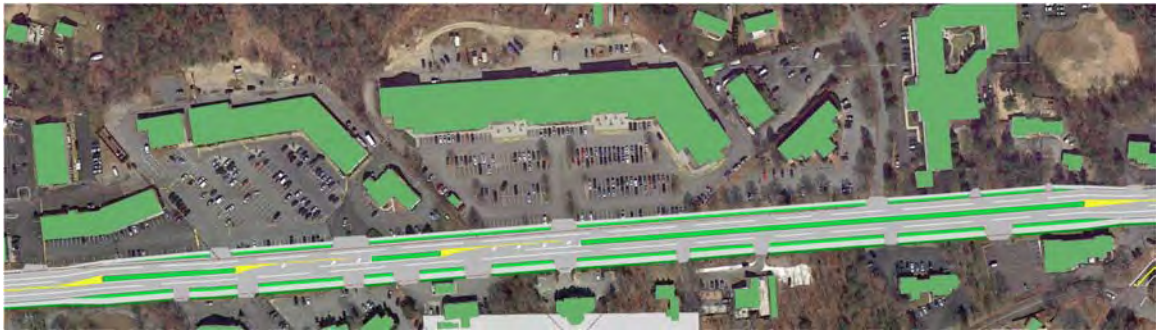
FIGURE 21 - AERIAL VIEW – ROUTE 28 CENTERVILLE CROSS-SECTION – OPTION 2D

Option 2D (long-term): Four-Lane, Median w/Turn Pockets, Expanded Right-Of-Way

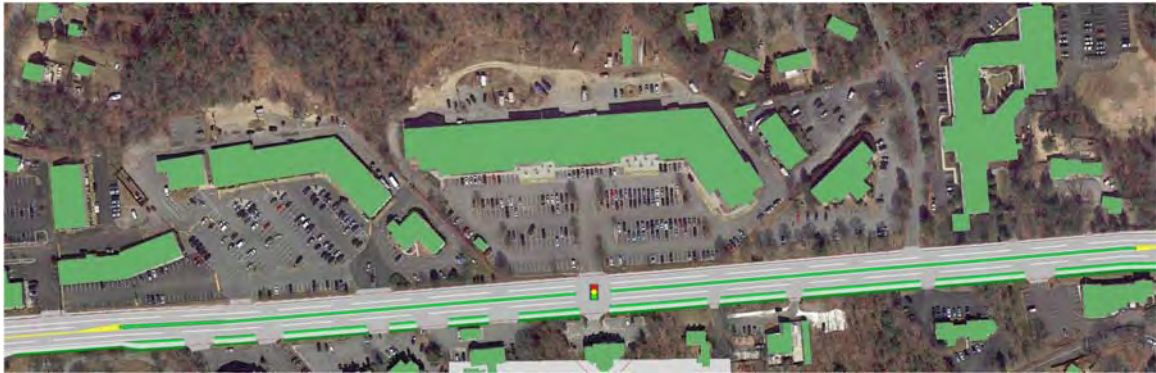
FIGURE 23 - AERIAL VIEW – ROUTE 28 CENTERVILLE CROSS-SECTION OPTION 2E

Option 2E (long-term): Four –Lane, Median, Added Traffic Signal, Within Existing Right-Of-Way

Cross Section Total: 80ft
Available ROW: 80ft
Facing East

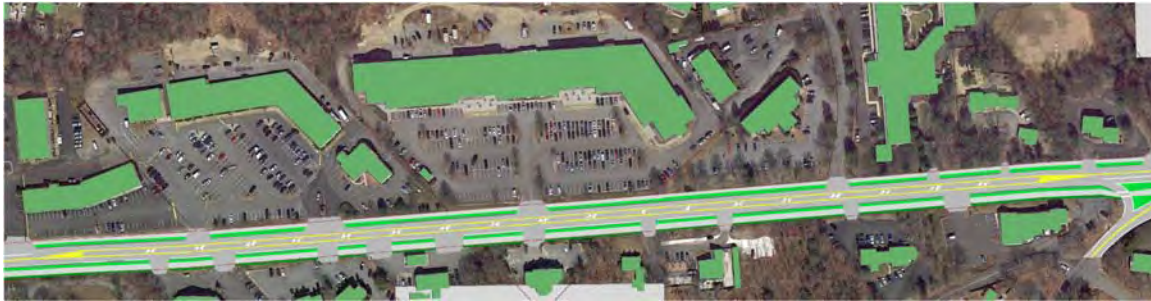
FIGURE 25 - AERIAL VIEW – ROUTE 28 CENTERVILLE CROSS-SECTION – OPTION 2F

Option 2F (long-term): Three-Lane, Undivided (One Eastbound Lane, One Westbound Lane, a Two-Way Left Turn Lane, within Existing Right-Of-Way

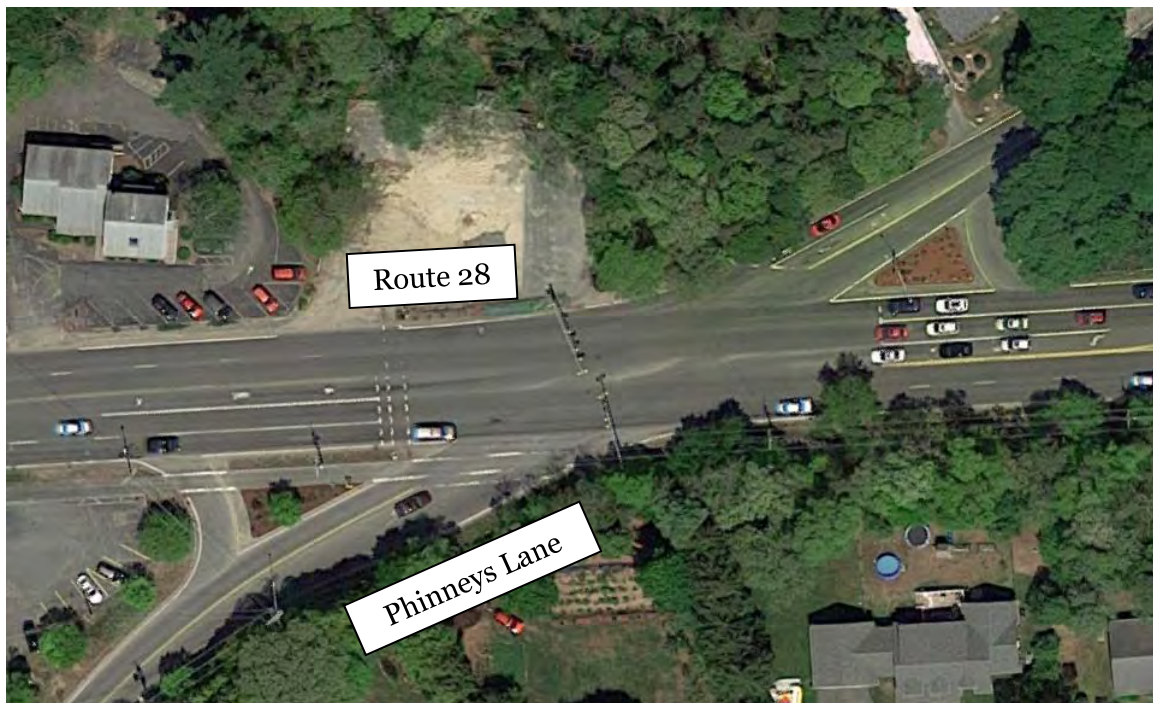
FIGURE 27 - ROUTE 28 AT PHINNEYS LANE (AERIAL VIEW)

- Phinneys Lane (north leg): left turn lane, through/right turn lane. There is one receiving lane for outbound traffic.
- Phinneys Lane (south leg): left turn lane, through/right turn lane. This approach includes a push-button activated pedestrian crossing to serve the substandard multi-use path. There is one receiving lane for outbound traffic.

The acute approach angles (approximately 30°) of both legs of Phinneys Lane create safety and operations problems at this intersection. For example, motorists on Phinneys Lane attempting to make a right turn onto Route 28 are forced to turn to look over their left shoulder before pulling out into traffic – and have great difficulty in also monitoring the actions of vehicles immediately in front of them. For Phinneys Lane motorists turning left, there is a large amount of pavement to traverse to reach the correct lane, this lengthy maneuver degrades the ability of the intersection to process vehicles efficiently.

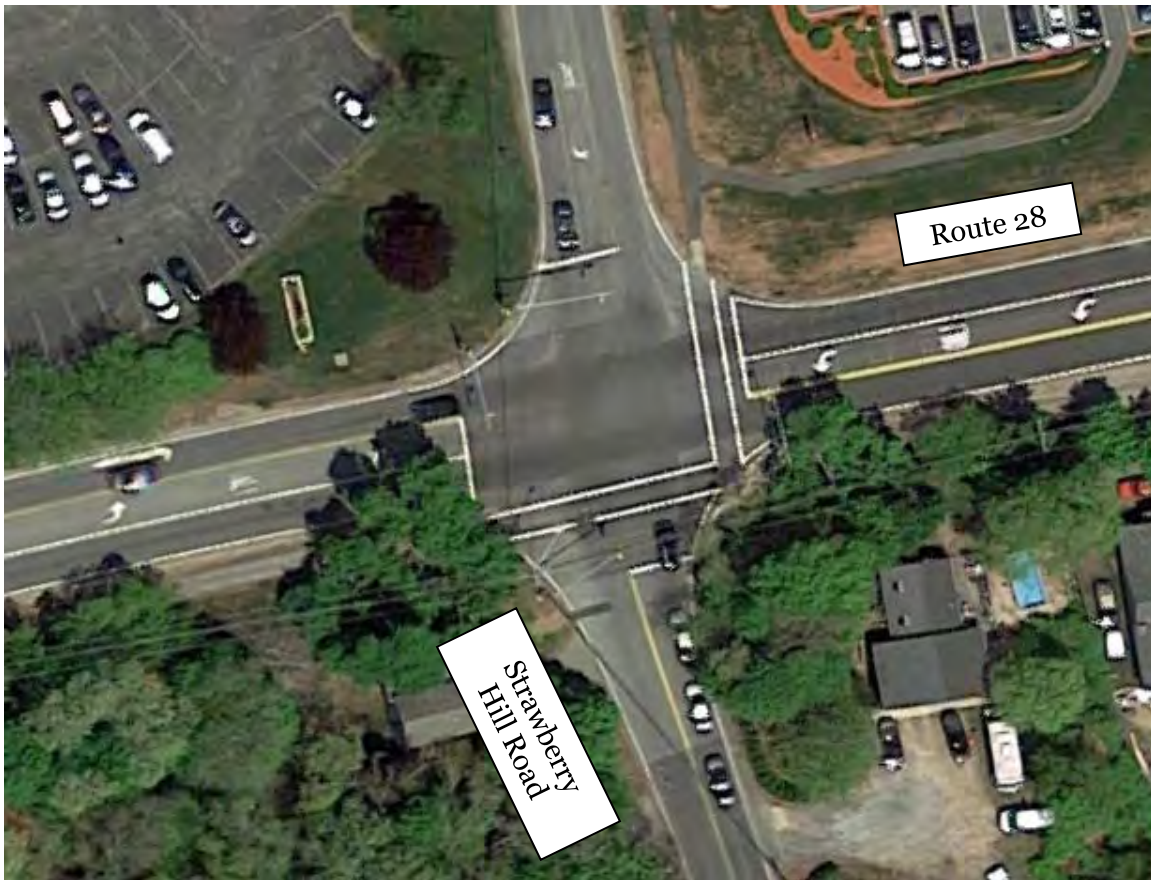
FIGURE 29 - ROUTE 28 AT STRAWBERRY HILL ROAD (AERIAL VIEW)

- Route 28 (east leg): left turn lane, through/right turn lane; with one receiving lane for outbound traffic. There is a pedestrian crosswalk and a substandard multi-use path along the south side of the roadway. A short segment of sidewalk is available along the north-side of Route 28 within the frontage of the CVS pharmacy.
- Route 28 (west leg): left turn lane, through/right turn lane; with one receiving lane for outbound traffic. There is a substandard multi-use path along the south side of the roadway.
- Strawberry Hill Road (north leg): left turn lane, through/right turn lane; with one receiving lane for outbound traffic. There is a sidewalk with landscaped buffer along the east side of the roadway.
- Strawberry Hill Road (south leg): single lane for all movements and one receiving lane for outbound traffic. There is a pedestrian crosswalk connecting the substandard multi-use path.

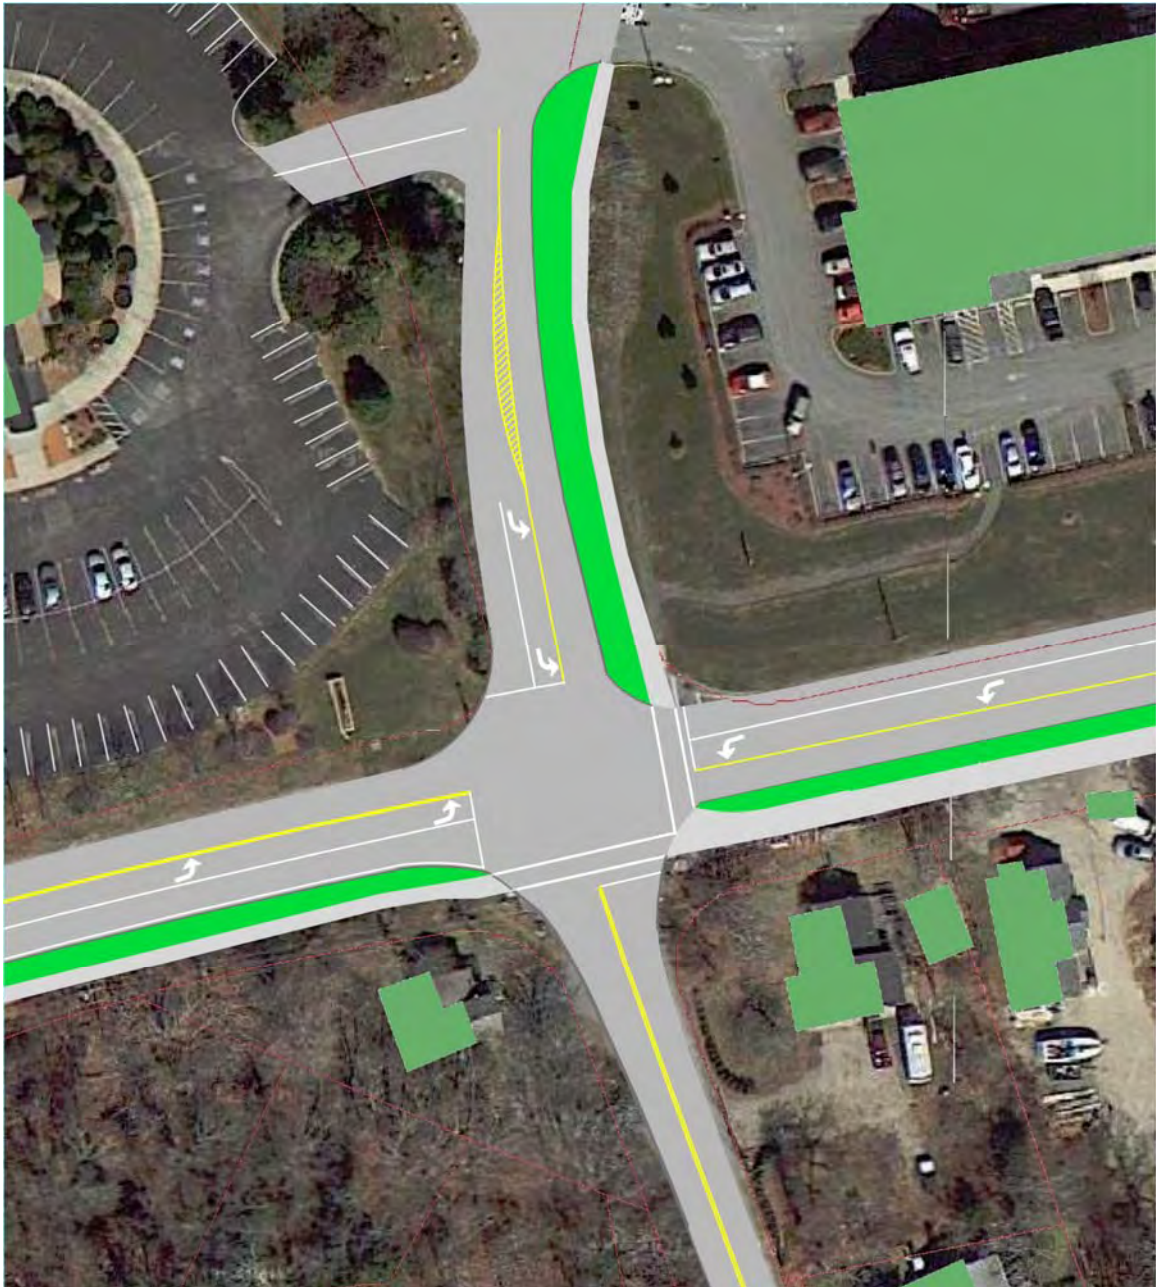
FIGURE 30 - ROUTE 28/STRAWBERRY HILL RD OPTION 5B

This option would address the difficulties experienced by motorists turning into or out of Strawberry Hill Road by properly aligning the approaching traffic and adjusting the grade of the approaches. This high-cost option may require an extensive work zone in order to accommodate safe slopes of approach and along the sides of Strawberry Hill Road. It is expected to have medium safety benefits and low safety and bicycle/pedestrian benefits. This option is shown in the following graphic:

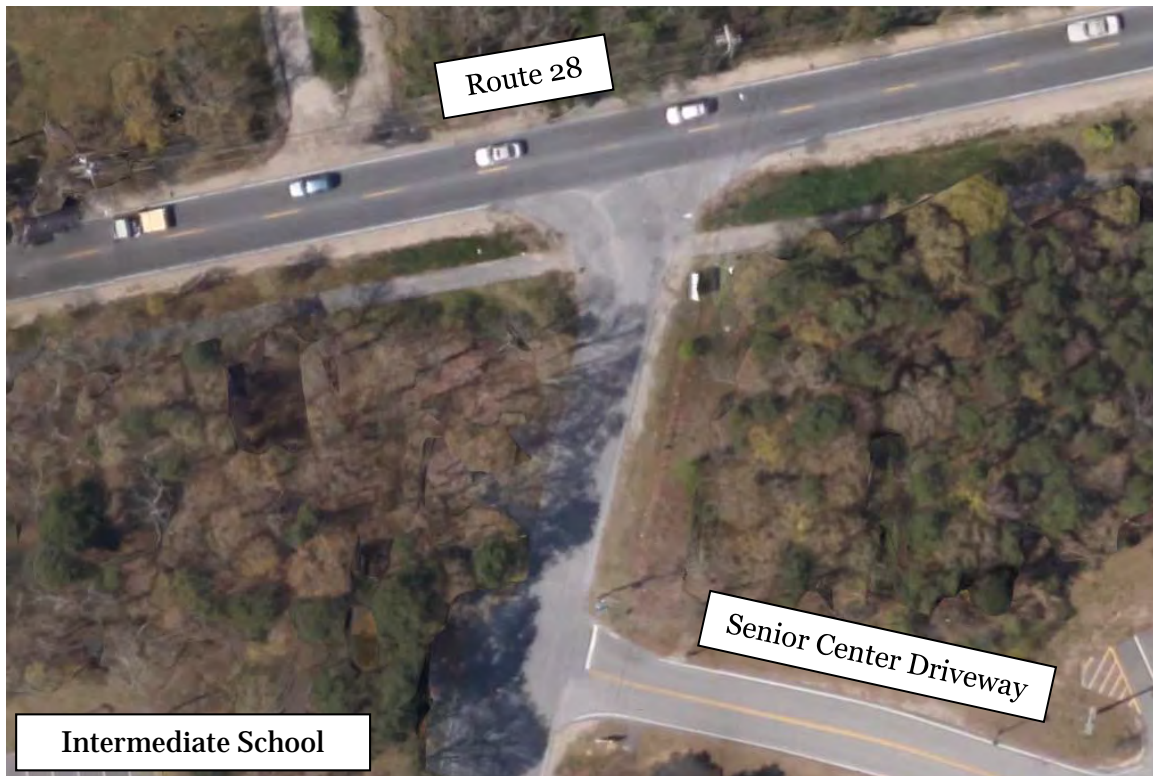
FIGURE 31 - ROUTE 28 AT SENIOR CENTER/INTERMEDIATE SCHOOL ACCESS

This intersection is heavily used during school arrival/departure hours and serves as an important facility for residents and visitors accessing the Barnstable Senior Center and Barnstable High School’s recreational fields. It provides direct Route 28 access to Barnstable High School (main access from West Main Street) and secondary access for Barnstable Intermediate School.

In 2015 the Commission staff performed extensive data collection at the intersection and adjacent roadway segments. Town of Barnstable staff are currently developing concepts to address safety, traffic congestion, and improved bicycle/pedestrian accommodation.

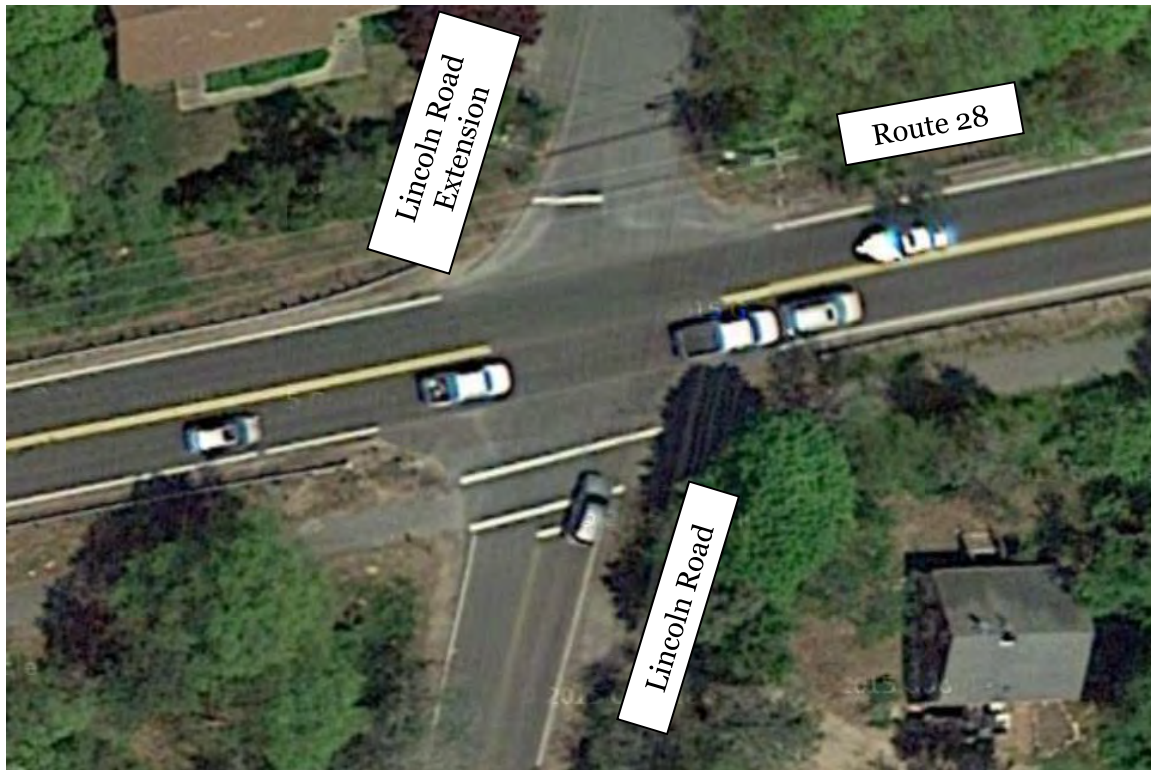
FIGURE 32 - ROUTE 28 AT LINCOLN ROAD (AERIAL VIEW)

- Route 28 (east leg and west leg): one multipurpose lane and one receiving lane for outbound traffic. There is a multi-use path along the south side of the roadway separated by a landscaped buffer.
- Lincoln Road (south side): one multipurpose lane and one receiving lane for outbound traffic. This approach includes a crosswalk connecting the multi-use path. This approach is stop-sign controlled.
- Lincoln Road Extension (north side): there are no lane demarcations. Pavement width is sufficient to replicate one multipurpose lane and one receiving lane for outbound traffic. This approach is also stop-sign controlled.

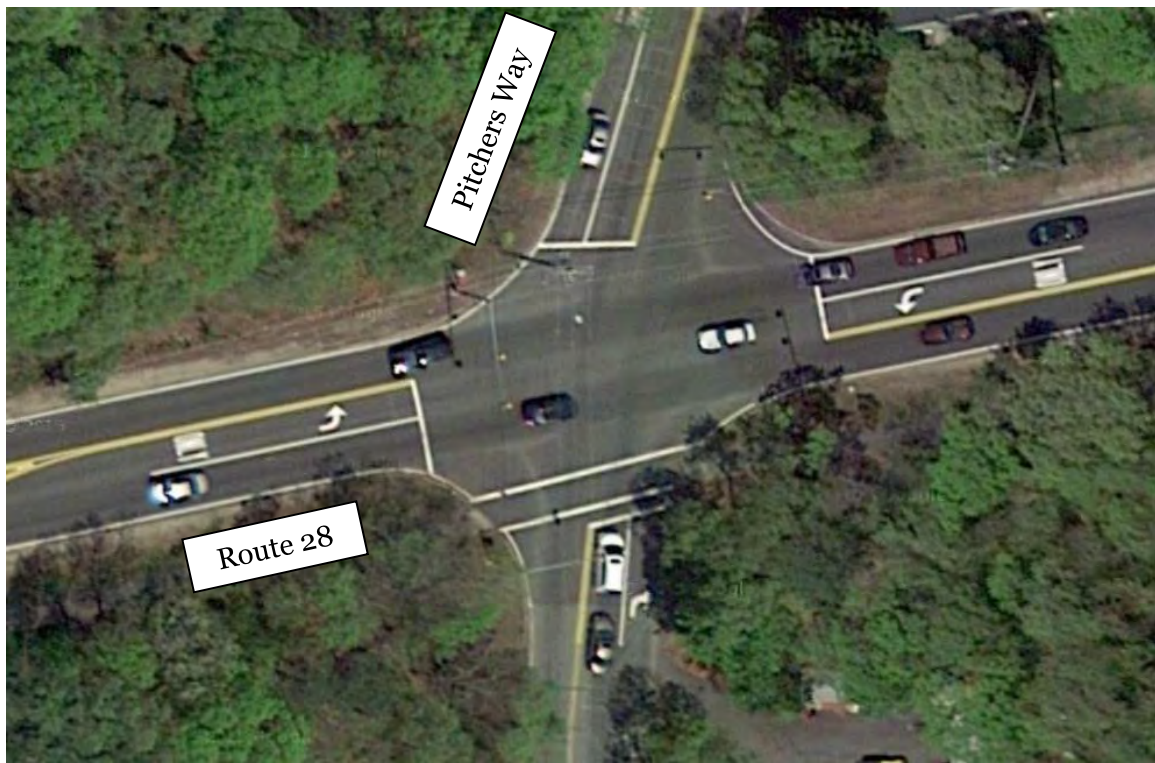
FIGURE 33 - ROUTE 28 AT PITCHERS WAY (AERIAL VIEW)

- Route 28 (east and west legs): left turn lane, right turn/through lane and one receiving lane for outbound traffic. There is a multi-use path along the south side of the roadway separated by a landscaped buffer.
- Pitchers Way (north leg): left/through lane, right turn lane, and one receiving lane for outbound traffic.
- Pitchers Way (south leg): left/through lane, right turn lane, and one receiving lane for outbound traffic. This approach includes a crosswalk connecting the multi-use path.

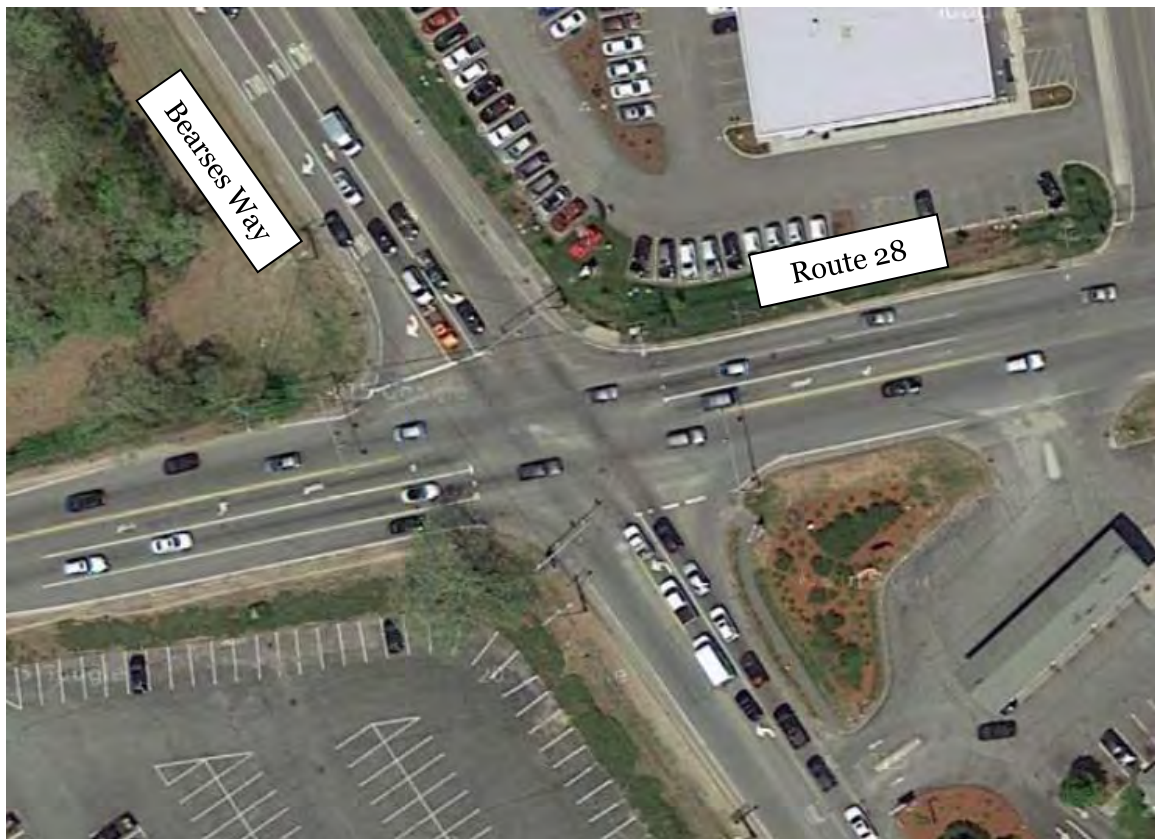
FIGURE 34 - ROUTE 28 AT BEARSES WAY (AERIAL VIEW)

- Route 28 (east leg): left turn lane, through lane, and a right turn/through lane with two outbound receiving lanes.
- Route 28 (west legs): left turn lane, through lane, and a right turn/through lane with two outbound receiving lanes. The multi-use path along the south side of Route 28 terminates at the commercial site drive approximately 150 feet in advance of the intersection.
- Bearses Way (north leg): left turn lane, through lane, right turn lane and one receiving lane for outbound traffic. There is a curbed sidewalk immediately adjacent to the east side of the roadway.
- Bearses Way (south leg): left turn lane, right/through lane and one receiving lane for outbound traffic. There is a sidewalk separated by a landscaped buffer along the east side of the roadway.

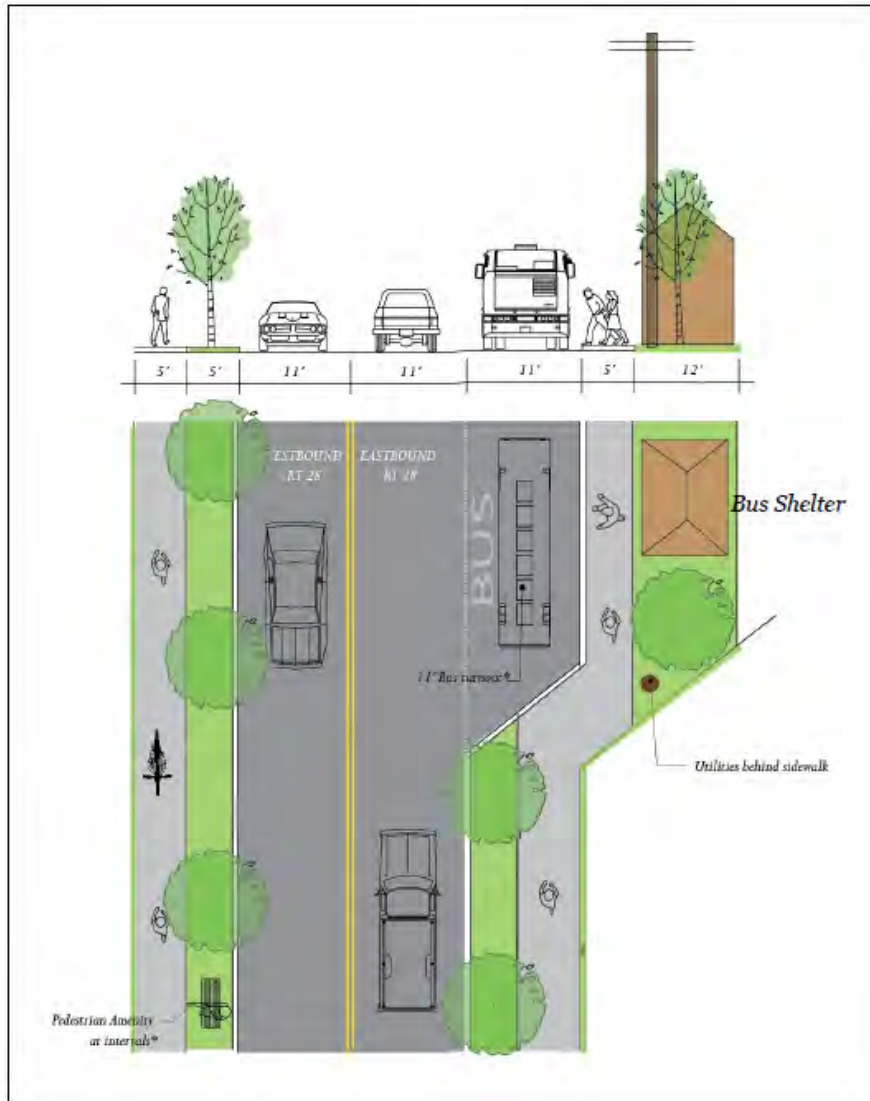
FIGURE 40 - POTENTIAL BUS TURNOUT DESIGN DISPLAYING A BUS SHELTER AND ADDITIONAL PEDESTRIAN AMENITIES.

This study recommends additional dedicated bus stops to accommodate transit users along the corridor. These bus stops may be designated with a simple sign and bench or more elaborate public art piece, to lessen rider confusion and create a sense of place. One alternative, as depicted by the following figure, is to provide bus turnouts which incorporate a bus shelter. This configuration would increase safety measures throughout the corridor by separating the users of the corridor and provide greater visibility of multimodal options.

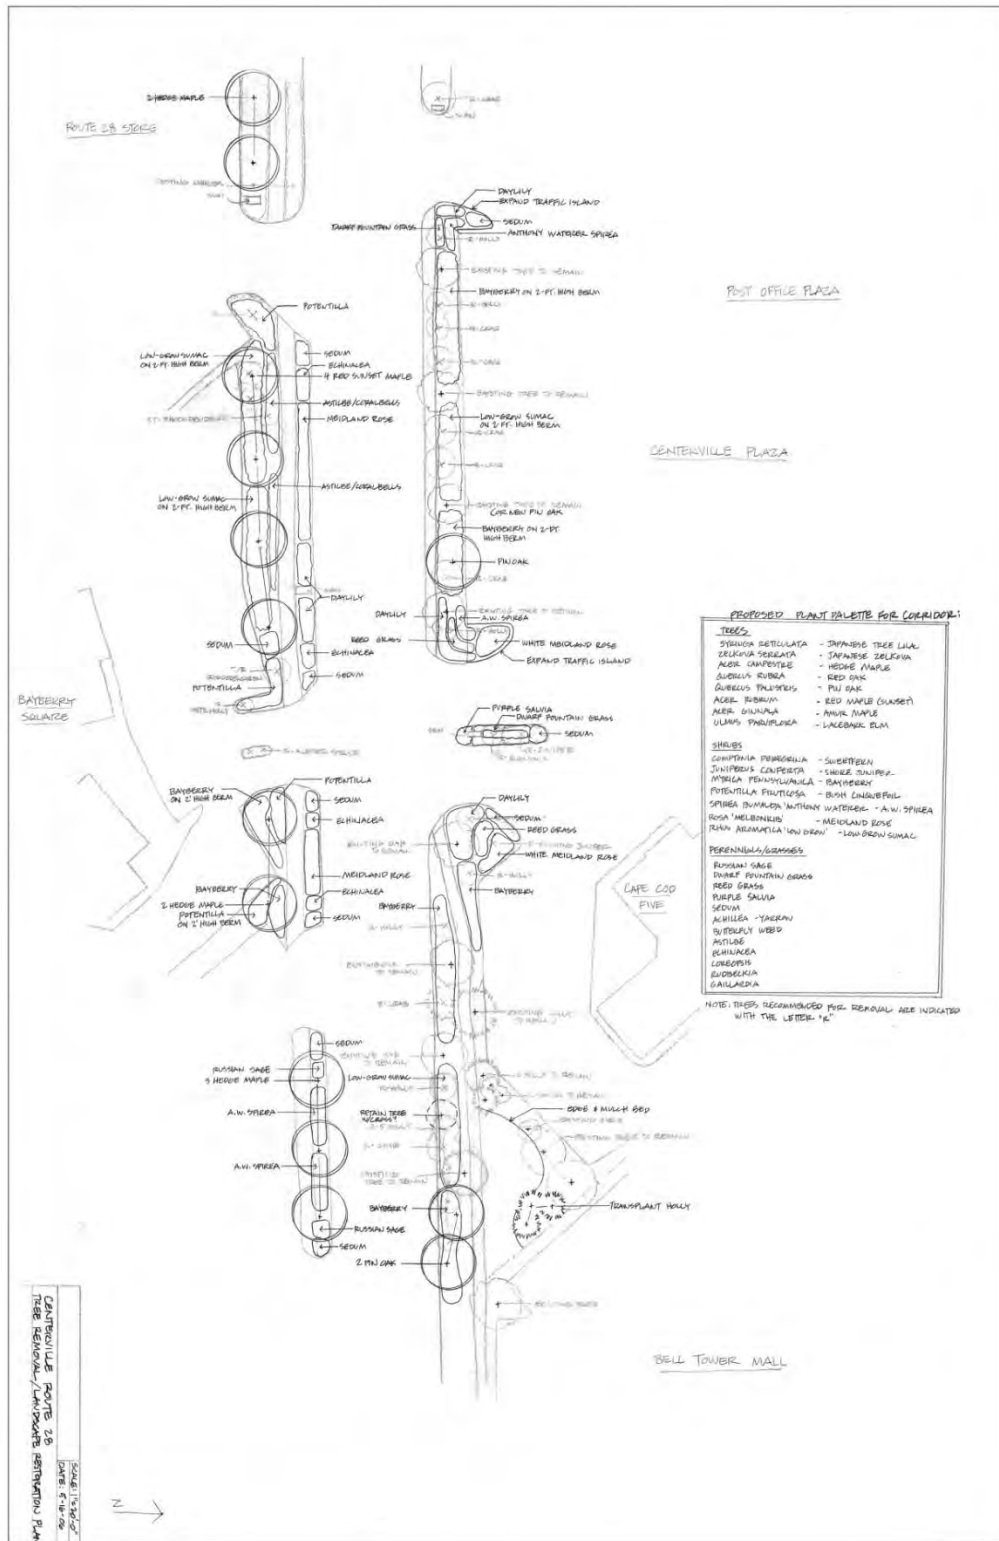
FIGURE 41 – TREE REMOVAL AND LANDSCAPE RESTORATION PLAN EXAMPLE FOR THE COMMERCIAL NODE OF THE ROUTE 28 CORRIDOR.

The study also recommends the implementation of a landscape design that incorporates local plant material, non-invasive materials, and environmentally friendly design that emphasizes on the Cape's unique landscape heritage. This study looks to present the following plan for the Commercial Node area as a first step of possible landscape revitalization efforts.

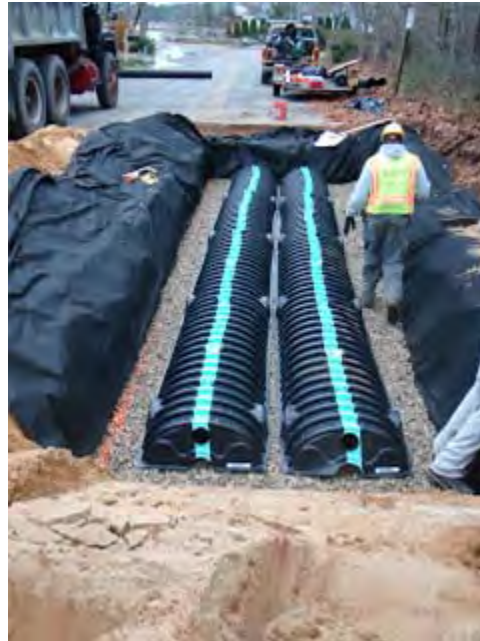
FIGURE 43 - HDPE SUB-SURFACE TREATMENT CHAMBERS

Sub-surface sediment chambers function similarly to surface sedimentation systems. Sediment trapping systems remove pollutants (mainly particulates) from stormwater runoff through a pretreatment sedimentation area followed by an infiltration bed containing filter media (typically sand, soil, gravel or a combination of media). This infiltration bed removes fines and the pollutants adsorbed, or attached, to these particulates. Various contaminants including, but not limited to metals, petroleum

hydrocarbons and bacteria may sorb to fines allowing infiltration systems to achieve removal efficiencies in these categories through the physical process of filtration.

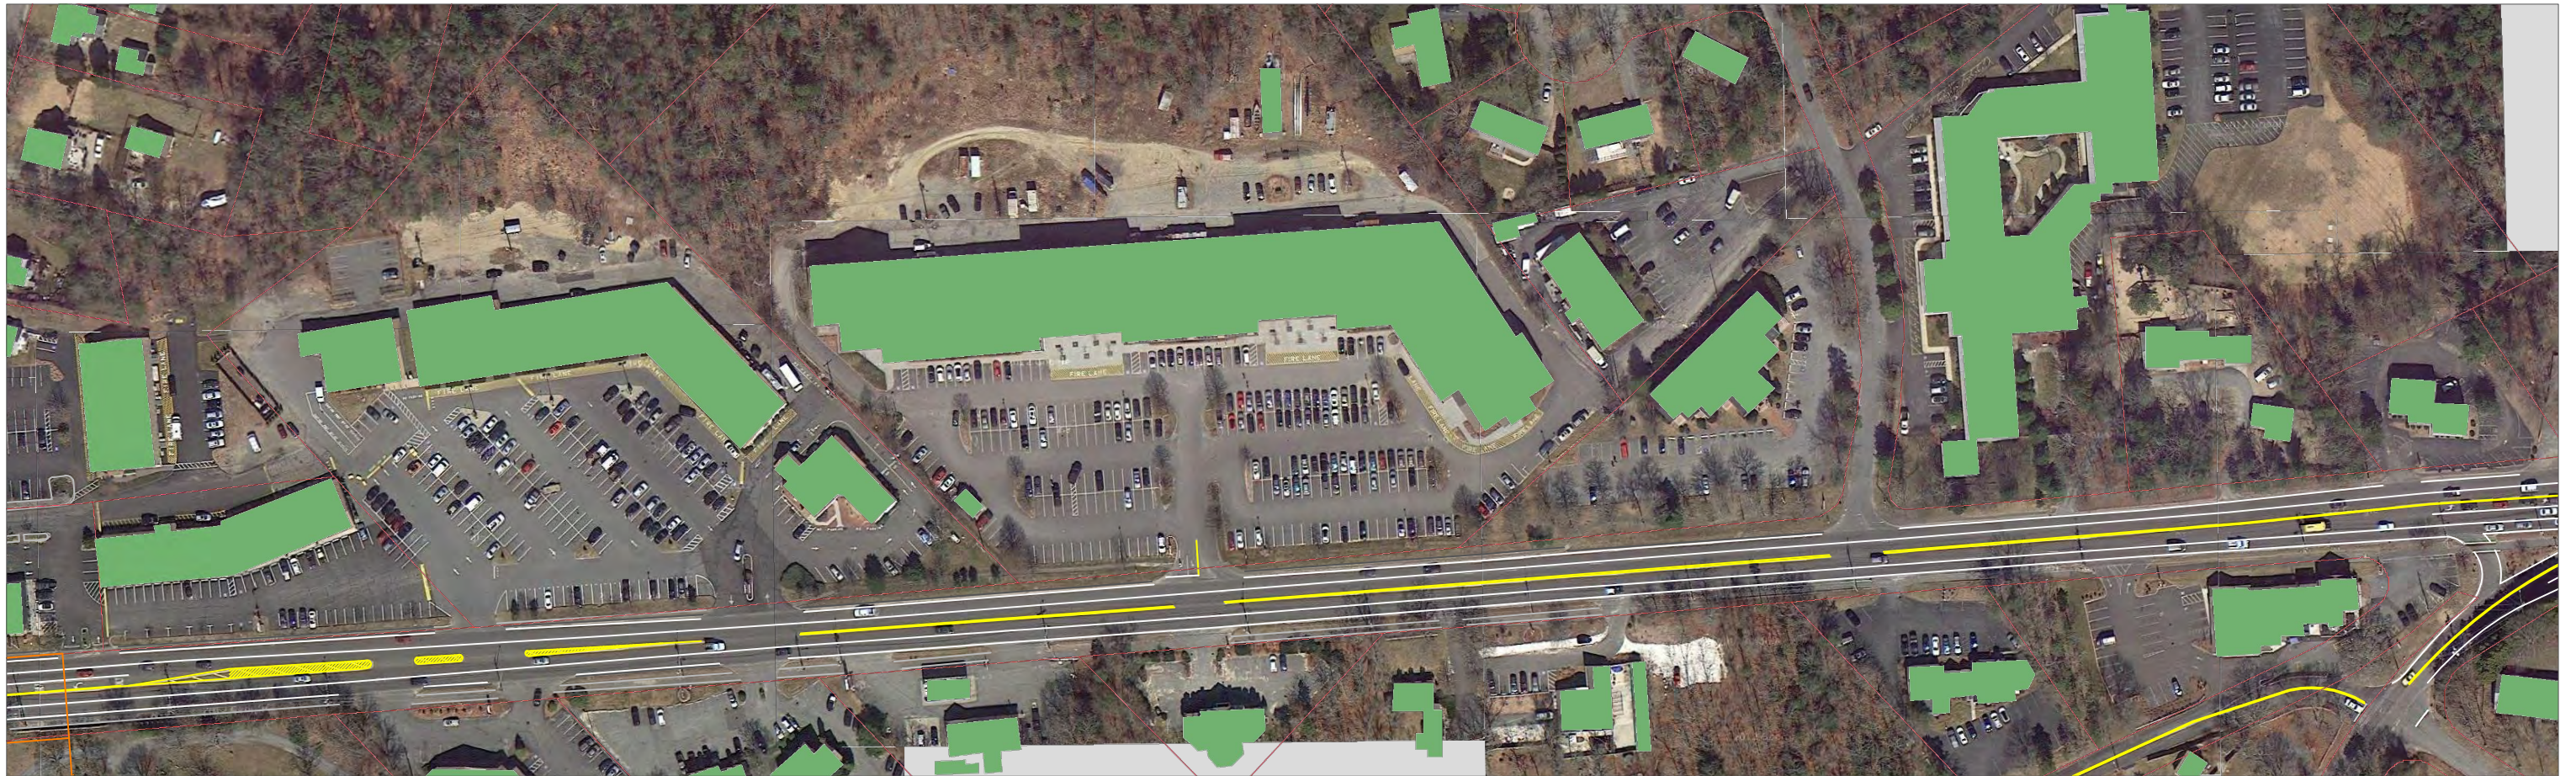
Cross Section Total: 60-70ft
Available ROW: 80ft
Facing East

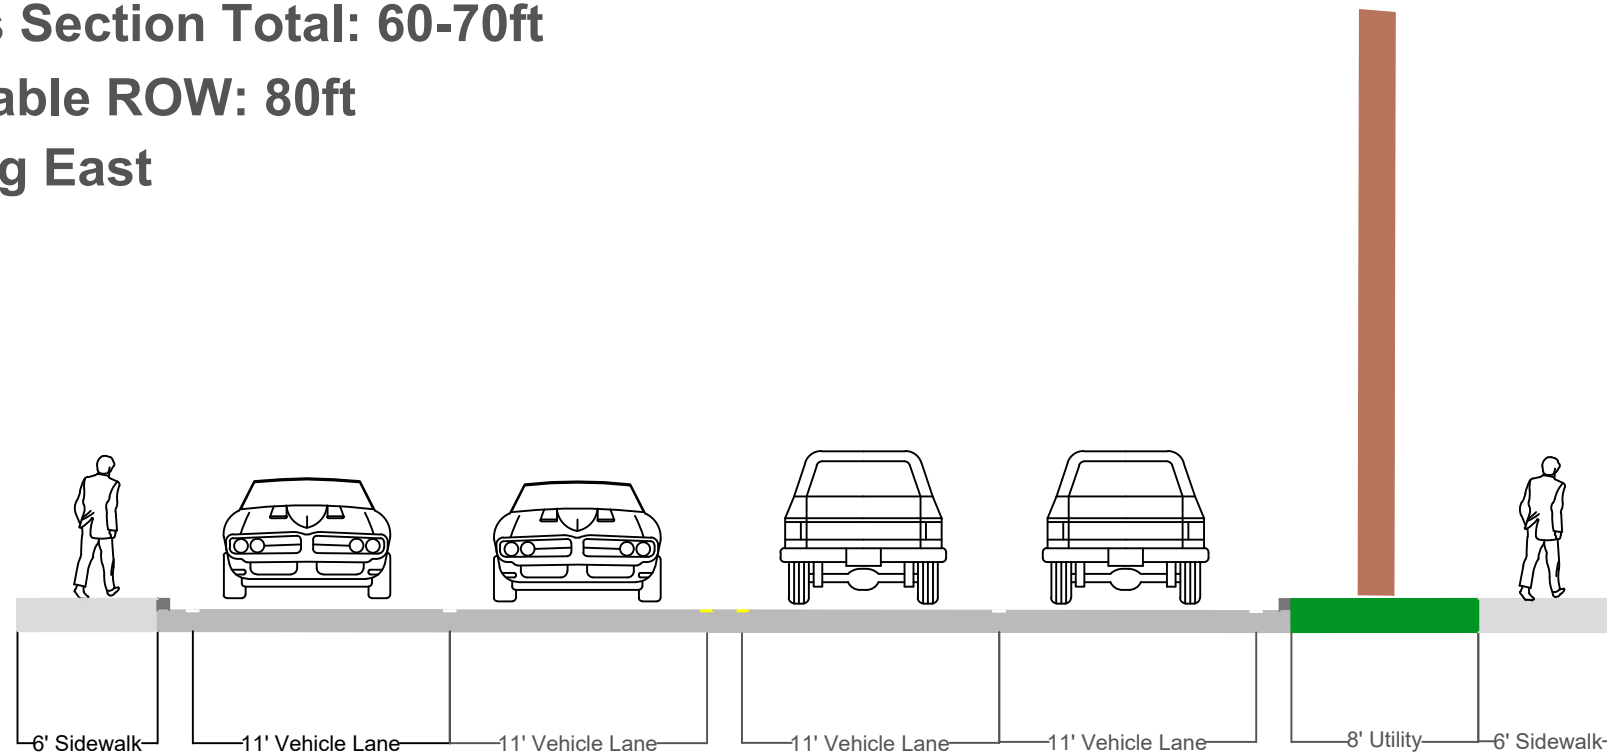
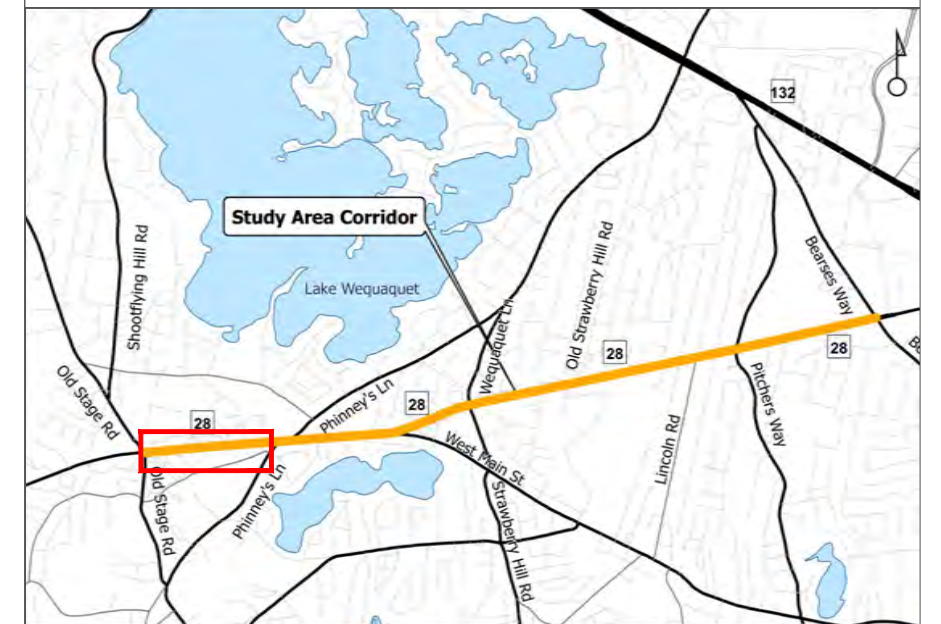
Barnstable Route 28 Corridor Study: Old Stage Road to Phinney's Lane Four-Lane Reconfiguration- Existing Conditions

Existing Conditions: Four Lanes undivided
 Cape Cod Commission Technical Services Staff

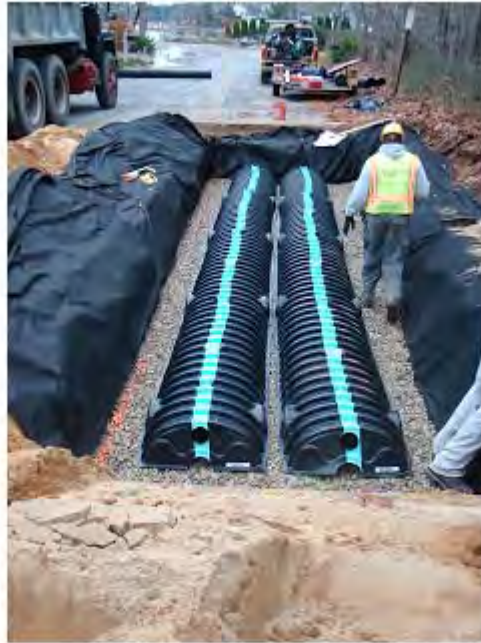
FIGURE 5: HDPE SUB-SURFACE TREATMENT CHAMBERS (PHOTO COURTESY LINDSAY COOK, CAPE COD CONSERVATION DISTRICT INTERN)

allowing infiltration systems to achieve removal efficiencies in these categories though the physical process of filtration.
