CAPE COD
COMMISSION

Route 28 Centerville-Hyannis Corridor Study

Old Stage Road to Bearses Way

February 2016

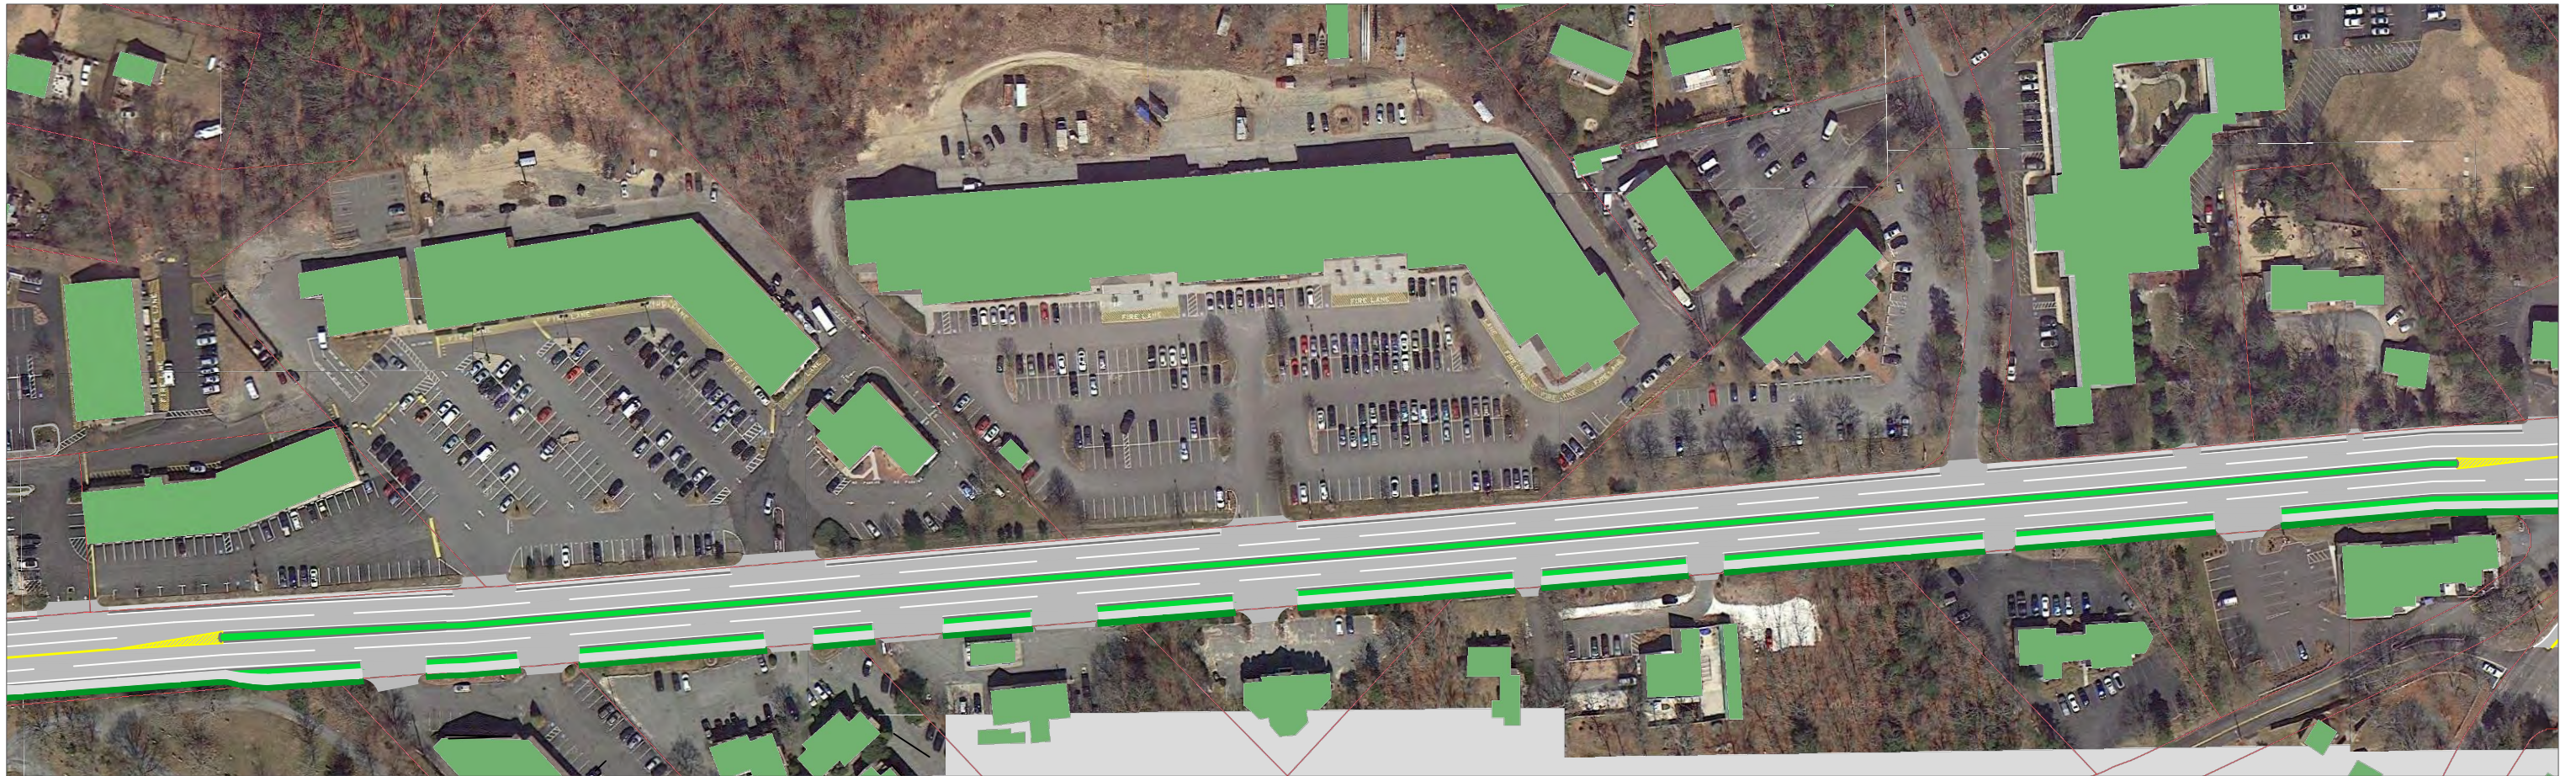
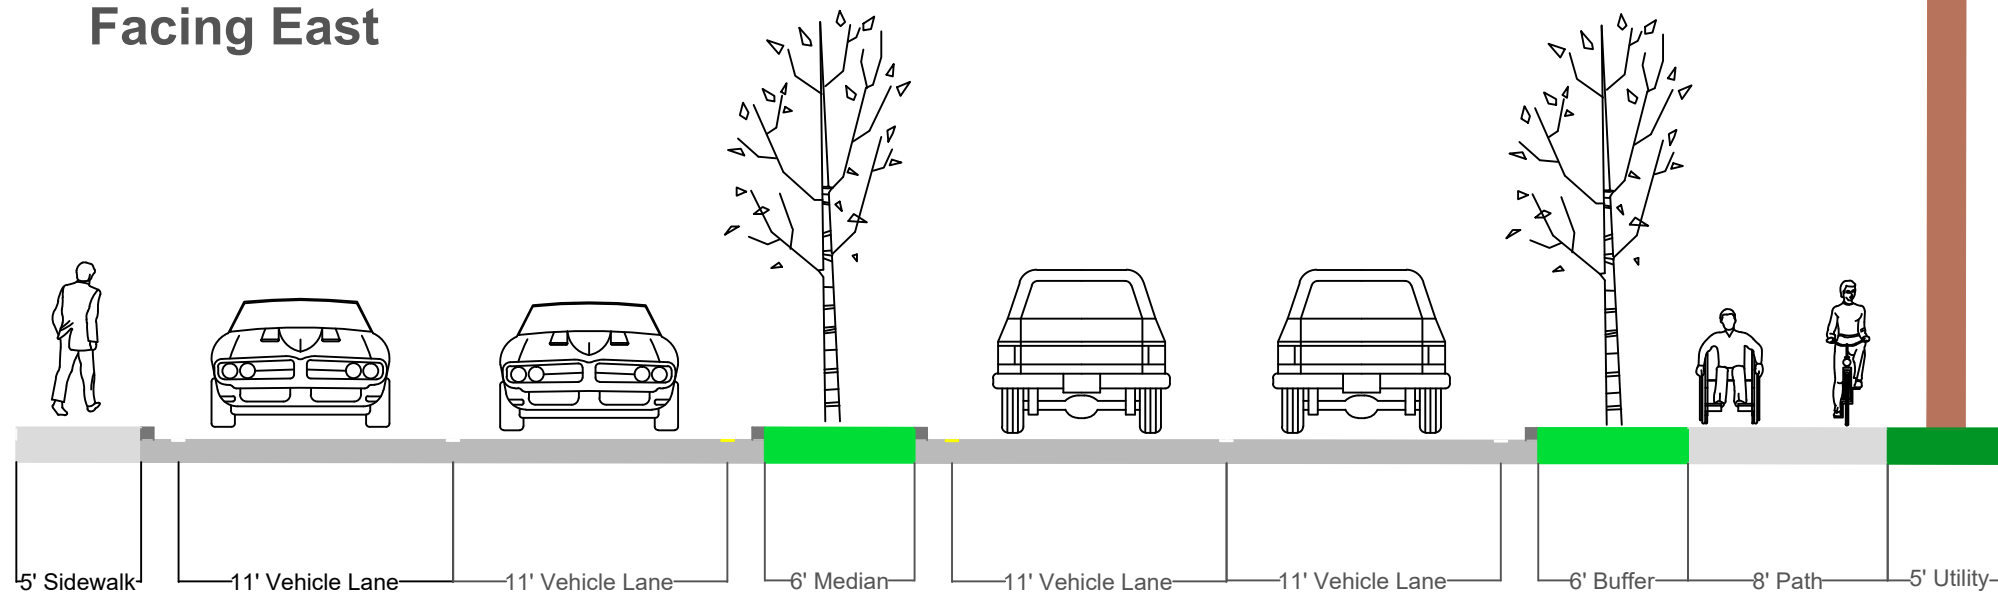
Barnstable Route 28 Corridor Study: Old Stage Road to Phinney's Lane Four-Lane Reconfiguration- Alternative One

Cross Section Total: 80ft
Available ROW: 80ft
Facing East

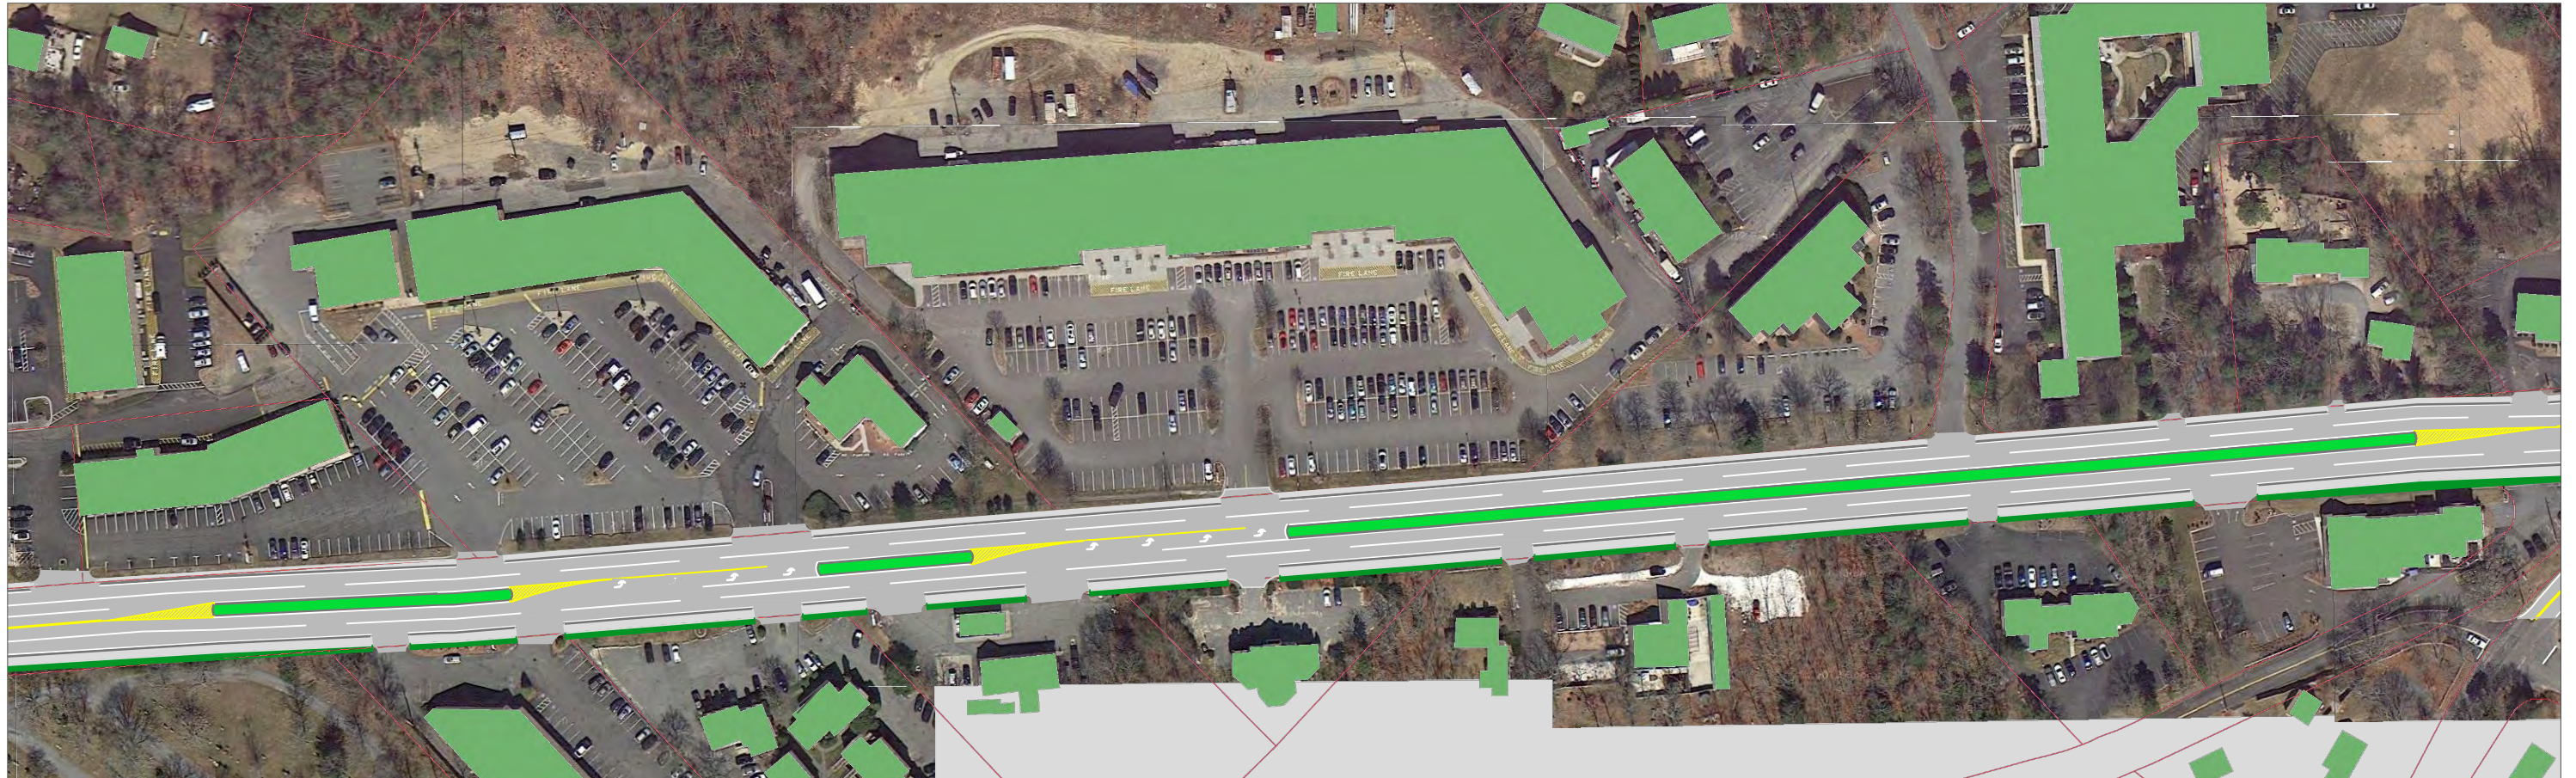
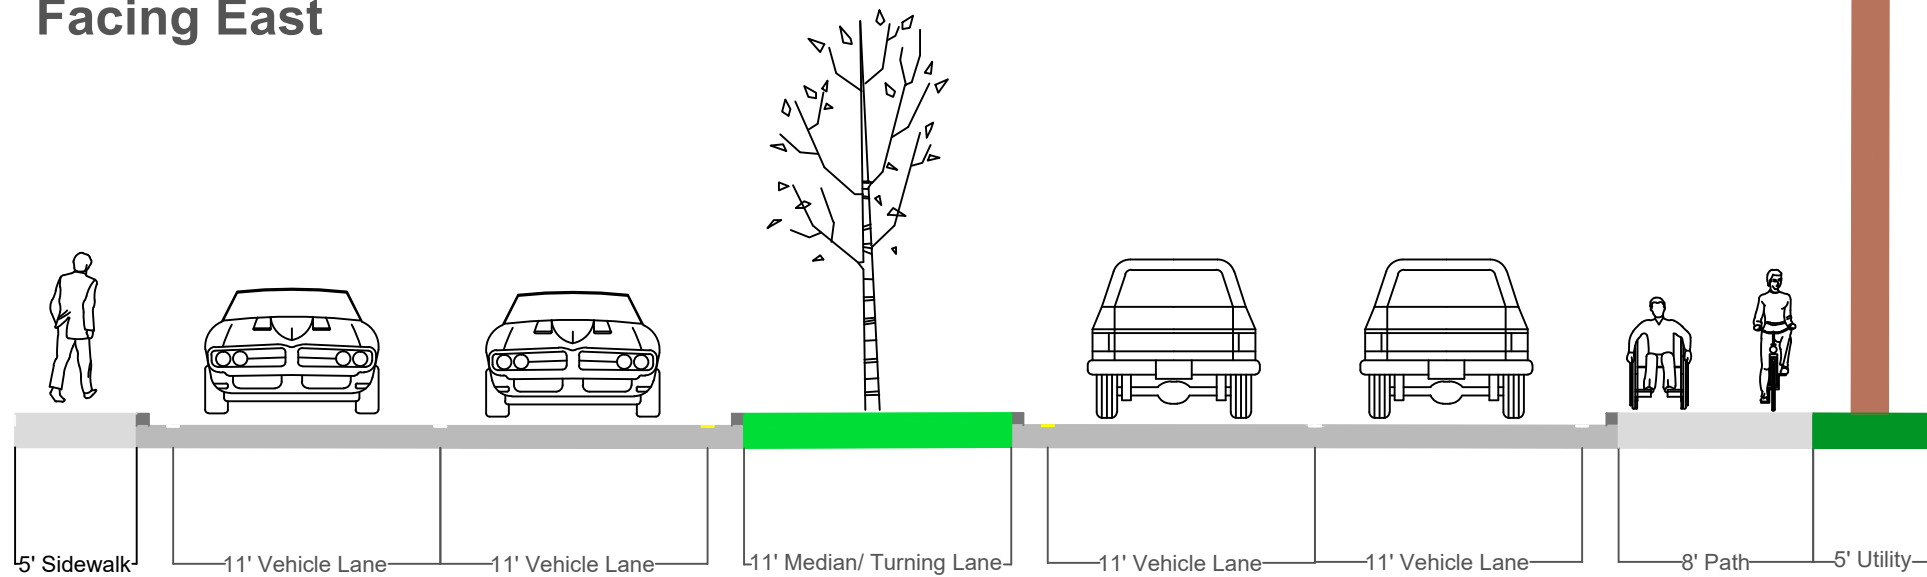
Barnstable Route 28 Corridor Study: Old Stage Road to Phinney's Lane Four-Lane Reconfiguration- Alternative Two

Cross Section Total: 80ft
Available ROW: 80ft
Facing East

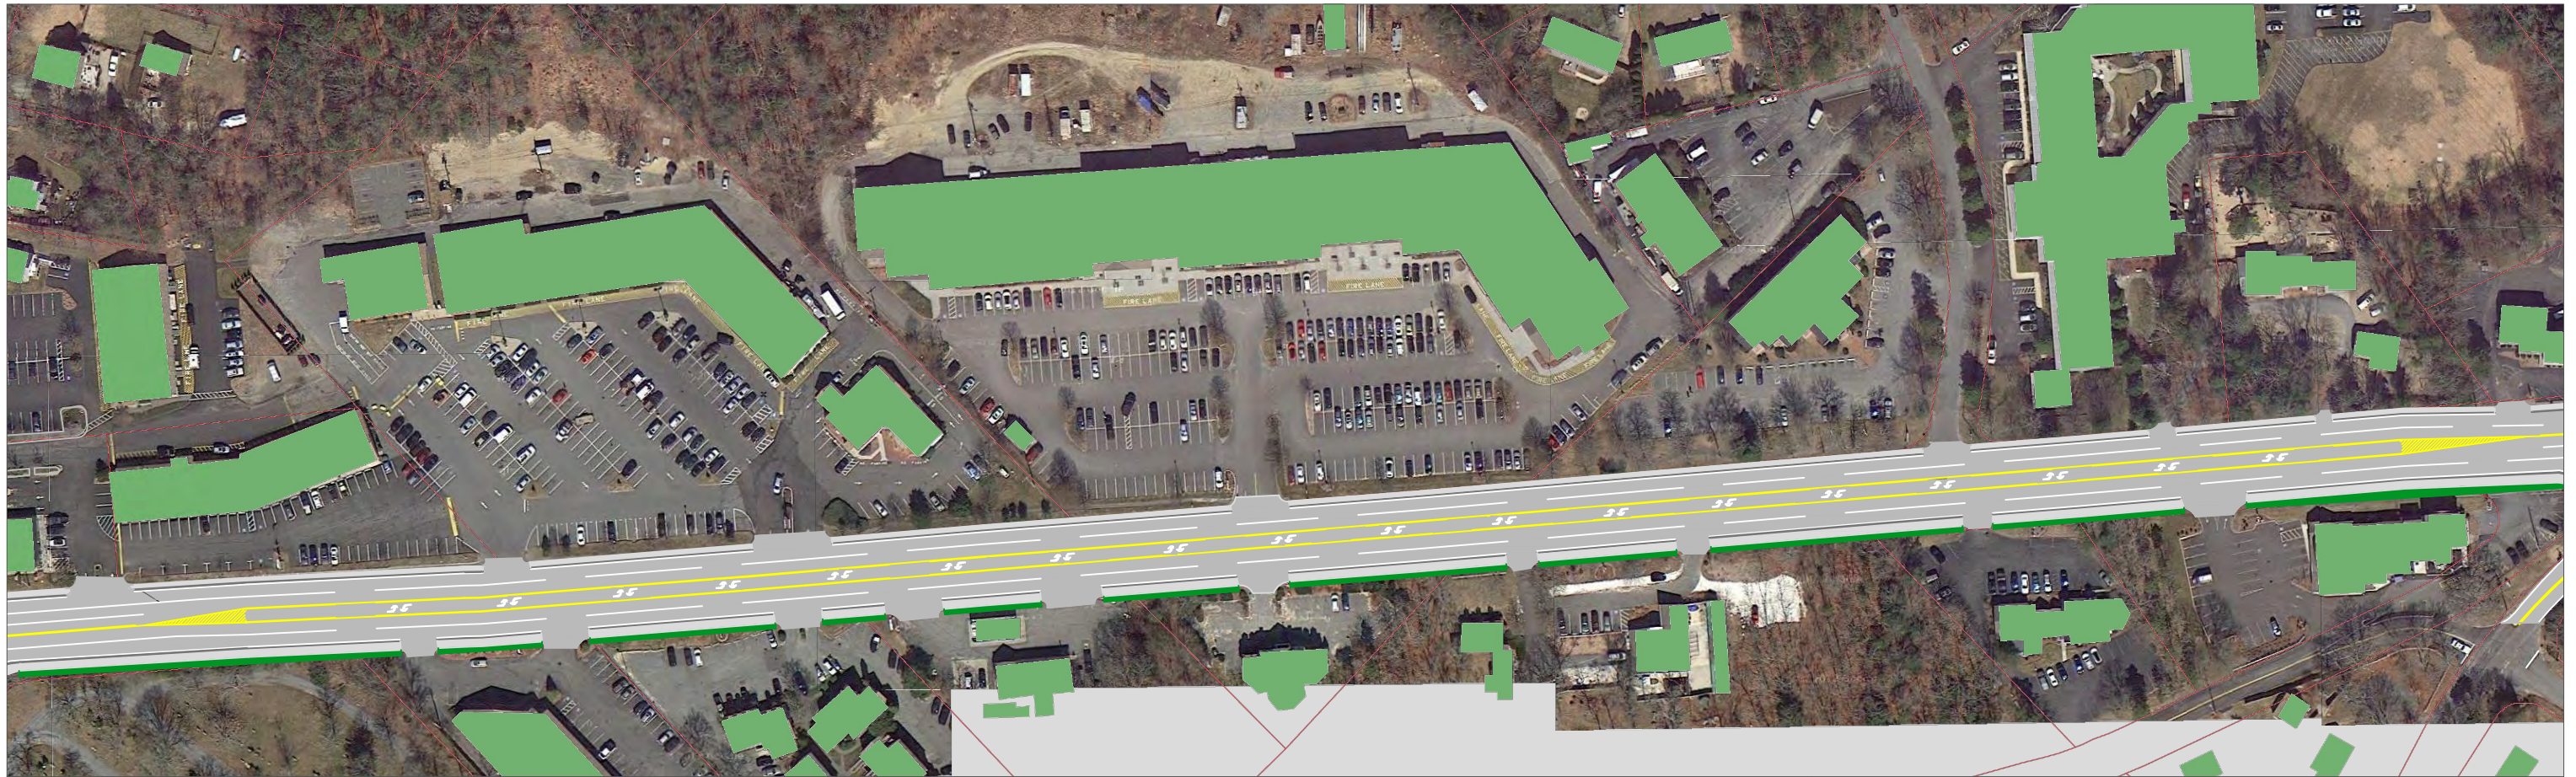
Cross Section Total: 80ft
Available ROW: 80ft
Facing East

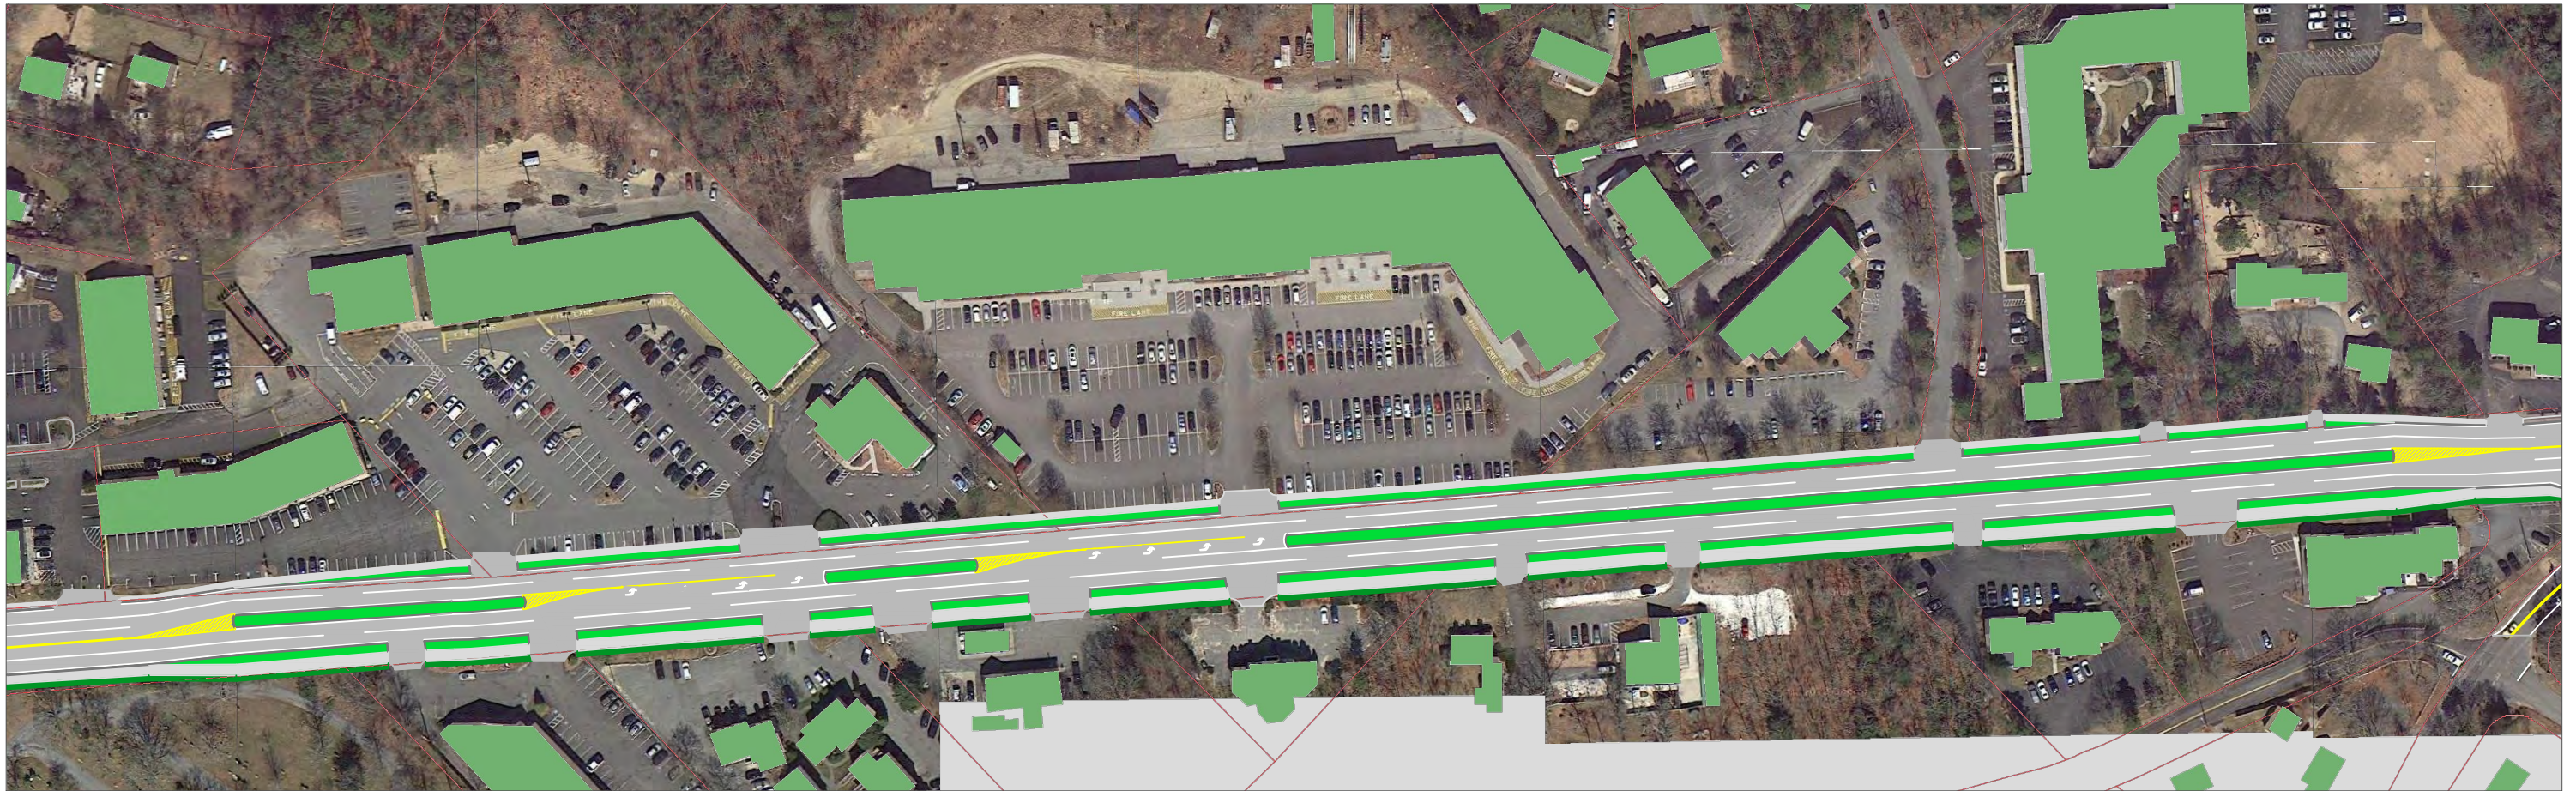
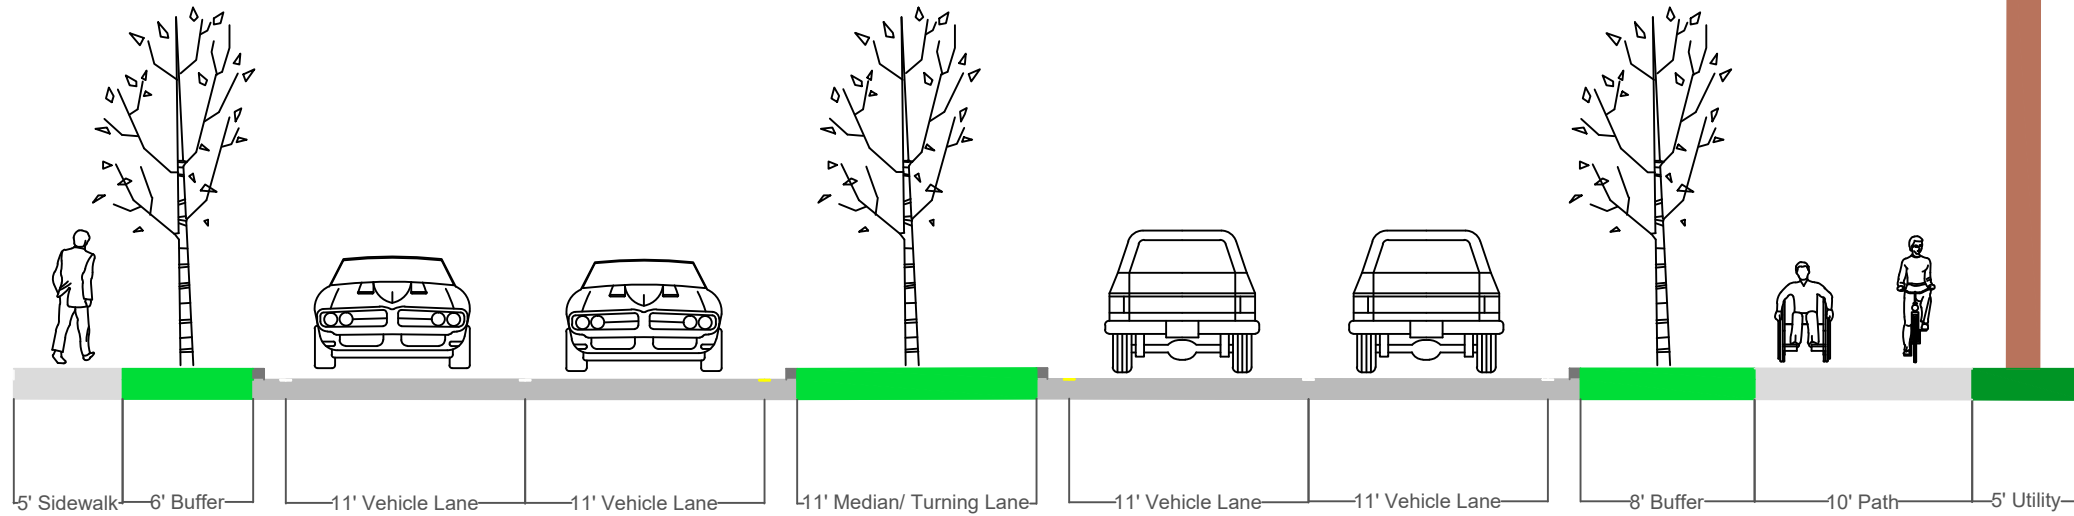
Barnstable Route 28 Corridor Study: Old Stage Road to Pinney's Lane Four-Lane Reconfiguration - Alternative Four

Cross Section Total: 95ft
Available ROW: 80ft
Facing East

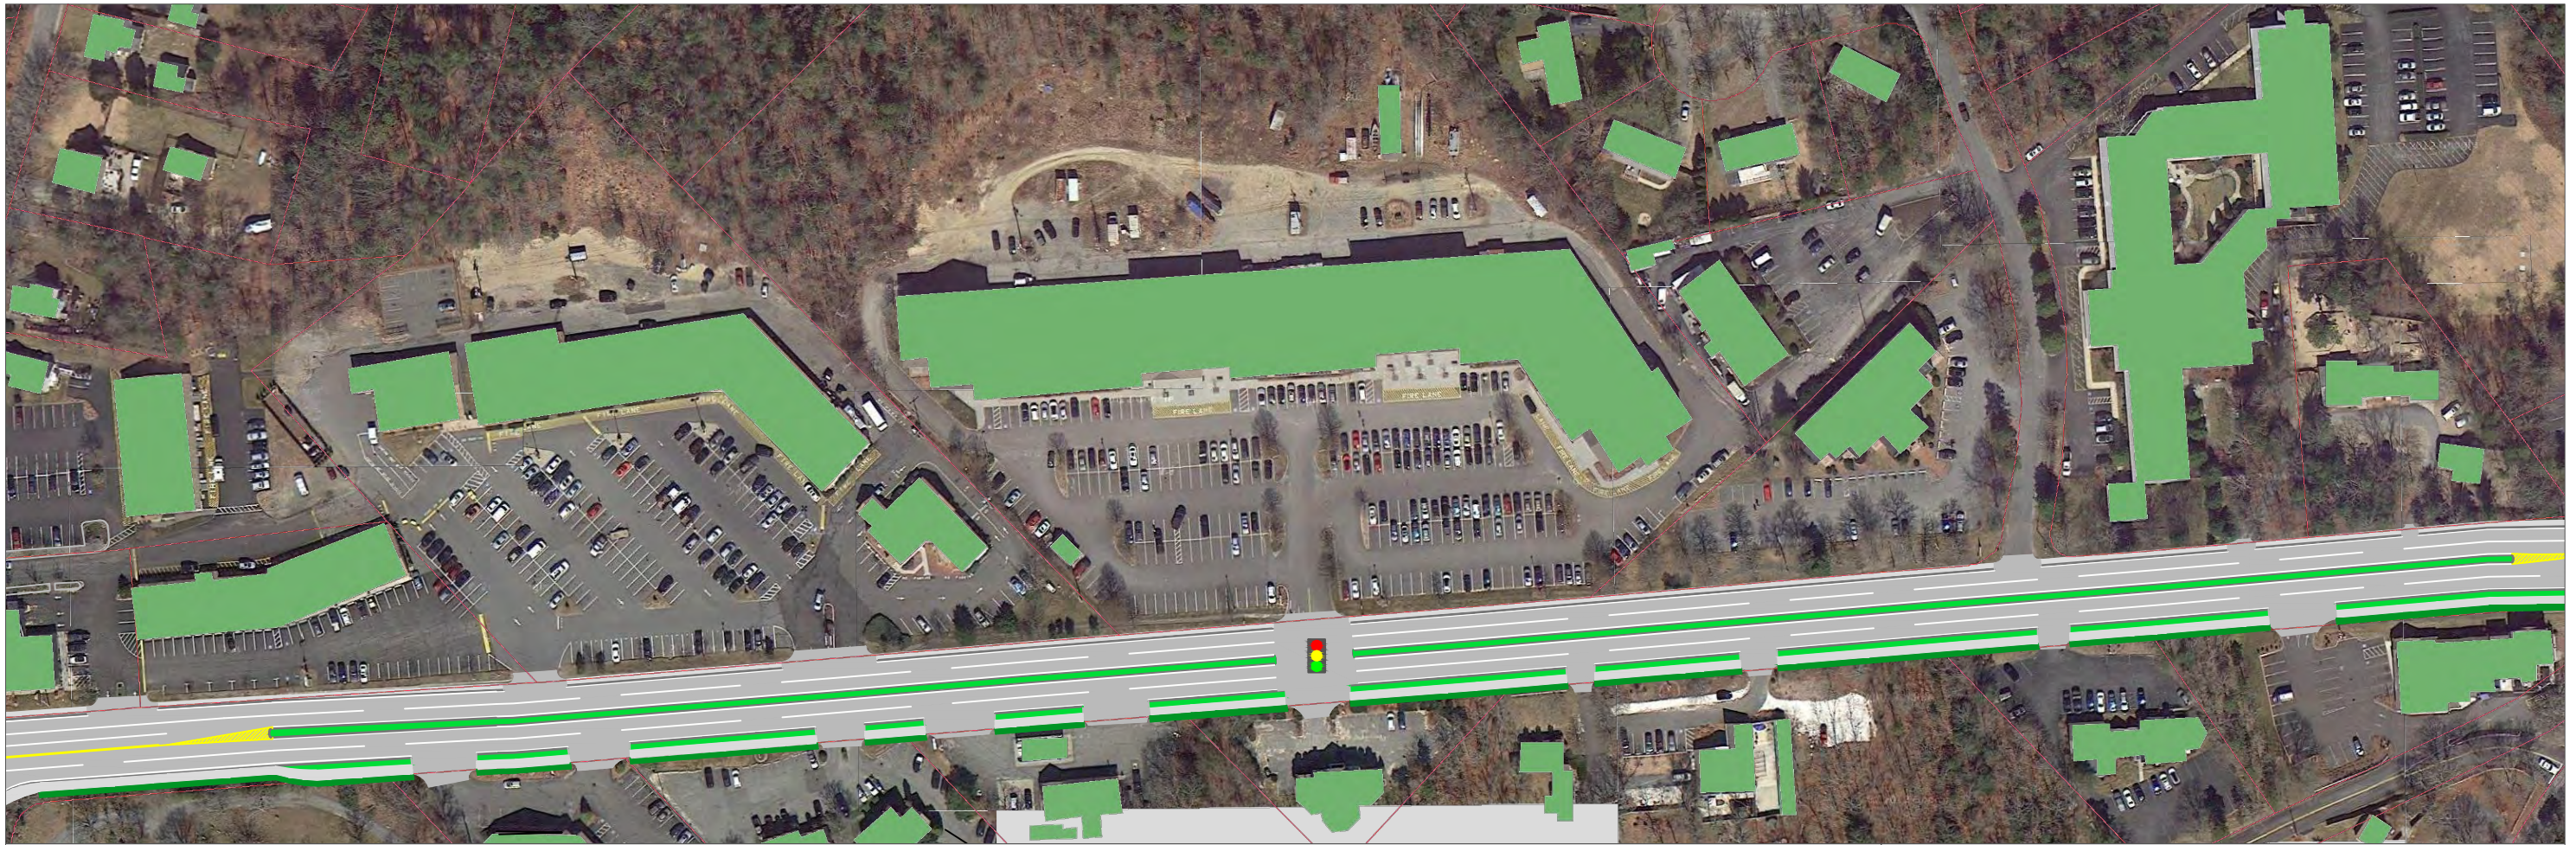
Cross Section Total: 80ft
Available ROW: 80ft
Facing East

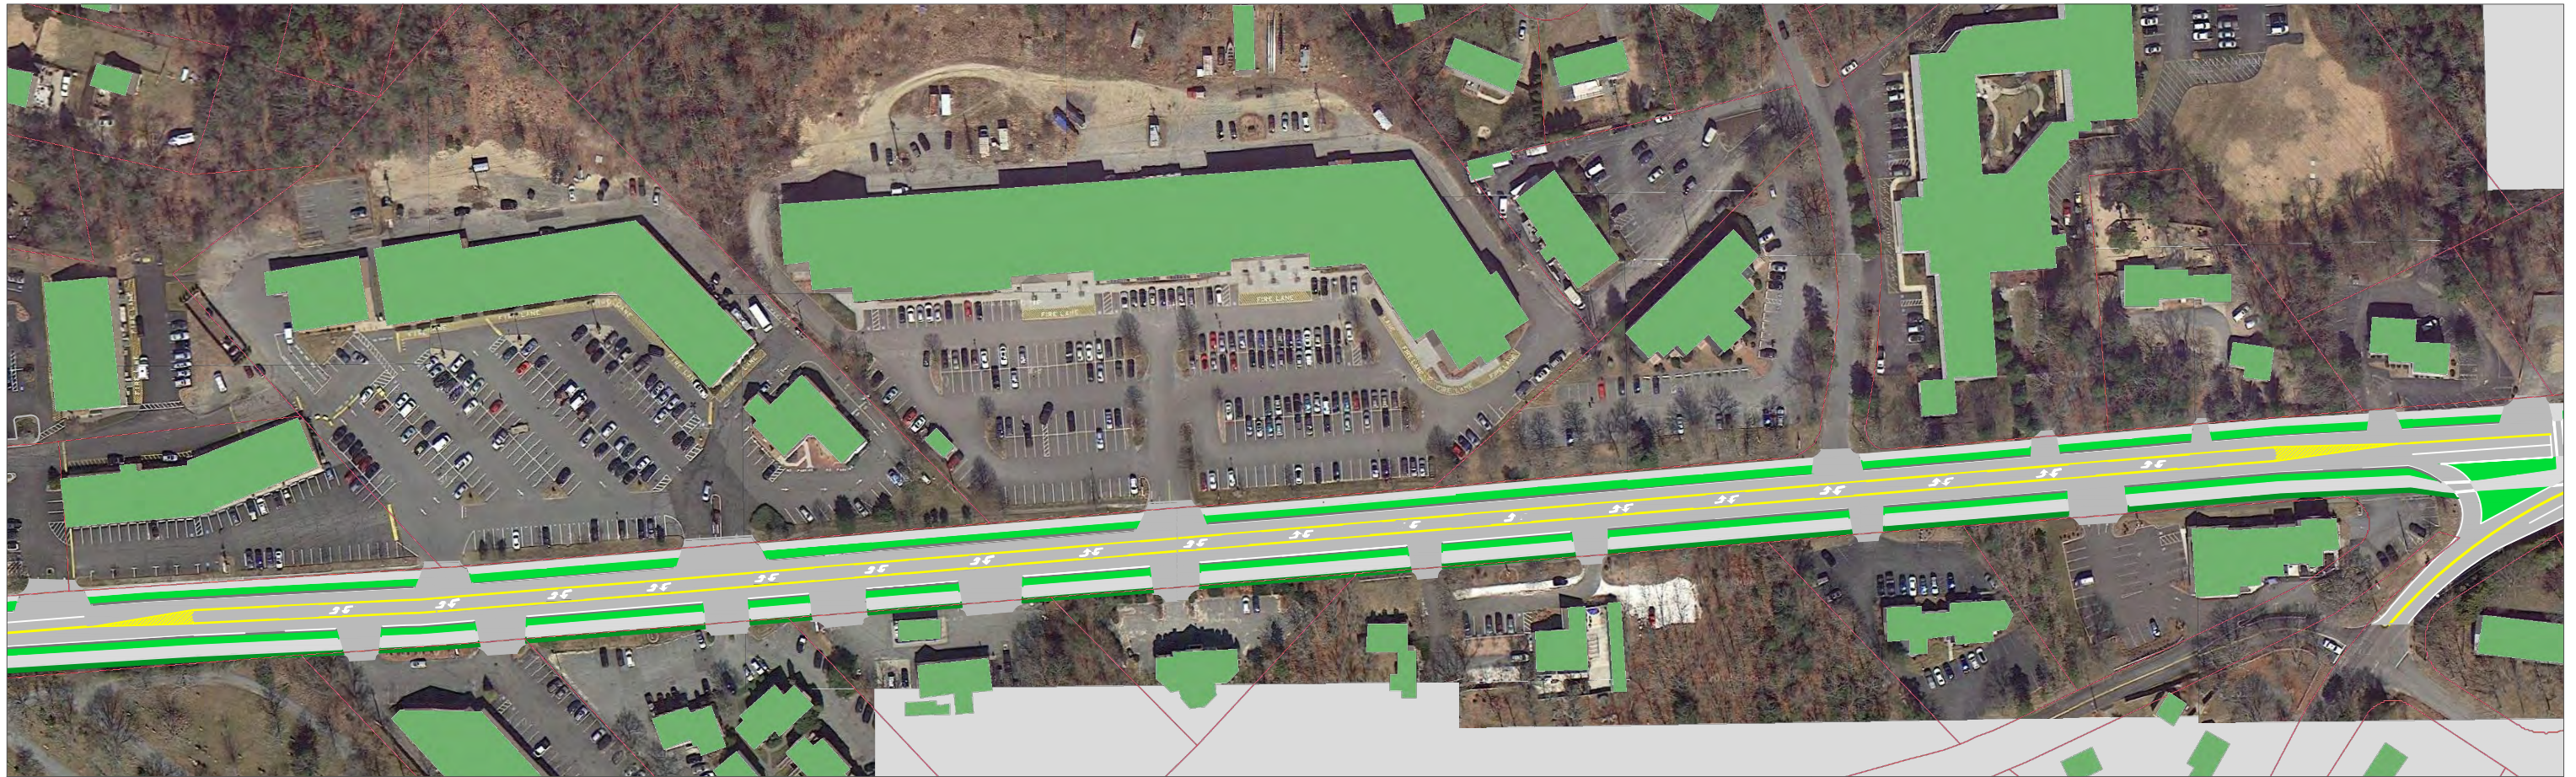
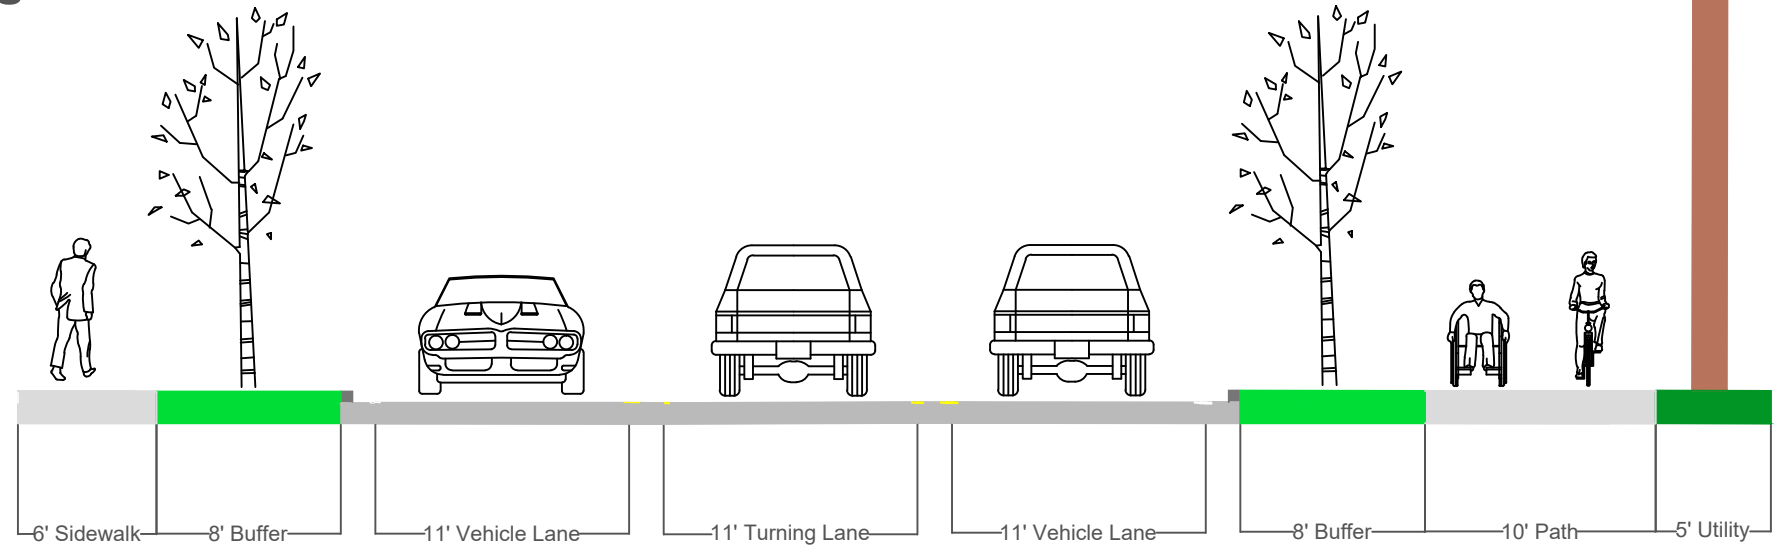
Barnstable Route 28 Corridor Study: Old Stage Road to Phinney's Lane Four-Lane Reconfiguration- Alternative Six

Cross Section Total: 74ft
Available ROW: 80ft
Facing East

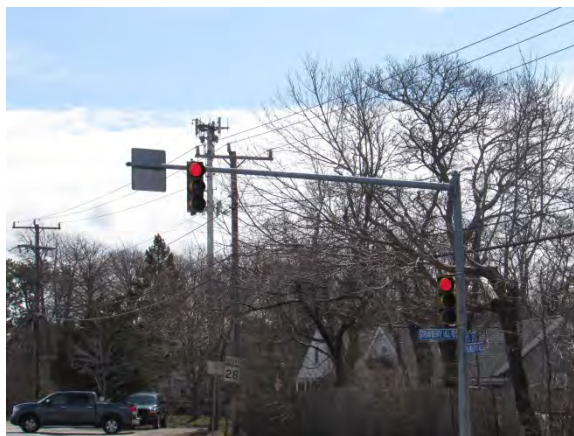
Lack of Backplates on Existing Signal Heads

In regards to the signal visibility, it was mentioned that the solar glare, specifically in the eastbound and westbound directions, presented a safety concern. During the site visit, the RSA team witnessed that the signal heads are lacking backplates, which improve the visibility issues pertaining to solar glare. Crash data supports solar glare potentially being an issue, as 38% of crashes occurring at this intersection are during the 4 pm to 6 pm time frame, when solar glare is at a maximum. In addition, review of the crash data presented a recurring issue of rear-end crashes, which accounted for six (38%) of the total crashes. The significant amount of rear-end crashes in the eastbound and westbound directions appear to coincide with the fact that the signal heads are lacking backplates.

- Evaluate the existing signal timings, specifically the clearance intervals, and propose new timing plans catered to time of day and/or time of year.
- Check the functionality of signal detection on Route 28 and either repair as needed and/or consider dilemma zone detection for the intersection.

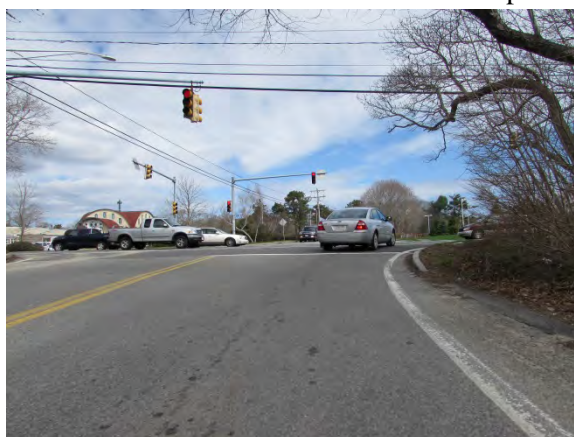
During the RSA discussion, some members of the team provided insight on the current alignment of the northbound and southbound approaches of Strawberry Hill Road at the intersection with Route 28. The concern focused on the offset of the roadway at the intersection and the perception of drivers that they may be directed toward the opposing lanes as they approach the intersection. Another discussion point related to the visibility of signal heads, specifically on the northbound and southbound approaches to the intersection, which is impacted by vegetation encroaching on the roadway.

Sight distance at the intersection was also raised as an issue by several RSA participants. From the northbound approach, the sight distance is impacted by vegetation on the southeast corner that is encroaching onto the roadway, as well as the uphill grade on the northbound approach. In regards to the southbound approach, there is a horizontal curve at the intersection of Strawberry Hill Road and Wequaquet Lane, which impacts the sight distance of drivers approaching the intersection.

Roadway Alignment and Grade from Strawberry Hill Road Northbound Approach

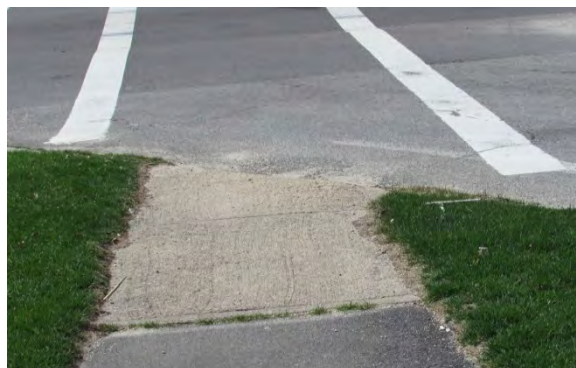
Observations made during the RSA indicate that the intersection is lacking pedestrian amenities, including pedestrian signals and sidewalks on the northern side of Route 28. Another observation was made regarding the lack of tactile pads on the existing handicapped ramps. It was also mentioned that the residential neighborhoods on the north side of Route 28 lack pedestrian connectivity due to the lack of pedestrian

Existing Crosswalk Markings and Ramp

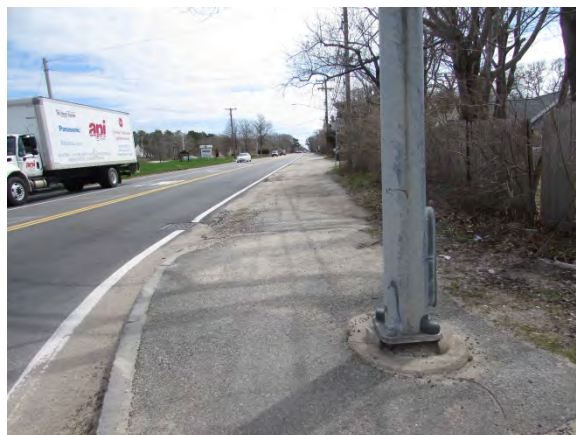
In regards to the mixed use path, the section that is located on the eastern side of the intersection exhibits poor conditions and the lack of curbing presents a safety concern. During the field visit, it was observed that the mixed use path stop sign height may present an issue for cyclists crossing the southern leg of the intersection. The group also recognized the lack of lighting along the mixed use path and raised that as a safety concern.

Mixed Use Path on Southeastern Corner of Route 28 and Strawberry Hill Road Intersection

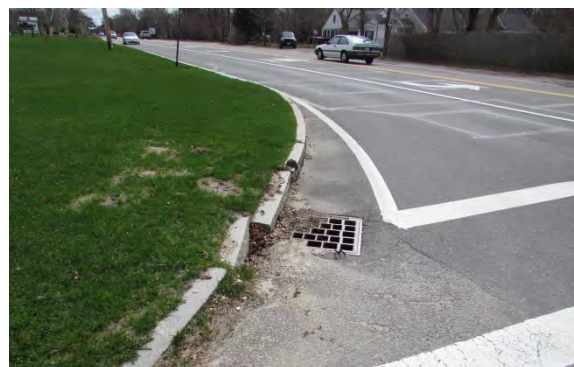
Curbing Damage on Northeastern Corner of Intersection

- Evaluate existing pavement markings and consider re-striping the approaches from Strawberry Hill Road to ensure visibility.
- Repair or replace the damaged curbing on the northwest corner of the intersection.
- Encourage coordination between Barnstable Department of Public Works and MassDOT for snow plowing activities at the intersection.

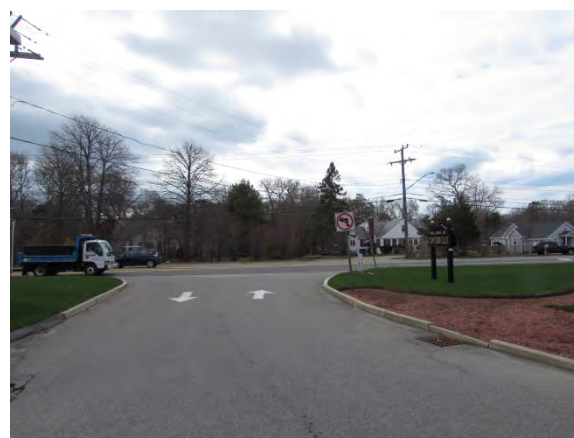
Throughout the Route 28 corridor, there are several driveways that provide access to commercial and residential land uses. According to members of the RSA team, efforts have been made to minimize the amount of access points along the corridor through the use of shared driveways. One particular driveway discussed during the audit was the “right-in, right-out” CVS driveway east of the intersection, which provides access from and to Route 28 in the westbound direction. The egress point of the driveway onto the corridor is currently restricted to right turns only by a sign and a scored median. However, the consensus amongst the RSA team was that left turns into and out of this driveway continue to occur, creating a potential safety risk. In general, the concerns in terms of access management related to the egress from the CVS driveway onto Route 28, as well as the frequency of driveways along the corridor.

Egress Point from CVS to Route 28

- Implement a structural barrier on Route 28 and/or a raised driveway island at the CVS driveway access onto Route 28 to prevent left turn movements.
- Encourage the use of shared driveways and/or internal driveways along the Route 28 corridor to reduce amount of access point that could cause potential crashes.
