CAPE COD
COMMISSION

Town of Eastham
Road Safety Audit
Route 6 (Grand Army of the
Republic Highway) at Nauset
Road/Wampum Lane

December 7, 2017

**Prepared by the Cape Cod Commission in cooperation with the Town of Eastham and
MassDOT Highway Division, Traffic Safety, and District 5 Offices.**

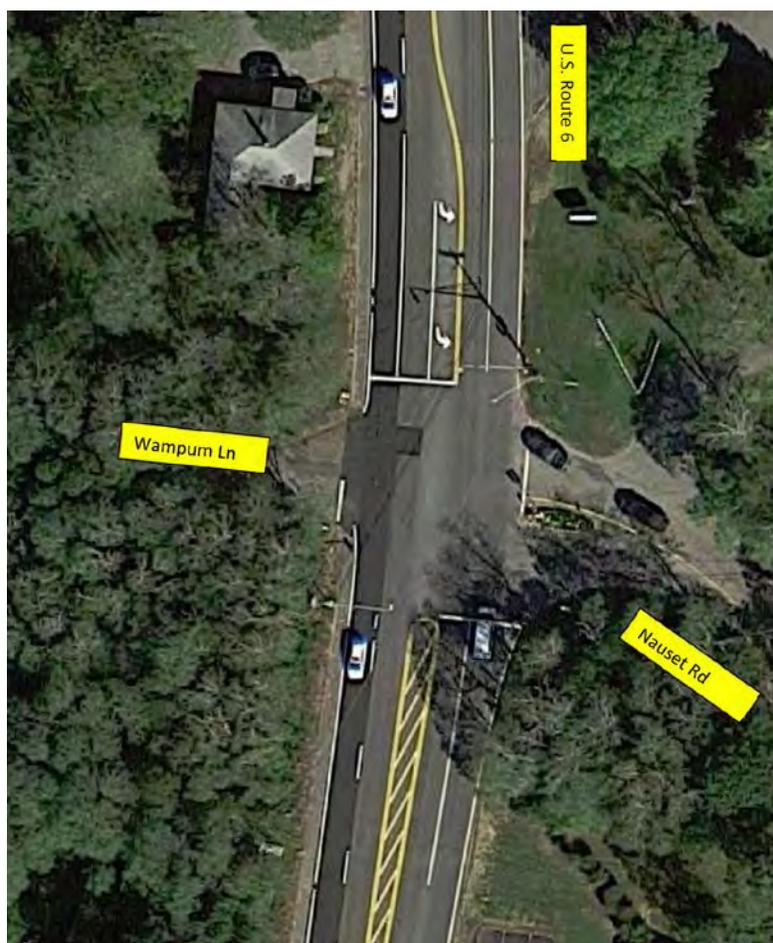
Figure 1 – Aerial view of Route 6/Nauset Road intersection

Route 6 (Grand Army of the Republic Highway) at Nauset Road/Wampum Lane in Eastham is a four-way signalized intersection shown in the aerial view of the figure below. The study area locus is shown in Figure 2.

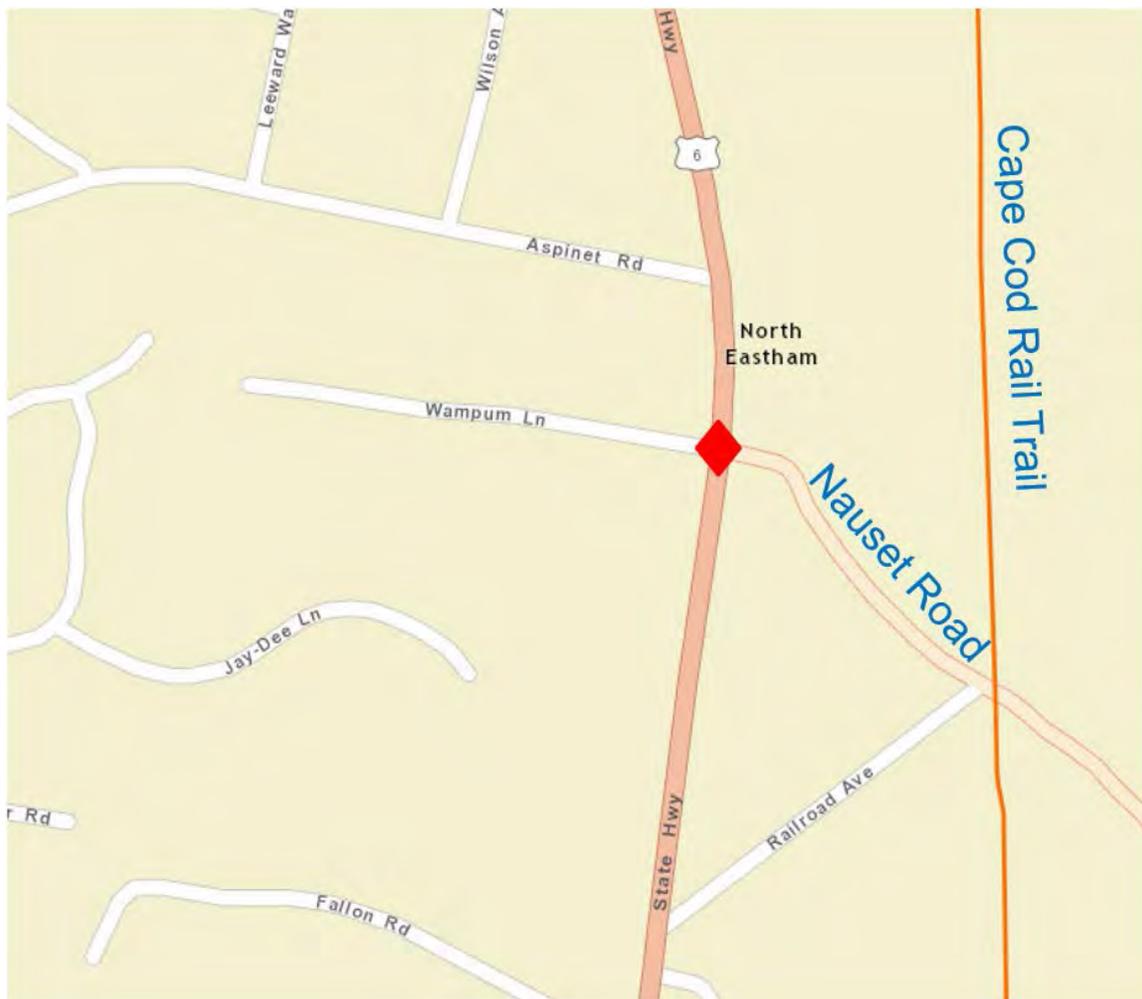
Figure 3 – Local Street Network including Cape Cod Rail Trail

The local street network is shown in Figure 3. Nauset Road is the main route for travel to Nauset Regional High School for residents of the towns to the north as well as Eastham residents living in areas to the north and west. Due to the challenges motorists face when attempting to turn left onto Route 6, some motorists to the south will make use of Railroad Avenue/Nauset Road as an ad-hoc “jughandle” intersection to turn left onto Route 6 to head south. Nauset Road also serves as an important connection to the Cape Cod Rail Trail for users traveling from/to the northern/western part of Eastham via Aspinet Road/Route 6.

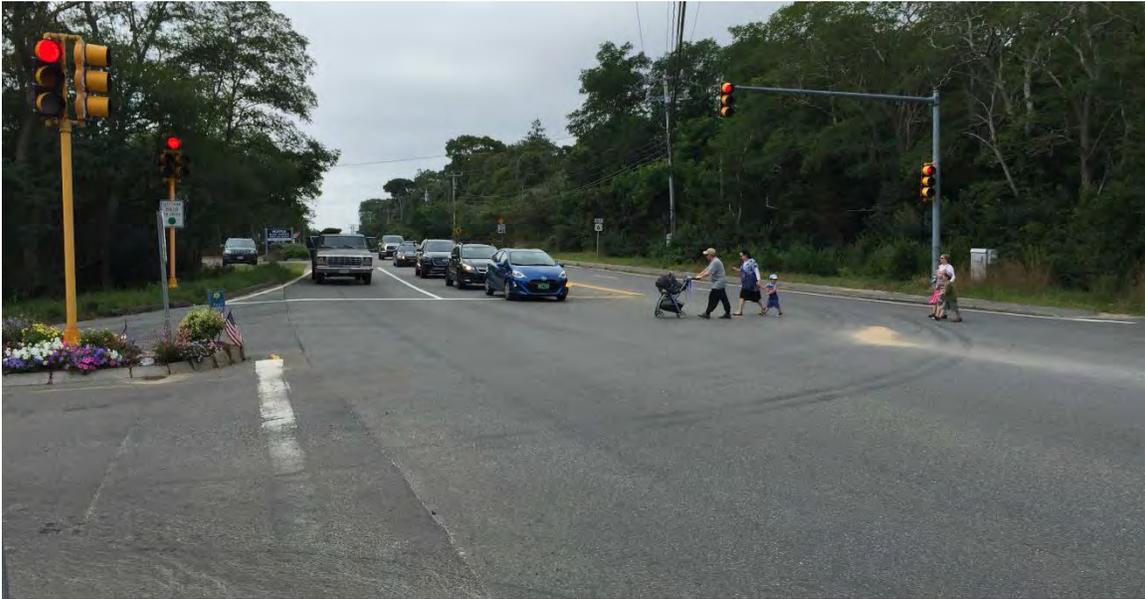
- The signal at Nauset Road has no pedestrian activation nor pedestrian signal head.
- Pedestrians attempting to safely cross Route 6 must wait for a vehicle on either Nauset Road or Wampum Lane to activate a phase to stop Route 6 traffic.

- The study team observed many pedestrians and cyclists crossing between Wampum Lane and Nauset Road. These people appeared to be traveling between points west and east via Aspinet Road, the sidewalk along the west side of Route 6, and Nauset Road (presumably to access the Cape Cod Rail Trail).

Figure 4 - Pedestrians crossing Route 6 to access Nauset Road

- Add an ADA-compliant pedestrian push button/signal head (includes countdowns both audible, visual, and vibrotactile), and crosswalk to cross Route 6 at Nauset Road (this also requires a ramp system on the east side of Route 6).
- Install ADA-compliant curb ramps on sidewalk along west side of Route 6.
- Provide crosswalks on all four approaches of the Nauset Road/Wampum Lane intersection and on the Aspinet Road approach.
- Provide a sidewalk along Nauset Road from Route 6 to the Cape Cod Rail Trail.
- Provide a sidewalk along the eastern side of Route 6.
- Consider a “road diet” for Route 6 (reducing number of travel lanes and add bike lanes).

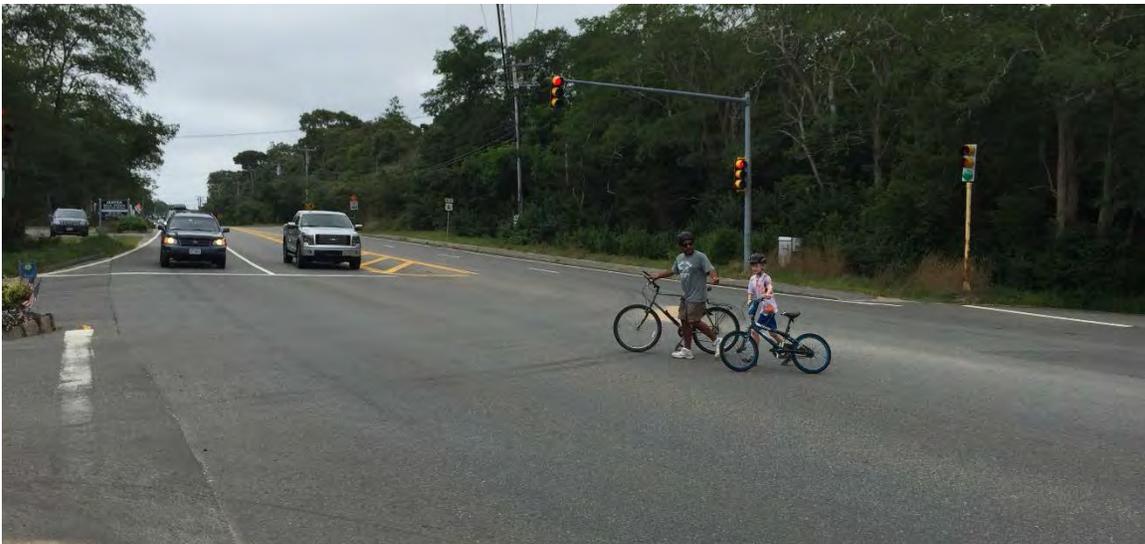
- During a crossing of Route 6 from Nauset Road attempting to access the west-side sidewalk, the study team witnessed one pedestrian (walking a bicycle) misjudge the curbing, trip, and collapse onto the sidewalk. The lack of crosswalk and bicycle/pedestrian signal activation could be a factor in this crash.

Figure 5 - Cyclists (on foot) crossing Route 6 to access Nauset Road

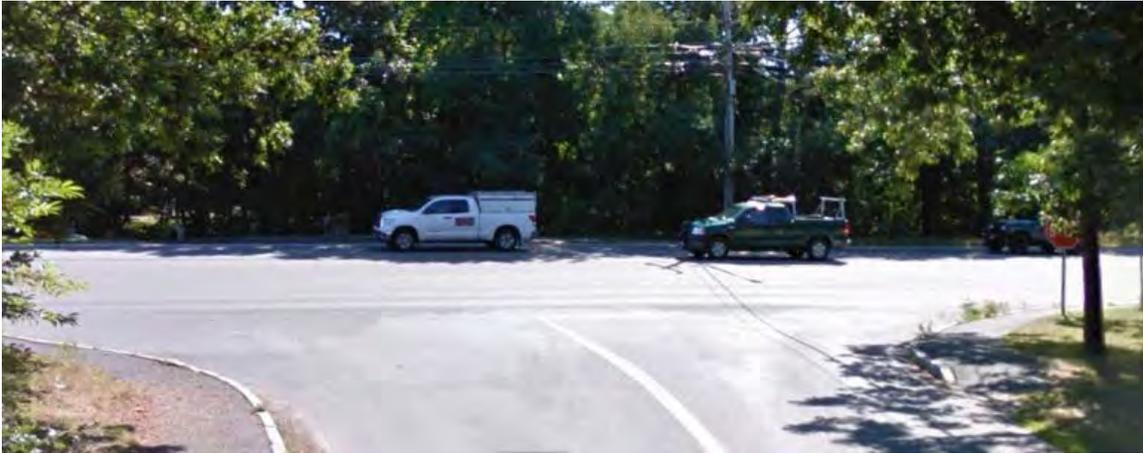
- There are no crosswalks on any of the approaches at either the Nauset Road or the Aspinet Road intersections.
- Due to large curb radii, pedestrian travel across Aspinet Road can be challenging due to longer crossing distance.

Figure 6 - Aspinet Road approach showing wide crossing distance and lack of crosswalk

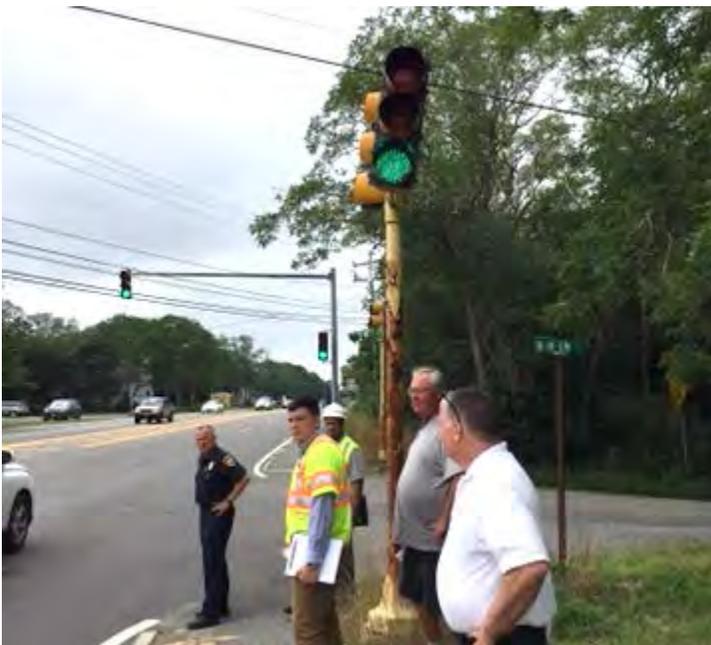
- stop despite there being no vehicle waiting on the minor street). This causes unnecessary delay and may lead to driver frustration/risk taking.
- The mounting hardware for the southbound Route 6 signal head is failing; the signal head is tilted. The lower connector arm on the signal head in the northeast quadrant is rusted through and broken. The post mounted on the northwest corner of the intersection is broken or not attached at the base. Should these mountings entirely collapse, motorists would have difficulty determining when to stop.

Figure 7 - Route 6 southbound signal housing damaged and tilting

- Increase frequency of speed enforcement
- Modify signal actuation on Nauset Road to eliminate stopping Route 6 traffic in cases where drivers have already turned right on red.
- Add visors, replace broken connectors, convert to LED signal heads, backplates, and retroreflective borders on existing signals to enhance signal visibility
- Add additional post mounted signals to provide better signal visibility
- Upgrade signal system with new signal heads, visors, backplates, poles, and vehicle pre-emption.
- Consider converting the Nauset Road intersection to a modern roundabout.

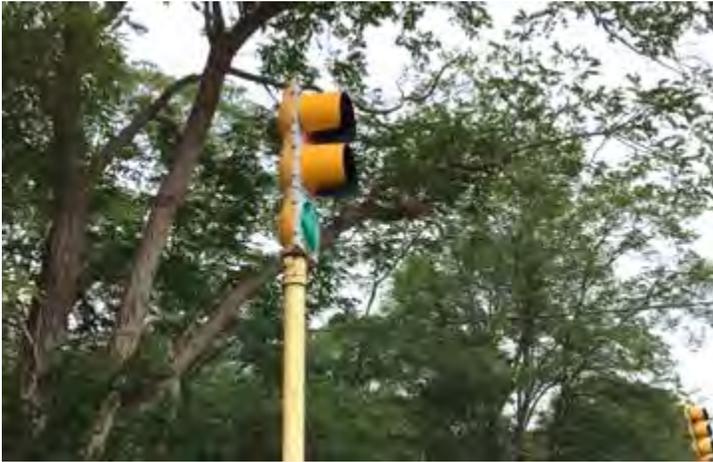
- The visor for the northbound Route 6 green light is missing; there are no backplates on the signal heads. These could be potential causes for the recorded rear-end crashes by reducing signal visibility.

Figure 8 - Entrance to Wampum Lane green signal head missing visor

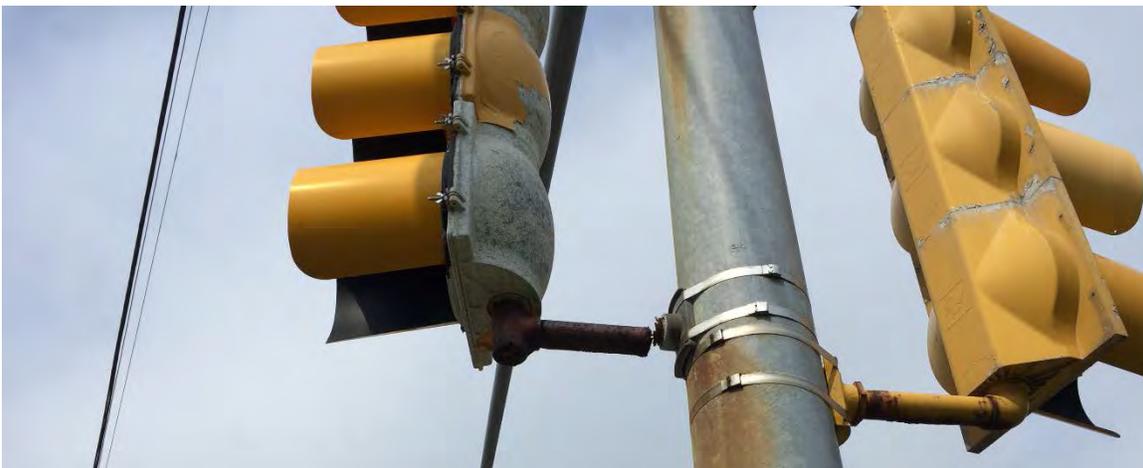
- Overall, the signal system is in poor condition; there is no emergency vehicle preemption (e.g., Opticom system).
- The signal actuation on the Nauset Road approach is in some cases unnecessary (e.g., when a car makes a right turn on red the actuation causes Route 6 traffic to

Figure 9 - Lower signal connector arm rusted through and separated from pole on signal head in the northeast quadrant

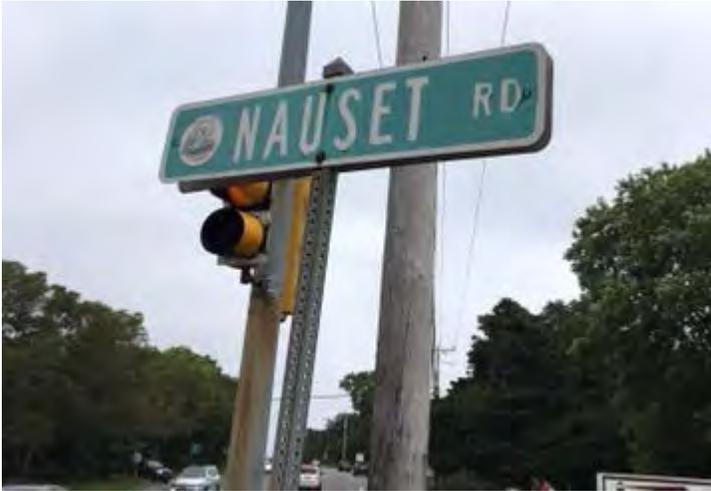
- The stop sign on Aspinet Road is much lower than the standard height of 7 feet and is not conspicuous due to its position to the right of the sidewalk.
- The Nauset Road street sign is broken and faded; sign visibility is poor.
- The guidance implied by the “Bike Route” sign at the entrance to Nauset Road is ambiguous (as it does not inform the cyclist of route name or destination).
- The stop line pavement marking on Nauset Road is worn and missing in sections.

Figure 10 - Nauset Road street sign faded and partly broken

- Add a “signal ahead” sign on Route 6 approaches to warn motorists of upcoming signalized intersection.
- Replace worn pavement marking including stop line on Nauset Road.
- Replace Nauset Road street sign at location to improve visibility.
- Include destination information & arrows for bike route signs (e.g., “To Cape Cod Rail Trail”) to provide better wayfinding for cyclists, pedestrians, and motorists.
- To improve stop sign visibility at Aspinet Road, consider:
 - Relocate stop sign to curb (install at standard height) & relocate adjacent side walk based on MUTCD standards.
 - Install pedestrian refuge at center of Aspinet Road with supplemental stop sign to provide an area for pedestrians to cross the road in two stages.

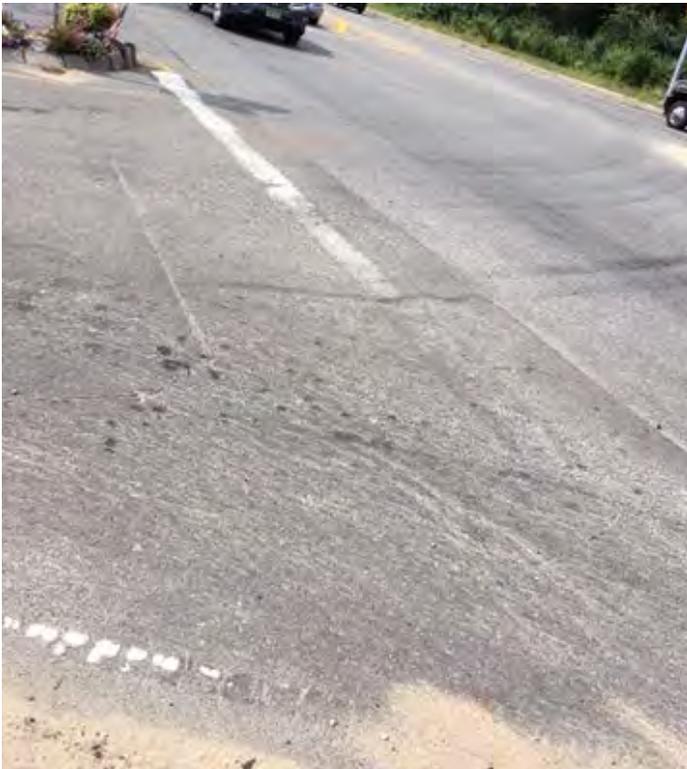
Figure 11 - Stop bar worn at Nauset Road approach

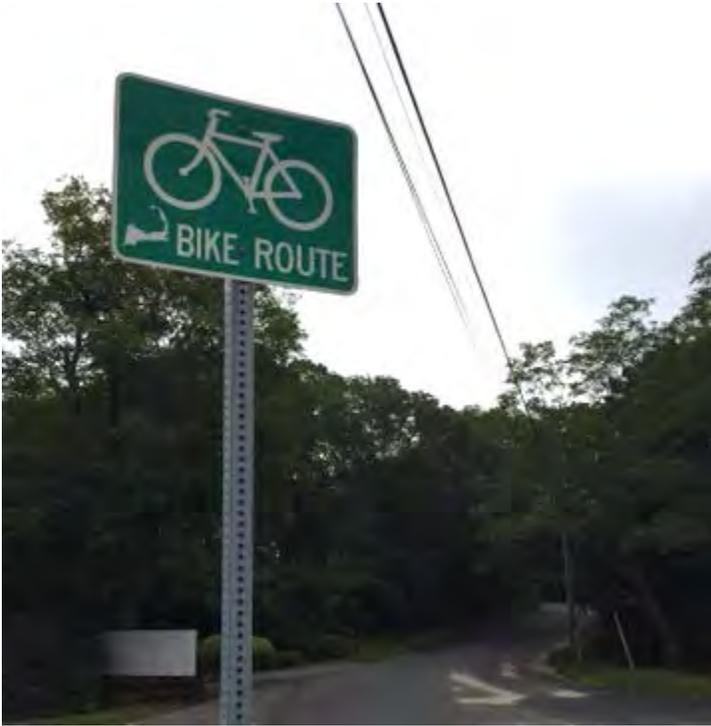
Figure 12 - Bike route sign at Nauset Road entrance – ambiguous

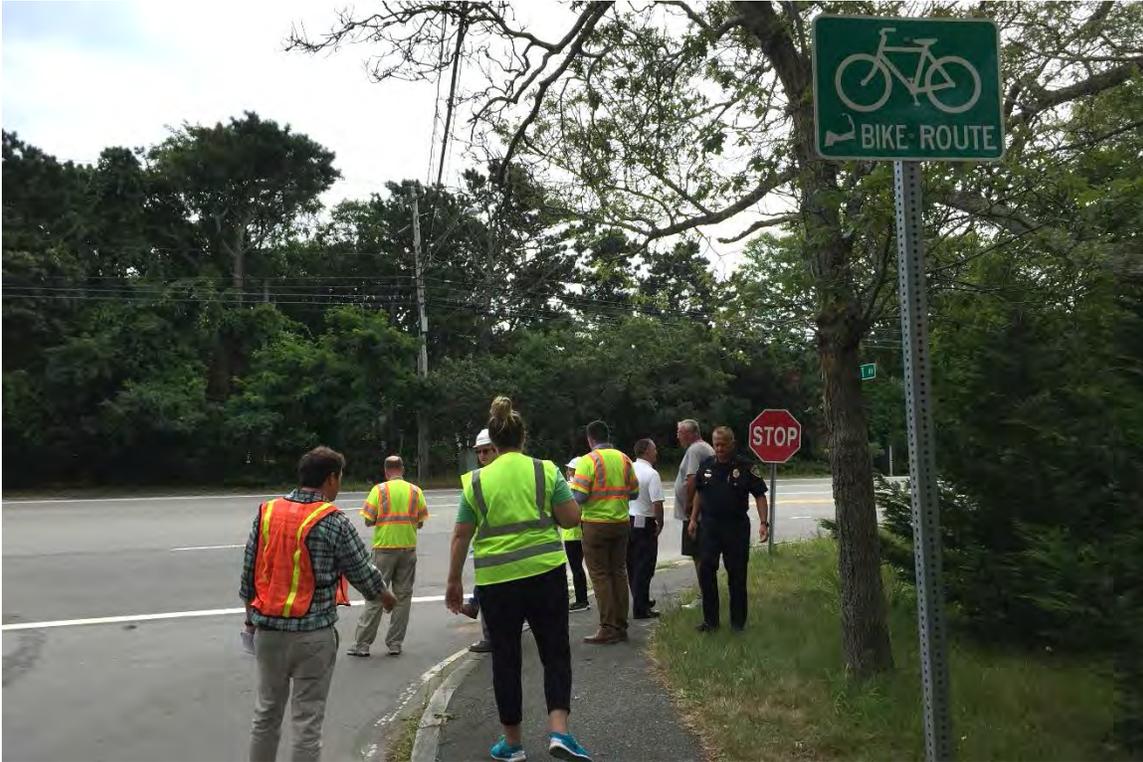
Figure 13 - Aspinet Road approach showing low stop sign and ambiguous bike route sign

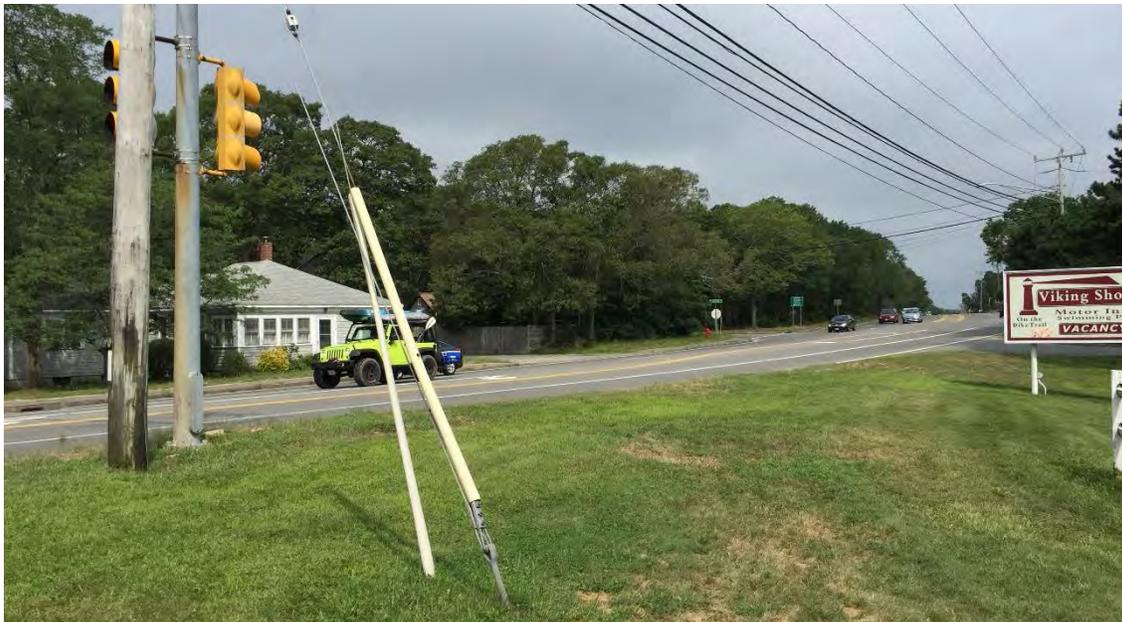
- For vehicles exiting Aspinet Road, sight distance is limited by vegetation in the northwest quadrant along Route 6; additional vegetation obscures the view of the stop sign. The limited sight distance at this location may be a contributing cause of three of the recorded crashes.
- For vehicles exiting Nauset Road, a utility pole and guy wire in the northeast quadrant slightly obscure sight distance. Site distance is limited by vegetation in the southeast quadrant along Route 6.

Figure 14 – Potential sight obstructions in northeast quadrant of Nauset Road intersection - utility pole and guy wires

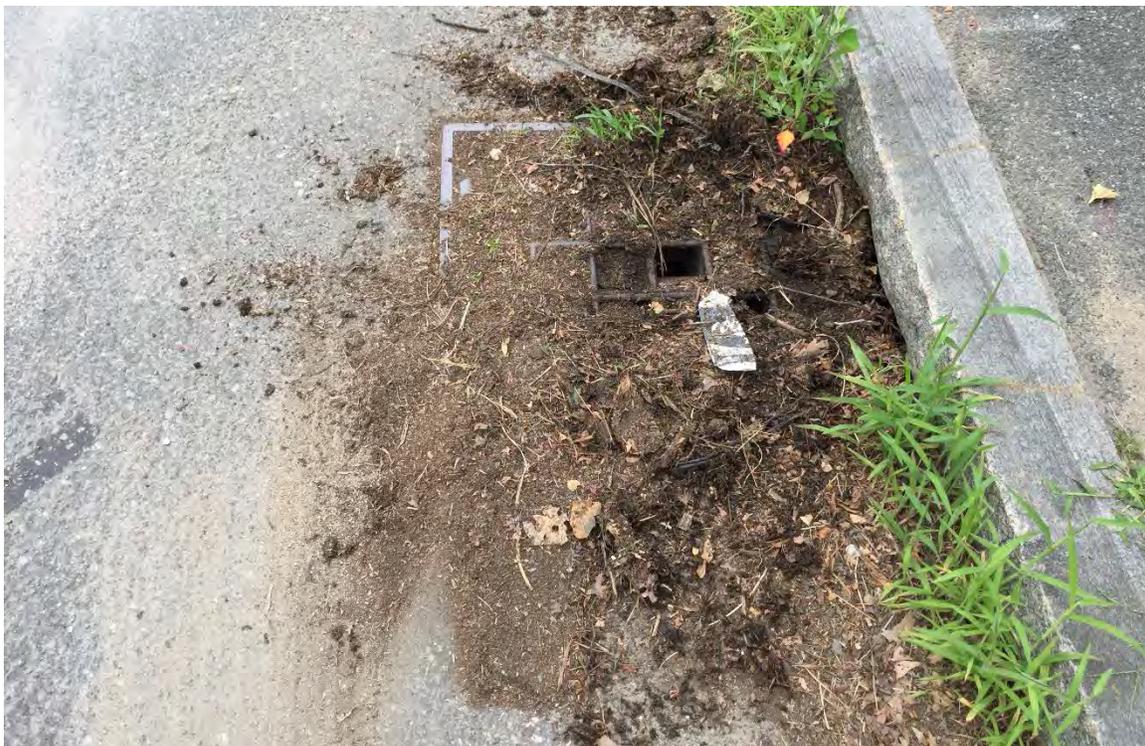
- Pavement is showing signs of wear including weathering, minor cracking and utility patches.
- At Wampum Lane, erosion of the road edge was noted in the northwest quadrant; possibly exacerbated by an incorrectly installed catch basin cover (installed in reverse orientation).

Figure 15 - Catch basin blocked by debris

<p>Pavement Conditions & Drainage</p>	<p>Maintain catch basins, re-install covers as needed.</p> <p>Consider repaving as part of a Nauset Road intersection upgrade.</p>	<p>Low . Low</p>	<p>Short . Medium</p>	<p>Low . Medium</p>	<p>Town . MassDOT/ Town</p>
