# DENNIS

### Cape Cod Rail Trail #39 (Great Western Road)

Dennis – Cape Cod Rail Trail

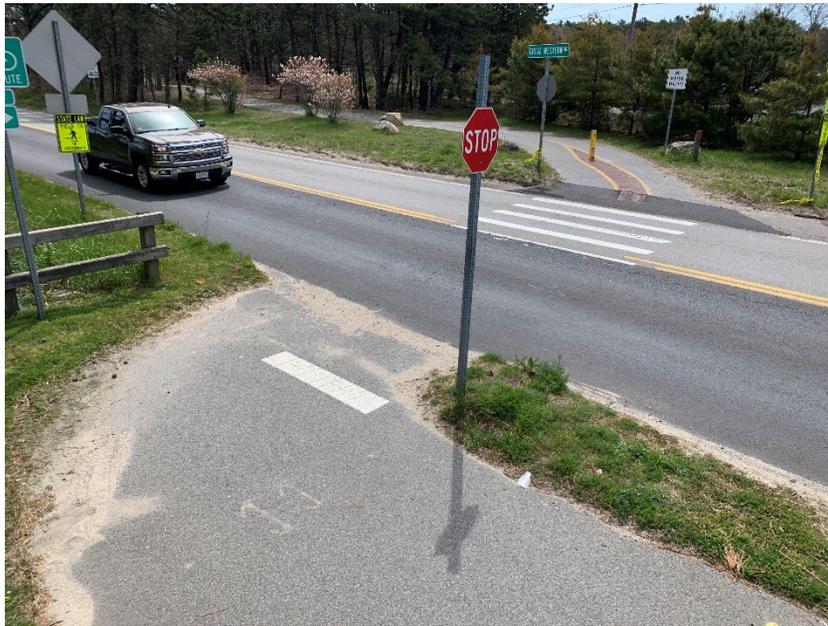
Dir.	Advance Warning Signs	Bike Trail Crossing Signs	Advance Pavement Markings	Control Type	Shark Teeth Yield Markings	Crosswalk Markings	Median Between Crosswalk	Additional Safety Features	Visibility of Bike Trail	Grade	Posted Speed Limit	Avg. Lane and Shoulder Width
EB	Good	Good*	Poor	None	None	Poor	No	None	Good	Slight Downhill	40	12' / 6'
WB	Good	Good*	None	None	None	None	No	None	Fair	Slight Uphill	40	12' / 0'

*Figure 192: Aerial Image of the Crossing from North Side. Crosswalk Markings are Completely Lacking for Westbound Traffic.*

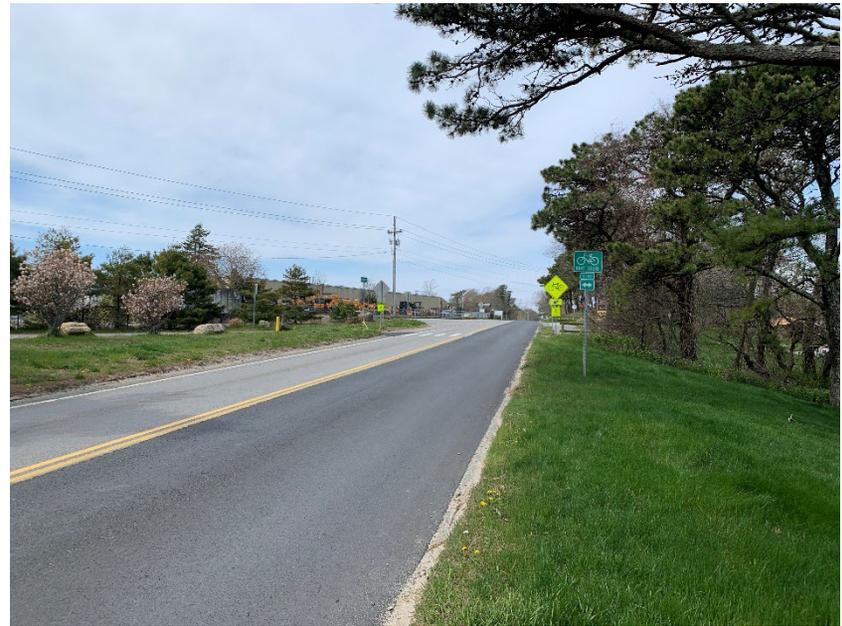
\*Green, wayfinding signage as well.

*Figure 193: Road Approach from East Side Showing the Bike Trail Crossing Signage and the Wayfinding Signage (Advance Signage is Not in Picture)*

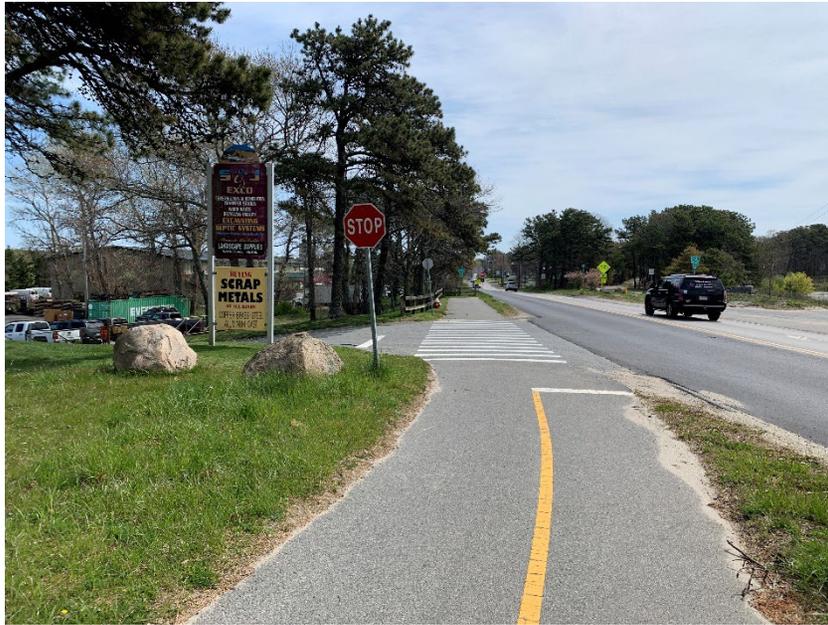
Steep driveway. No advanced warnings on path.

*Figure 194: Bike Trail Crossing, Facing East*

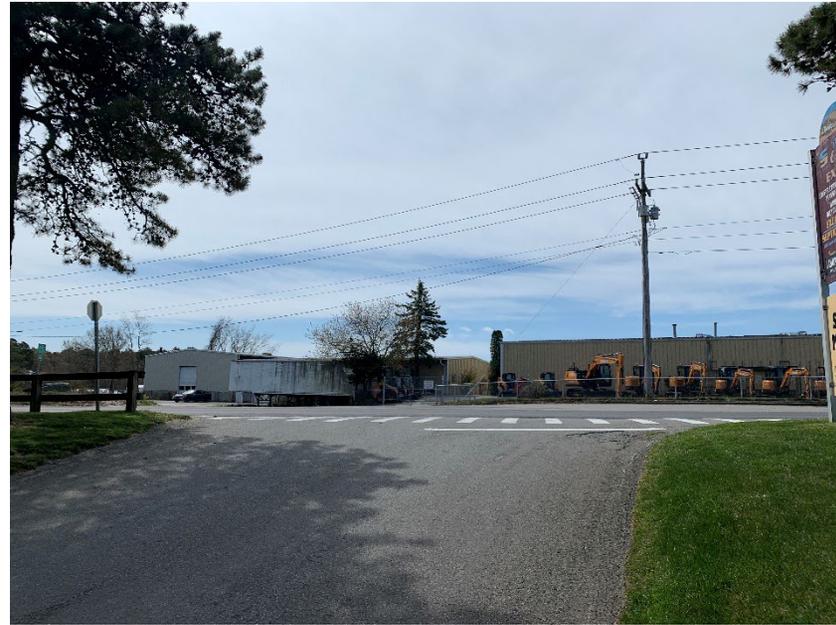
*Figure 195: A View of the Path Crossing from S & J Exco Parking Lot*

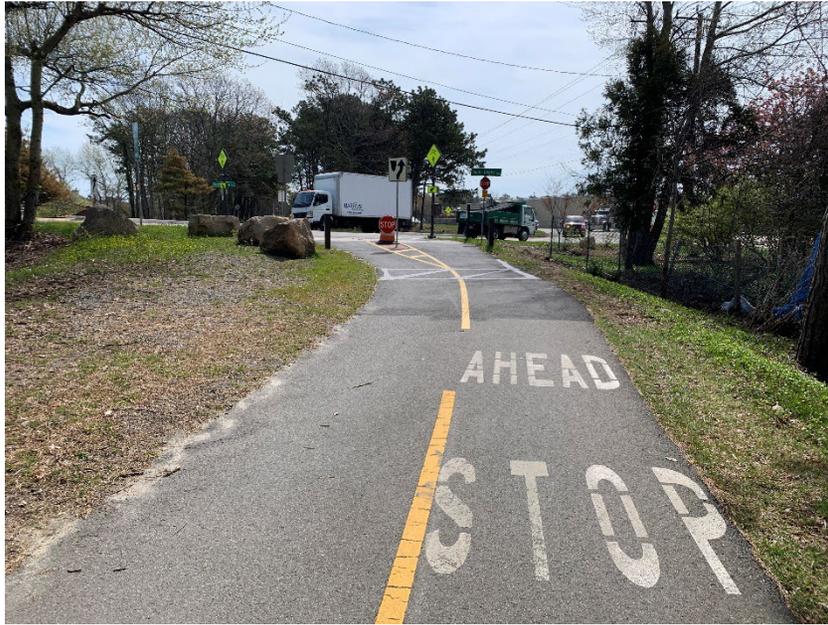
Lots of sand in the path due to vehicles. Lots of heavy vehicle traffic in this area due to local businesses.

*Figure 196: Bike Trail Approach with Pavement Markings*

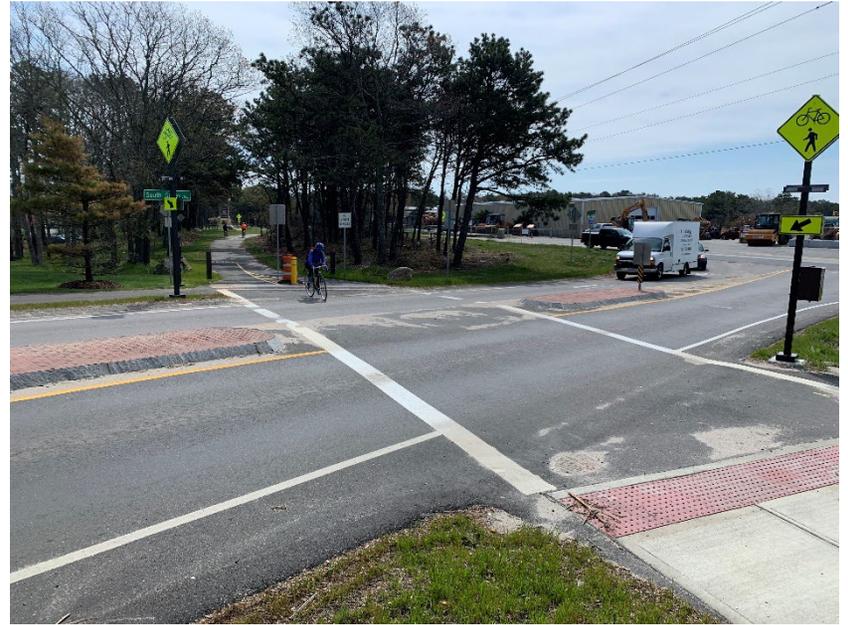
*Figure 197: A View of the Crossing Looking Eastward (Note RRFBs)*

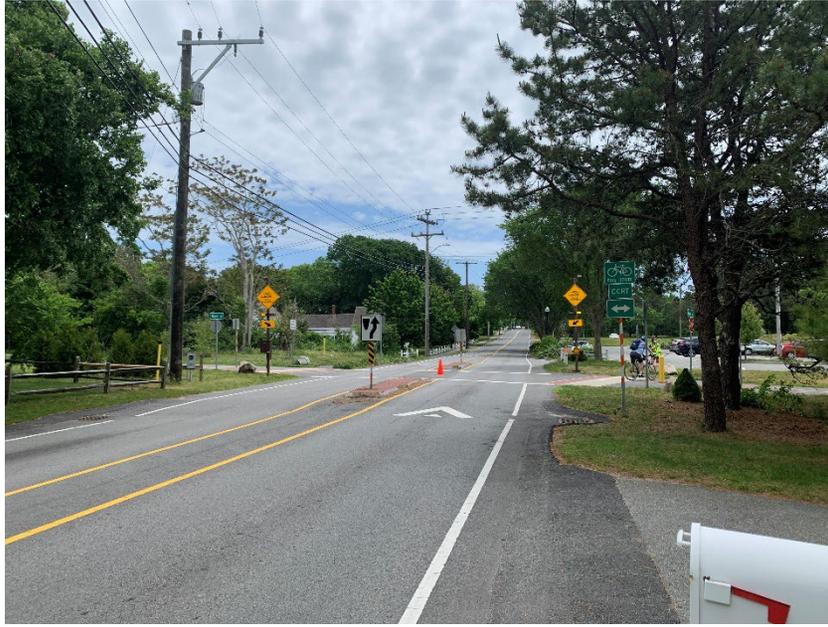
*Figure 198: Bike Trail Crossing Signs, RRFBs, Raised Crosswalk, and Clear Sightlines Make Crossing Highly Visible*

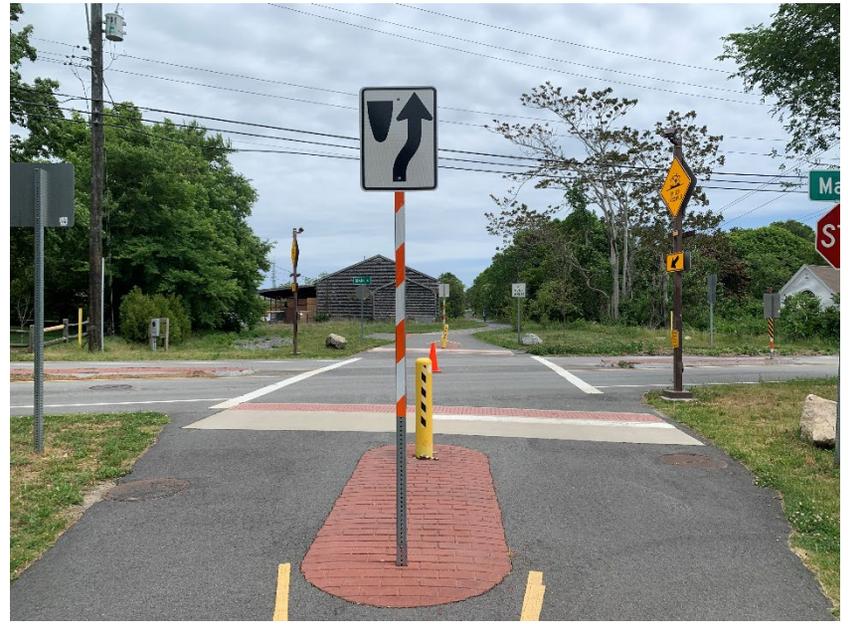
*Figure 199: East-Facing View of Path Crossing. Medians Provide a Place for Bicyclists and Pedestrians to Make 2-Stage Crossings*
