CAPE COD
COMMISSION

Rail Trail Crossing Inventory

FINAL REPORT

FEBRUARY 8, 2022

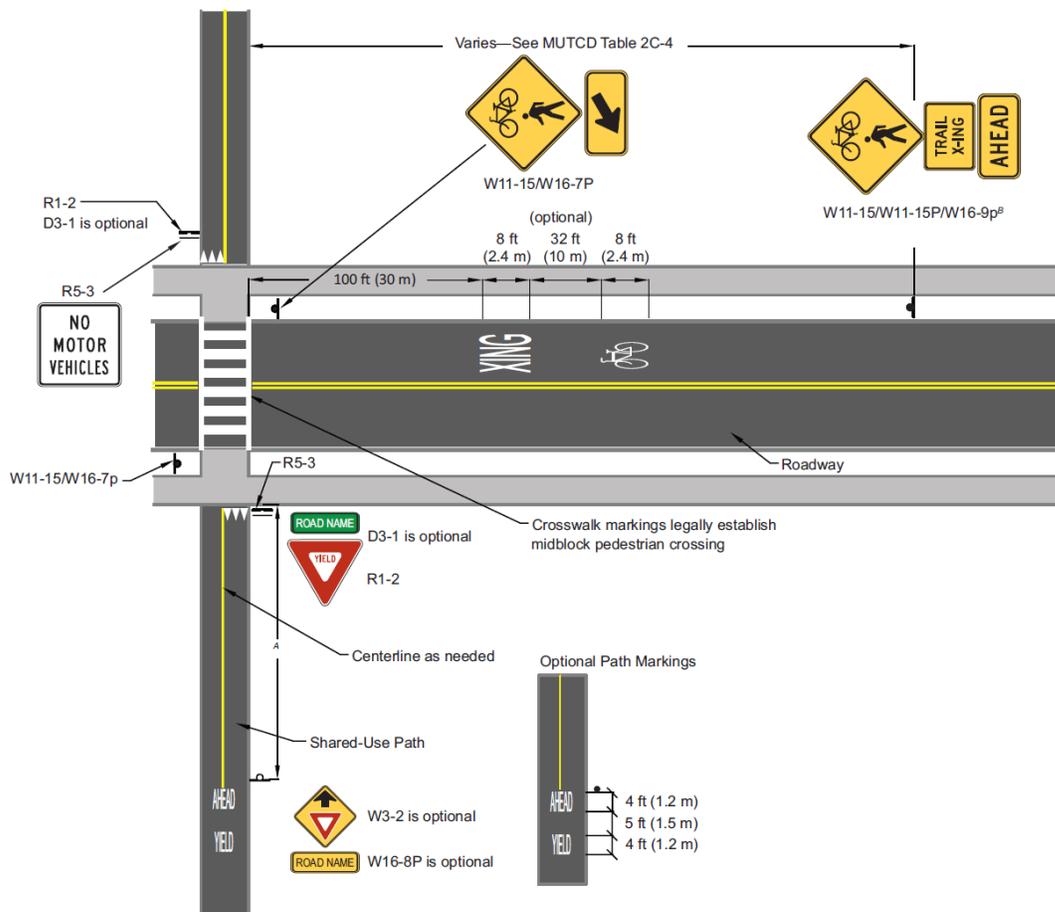
Figure 6: Example of Pavement Markings from AASHTO's Guide for the Development of Bicycle Facilities

When there is YIELD control or no control for drivers on the crossing approach, pavement markings are optional, but they do increase visibility, according to AASHTO’s *Guide for the Development of Bicycle Facilities*. The image below offers a view of what such markings can look like (letters of “XING” and an image of a bicycle). More specific guidance is found in that guide, and in [Section 3B of the MUTCD](#). When drivers have a STOP sign, the “XING” and bicycle image pavement markings should not be used.

- ^A Advance warning signs and solid centerline striping should be placed at the required stopping sight distance from the roadway edge, but not less than 50 ft (15 m).
- ^B W11 series sign is required, supplemental plaques are optional.

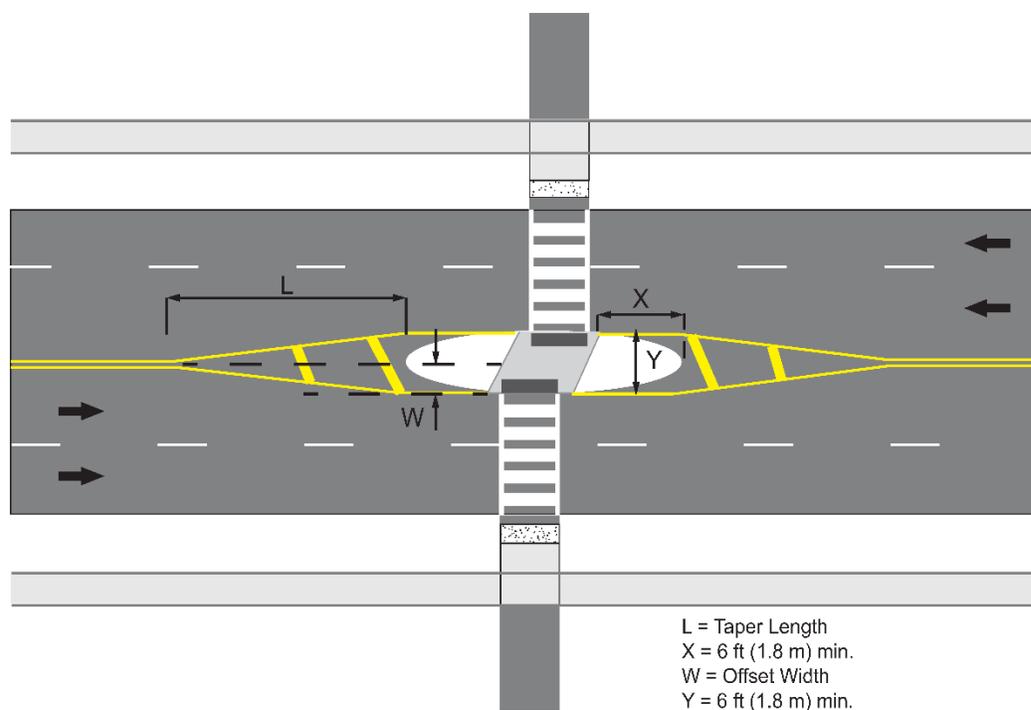
Figure 9: A Crossing Median from AASHTO's Guide for the Development of Bicycle Facilities

A median in the middle of the road breaks up the crossing distance and improves safety by allowing pedestrians to only focus on traffic coming from one direction at a time (and taking refuge in the middle of the street). While medians can be used anywhere, AASHTO notes that they are particularly useful when one of the following conditions is present:

1. High volumes of roadway traffic and/or speeds create difficult crossing conditions for path users
2. Roadway width is excessive given the available crossing time
3. The roadway cross section is three or more lanes in width.

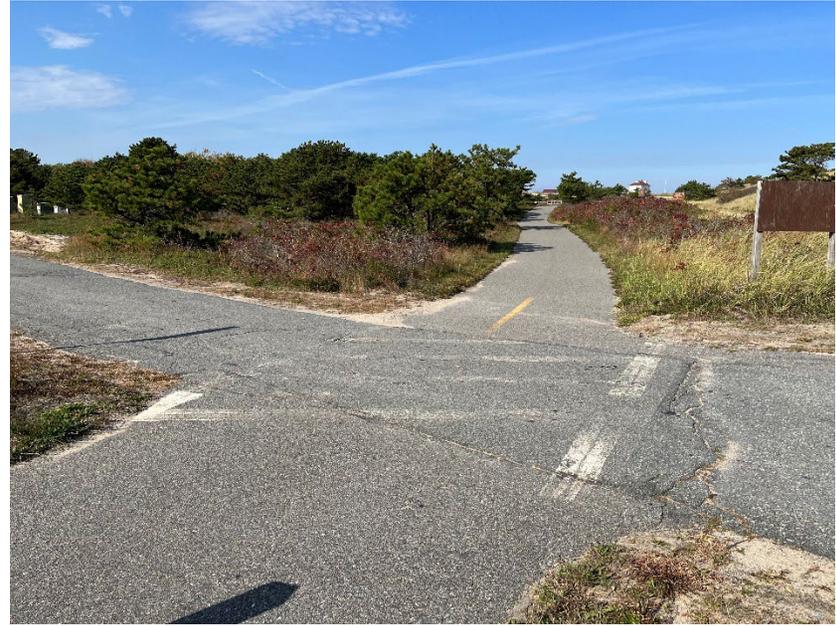
Figure 54: Path Approach (Facing Northbound)

Crosses the employee parking entrance of the airport. Entrance has a makeshift reflective warning sign.
