# ROAD SAFETY AUDIT

Orleans/Eastham Rotary  
Route 6/Van Dale Avenue Intersection  
Towns of Eastham and Orleans  
April 2019

**Michael Baker**

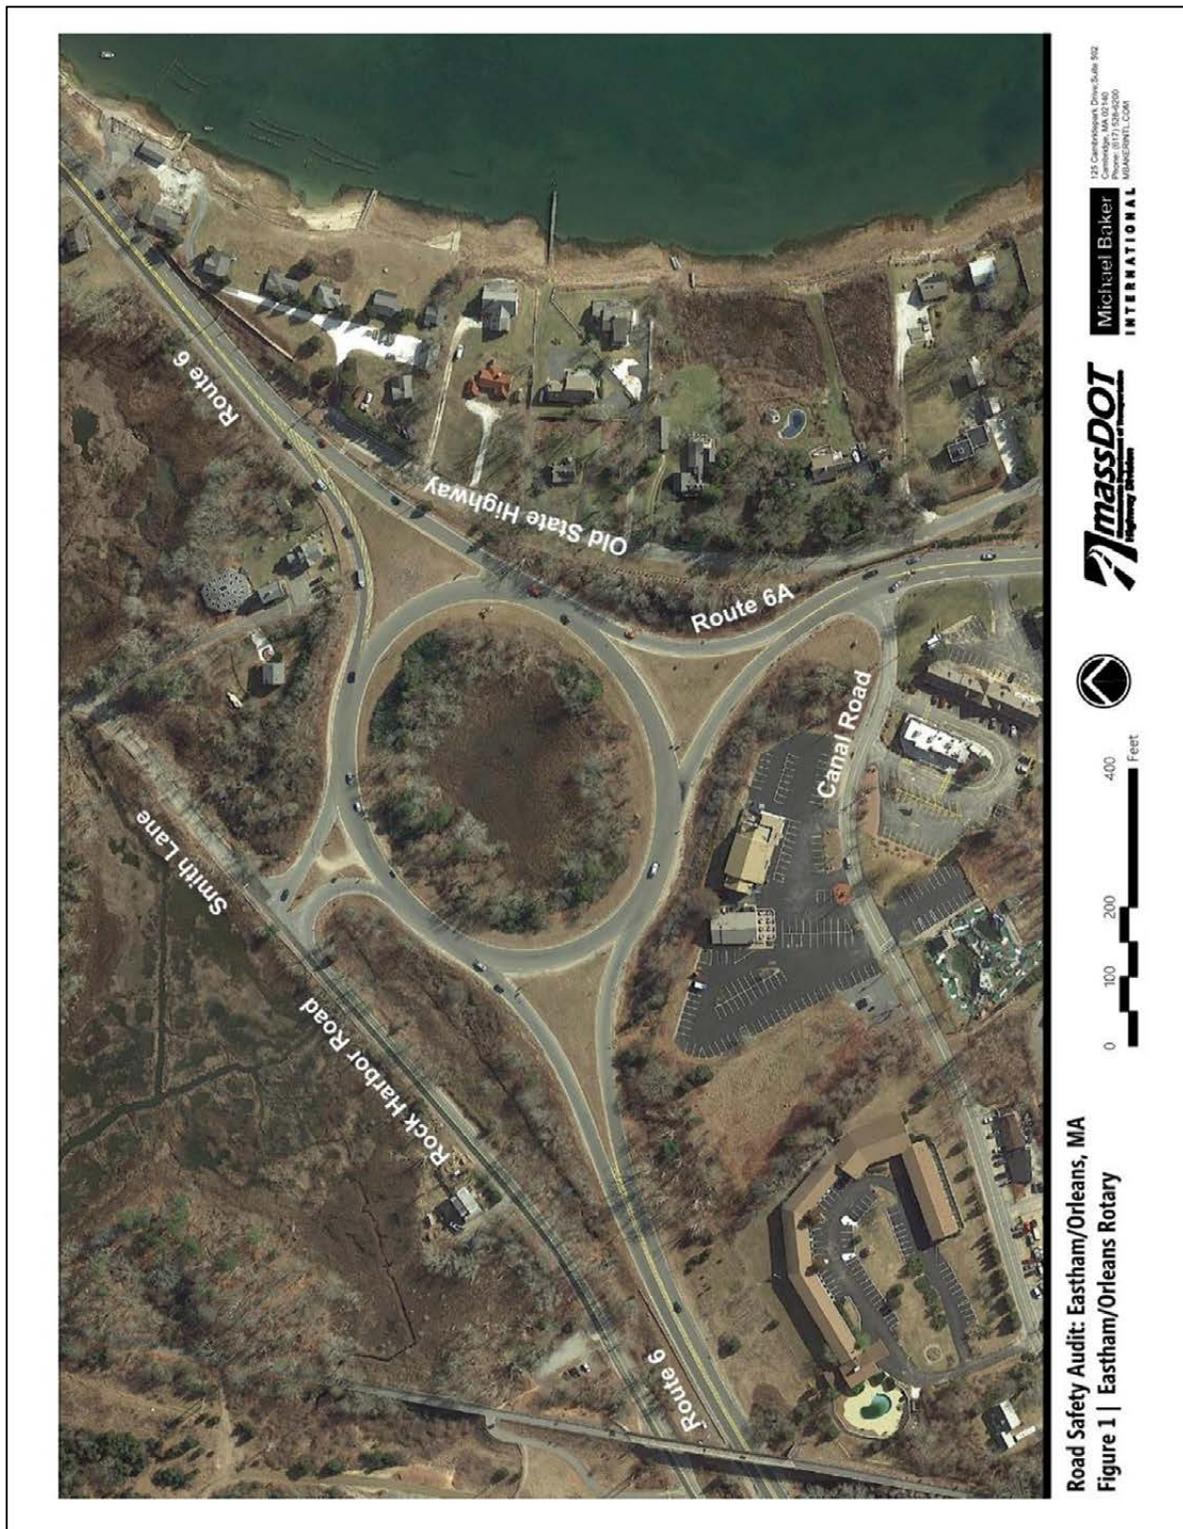
Figure 1: Orleans/Eastham Rotary Locus Map

**Eastham/Orleans Rotary:** The Eastham/Orleans rotary is a major circular intersection on Cape Cod along Route 6, a critical regional roadway under MassDOT jurisdiction (see Figure 1). Route 6A meets the rotary on the southern approach. Smith Lane is the northern leg of the rotary, which offers access to local roads in Orleans and Eastham. Smith Lane becomes Rock Harbor Road when crossing the Orleans town line. The Barnstable 2nd District Courthouse is located on Rock Harbor Road. The town line between Orleans and Eastham bisects the circle. Route 6 and Route 6A are classified as Principal Arterials and located on the National Highway System (NHS). The rotary approaches, departures, and circulating roadways are unmarked, and assumed to be one lane. The RSA team members noted that the pavement widths are wide enough for two lanes and sometimes operate as such.

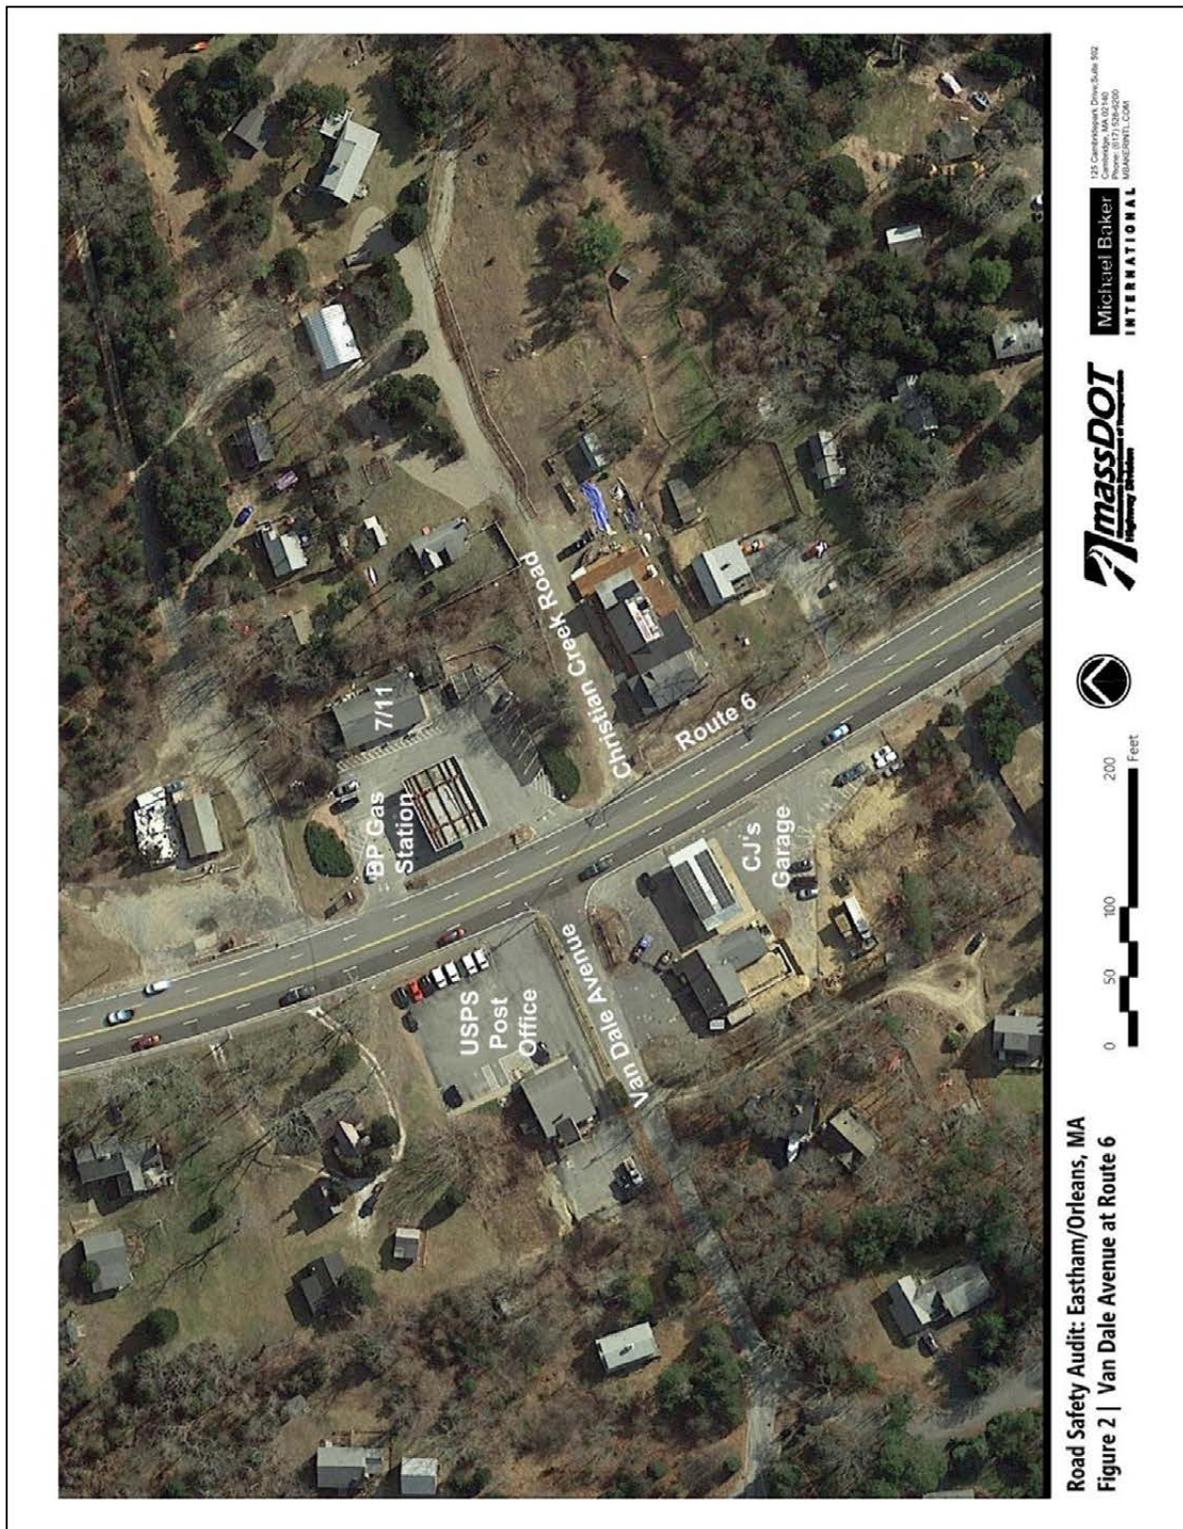
Figure 2: Van Dale Avenue at Route 6 Locus Map

**Route 6 at Van Dale Avenue:** The Route 6 at Van Dale Avenue intersection is an unsignalized “T” intersection (see Figure 2). Van Dale Avenue is a local road under Town of Eastham jurisdiction and intersects Route 6 from the west. Route 6, at this location, is under MassDOT jurisdiction and is classified as a Principal Arterial and is located on the National Highway System (NHS). Route 6 runs north-south and is two-lanes in each direction within the study area. A United States Postal Service post office (USPS post office) is located at the northwest corner of the intersection. The building is served by a 40-foot wide driveway just north of Van Dale Avenue. The USPS post office building is set approximately 100-feet back from the edge of the roadway. CJ’s Auto Garage is located at the southwest corner of the intersection. The garage is serviced by two 70-foot wide driveway curb cuts off Route 6 and a third 55-foot wide driveway off Van Dale Avenue. 7-Eleven with BP gas station is located on the east side across from the USPS post office. The convenience store/gas station is serviced by two driveways, one is signed as Enter Only the other is signed as Exit Only. A small private roadway, Christian Creek Road, is located south of Van Dale Avenue and intersects with Route 6 from the east.

The posted speed limit on Route 6 is 40 mph. Van Dale Avenue is not posted.

There is sidewalk along the west side of Route 6 that ends just north of the USPS post office driveway and picks back up south of the northern driveway to CJ’s Auto Garage.

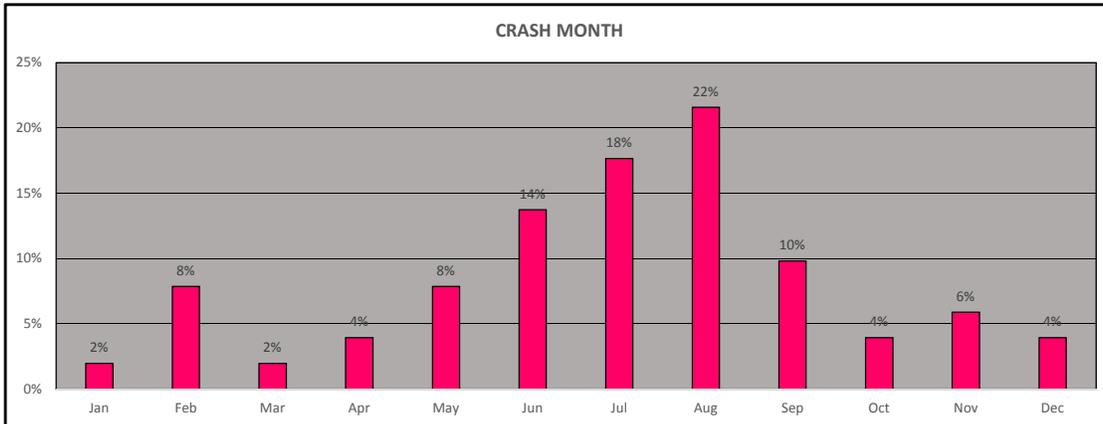
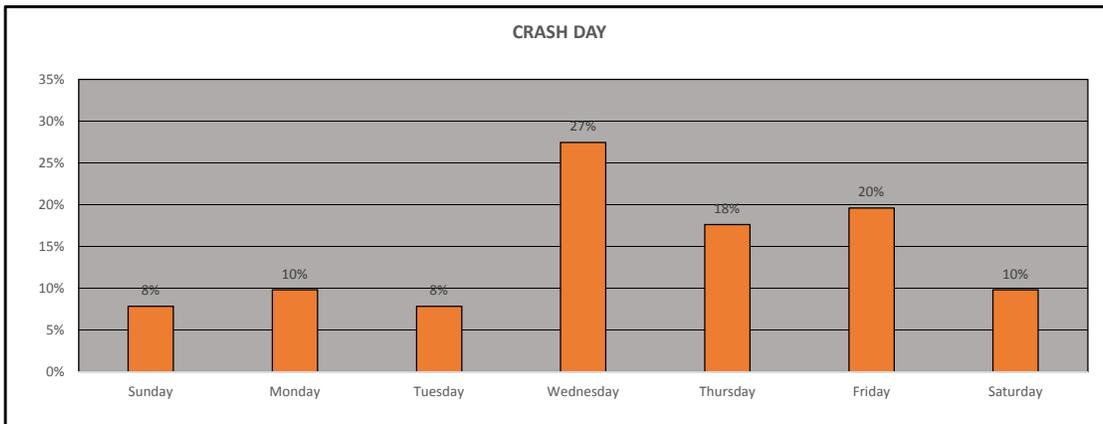
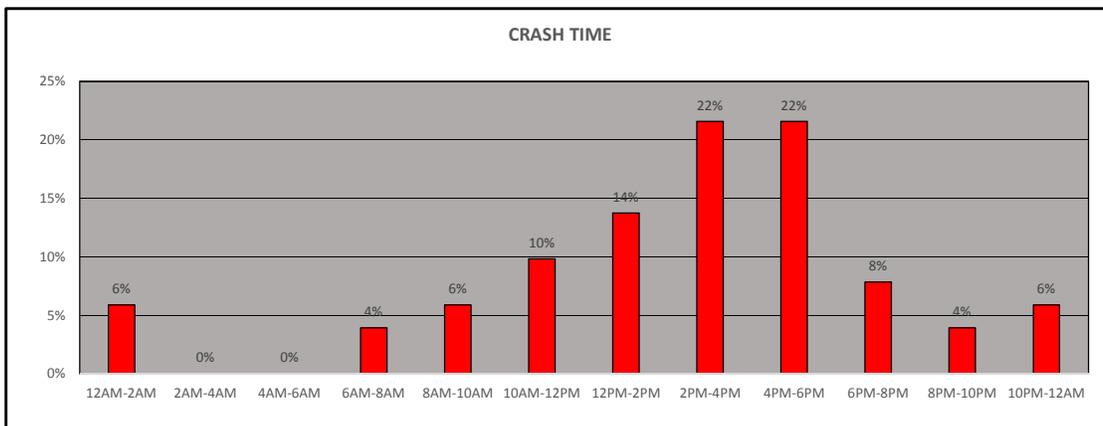
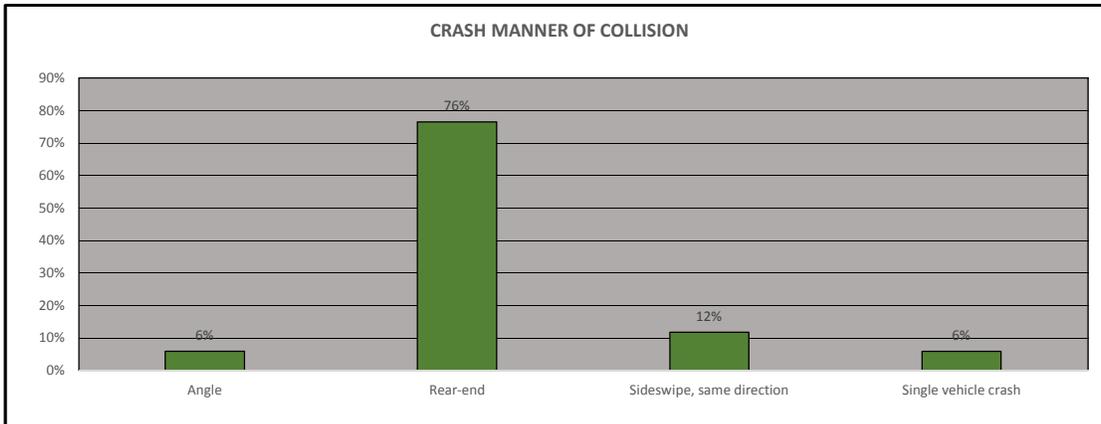
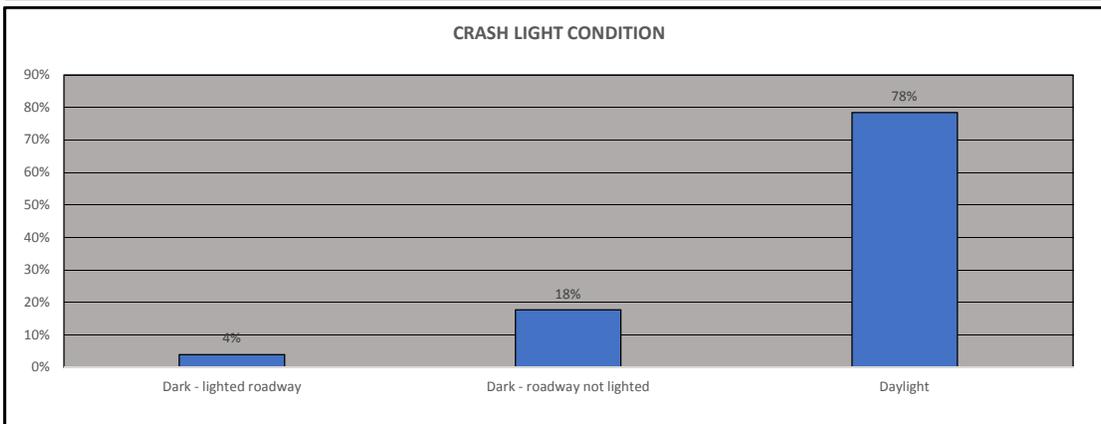
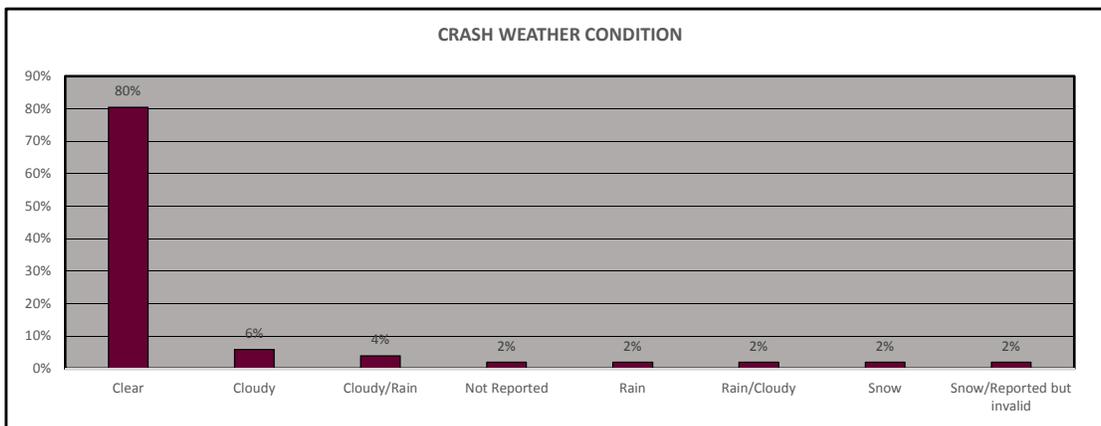
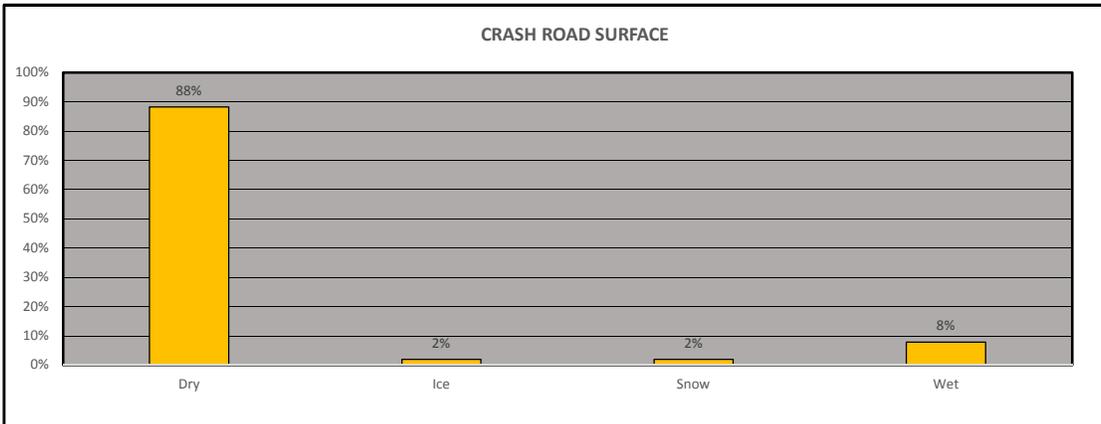
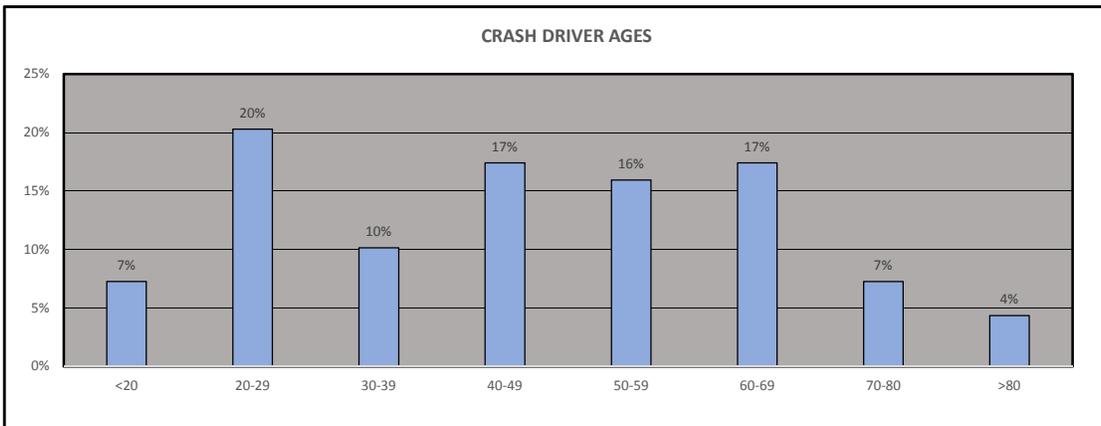
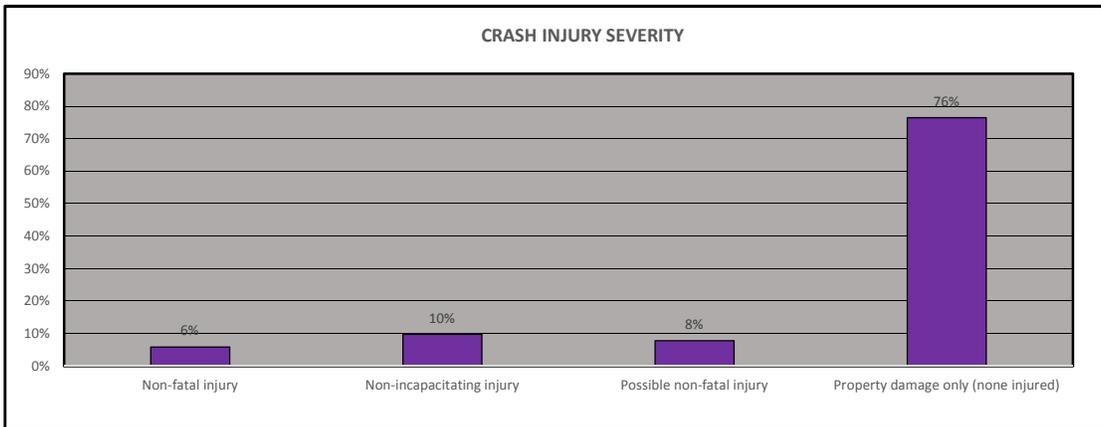
**Crash Data Summary Charts**  
Route 6 Rotary in Eastham/Orleans, MA

For the Eastham/Orleans rotary, the most prevalent crash type was rear-end crashes, accounting for 76% of all crashes. Sideswipe crashes were the second most common manner of collisions, accounting for 12% of crashes. Single vehicle crashes and angle collisions account for 6% and 6% of the crashes, respectively. 78% of crashes occurred under daylight conditions, while 22% of crashes occurred under dark conditions.

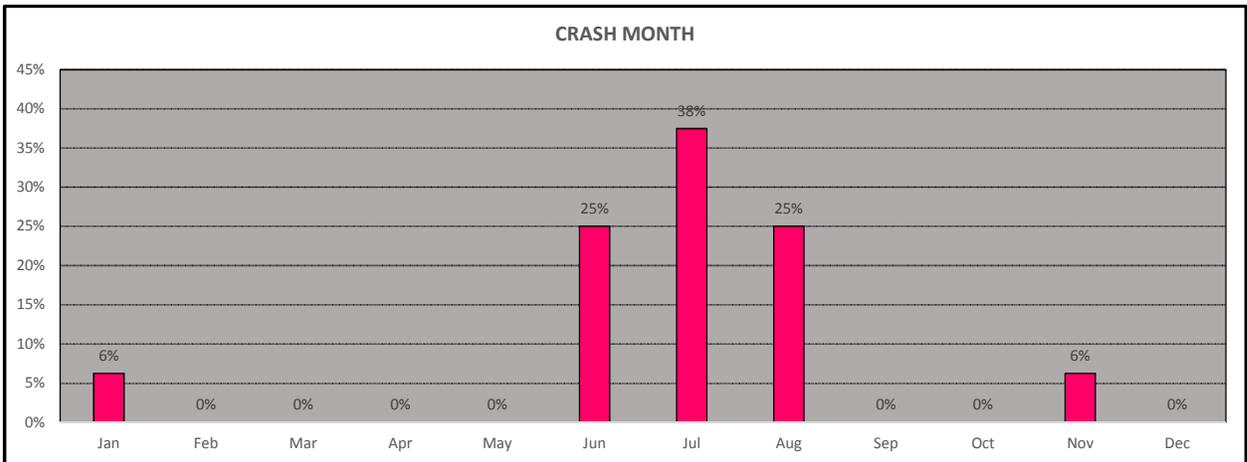
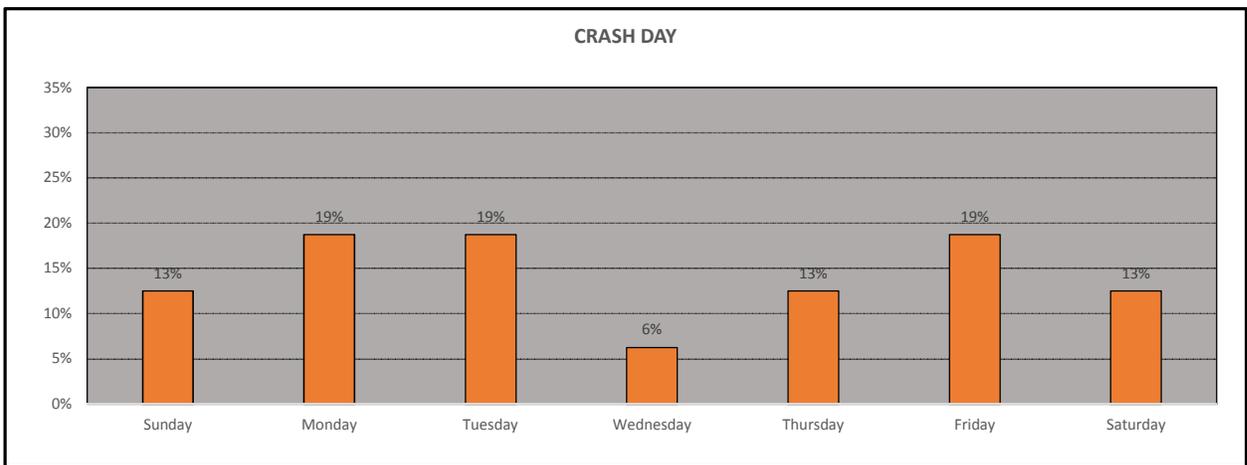
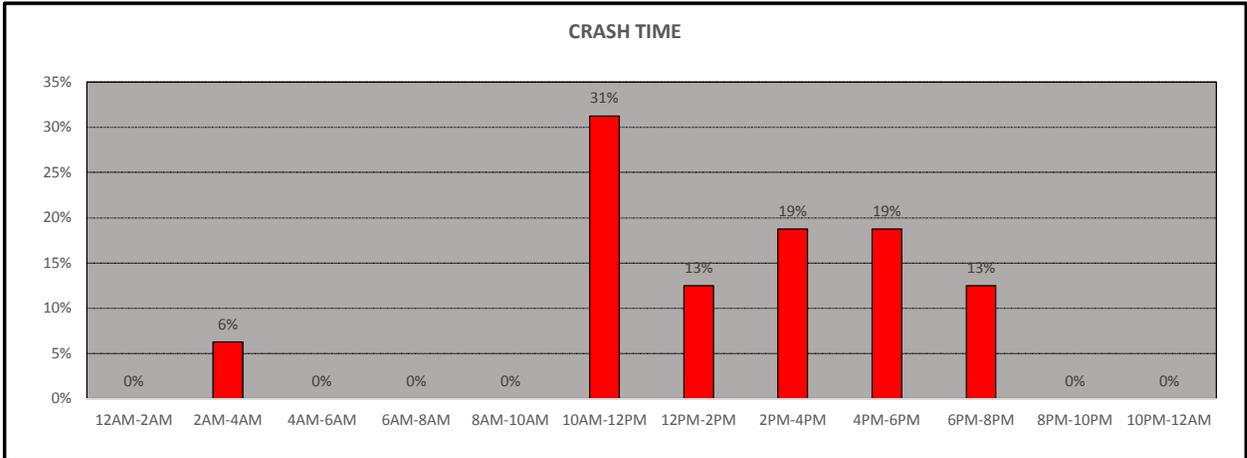
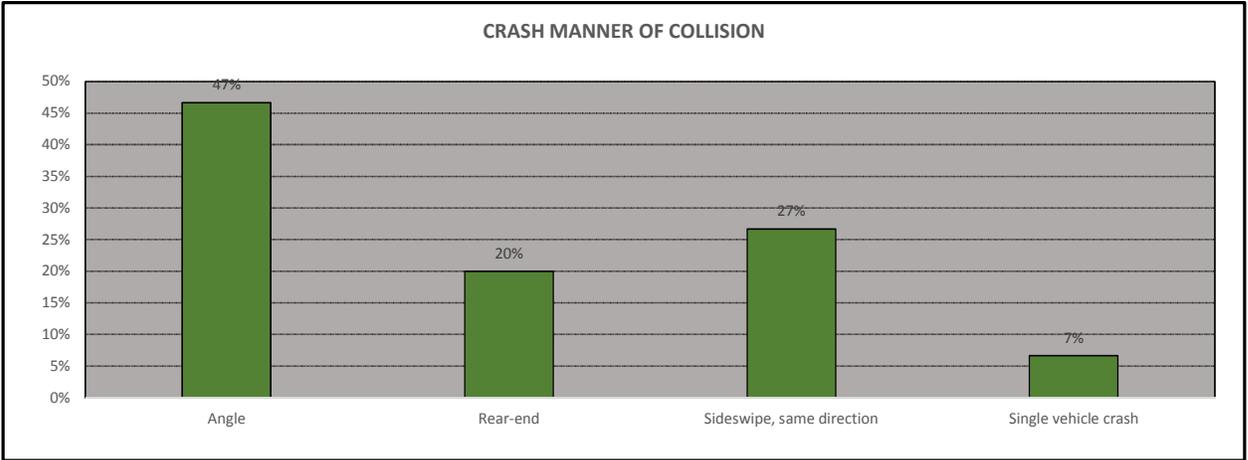
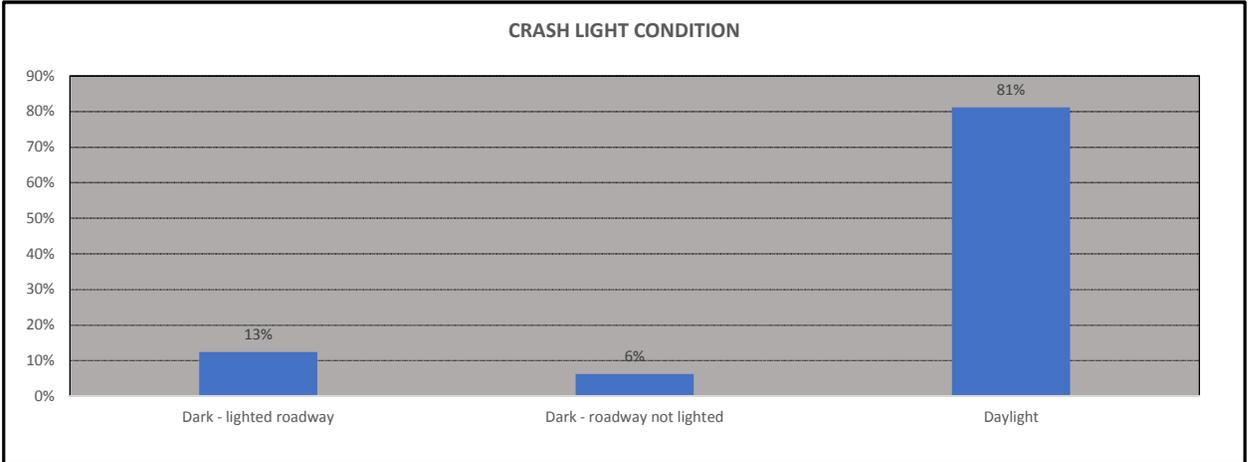
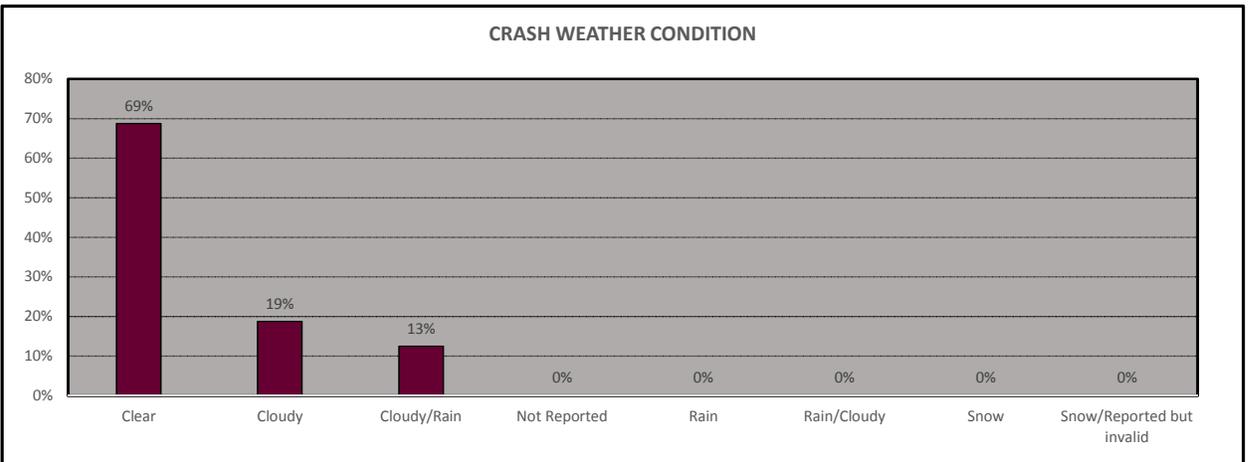
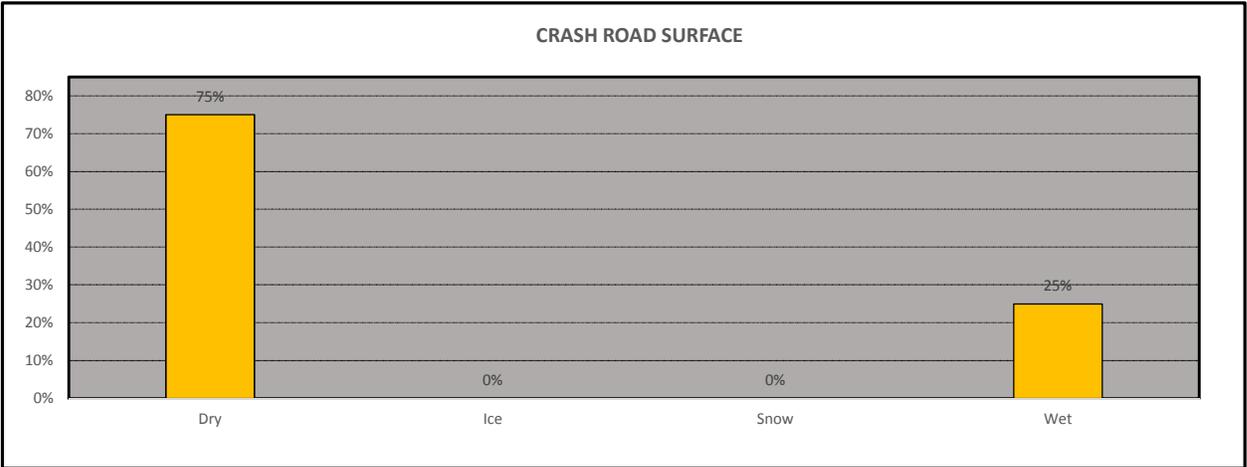
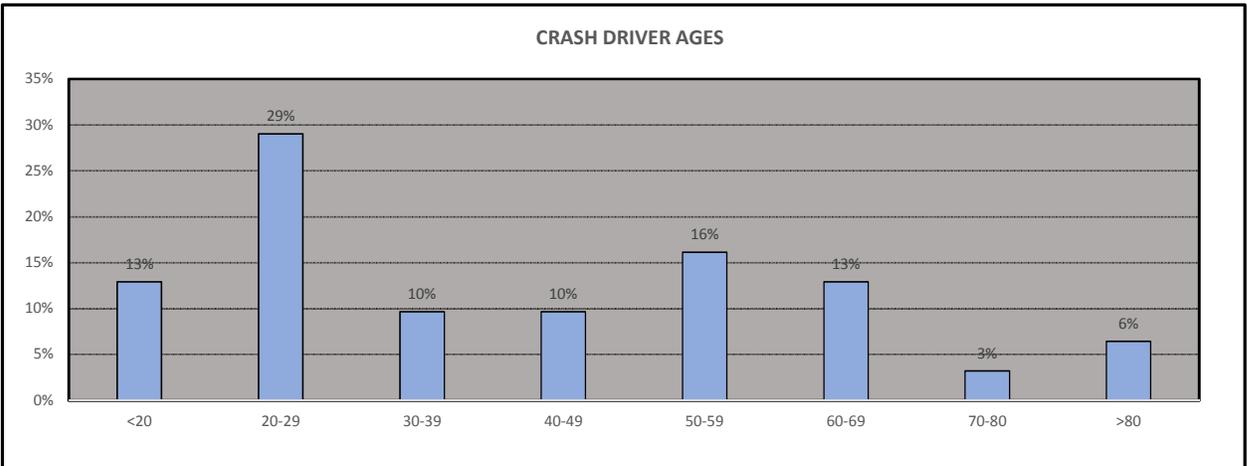
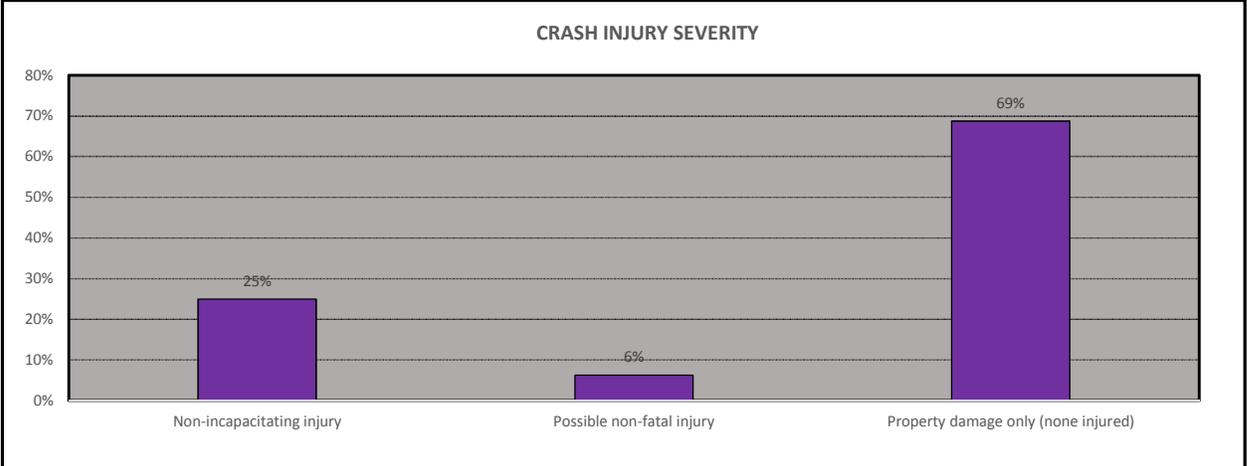
**Crash Data Summary Charts**  
Route 6 & Van Dale Avenue, Eastham, MA

For the Route 6/Van Dale Avenue intersection, the most prevalent crash type was angle crashes, accounting for 47% of all crashes. Sideswipe crashes were the second most common manner of collision, accounting for 27% of crashes. Rear-end and single vehicle collisions account for 20% and 6% of the crashes, respectively. 81% of crashes occurred under daylight conditions, while 19% of crashes occurred under dark conditions.
